Head-up display in model series167 is in-  
termittently inoperative or pixelated

| Topic number | LI54.30-P-078309 |
| Validity | Model series 167 code 804 with SA code 463 |

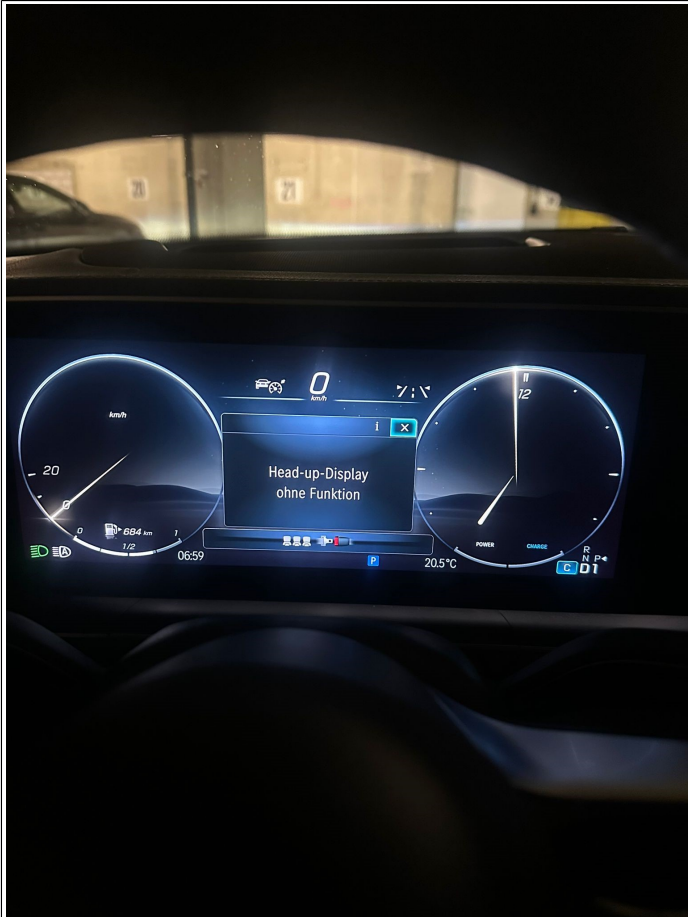
| Attachments | |
|---|---|
| HU+Meldung.jpg | HUD inoperative message |

- Head-up display permanently or sporadically unavailable - with warning message in driver display (see attachment)
- Head-up display permanently or sporadically unavailable - without warning message in driver display
- Display permanently or sporadically discolored and out of focus (see attachment)

Software for the A40/12 - Head-up display and N133/1 - Instrument cluster (IC)

Software for the A40/12 - Head-up display and N133/1 - Instrument cluster (IC) is now available. Please update both control units.

Note: Please do not replace any parts for this complaint.

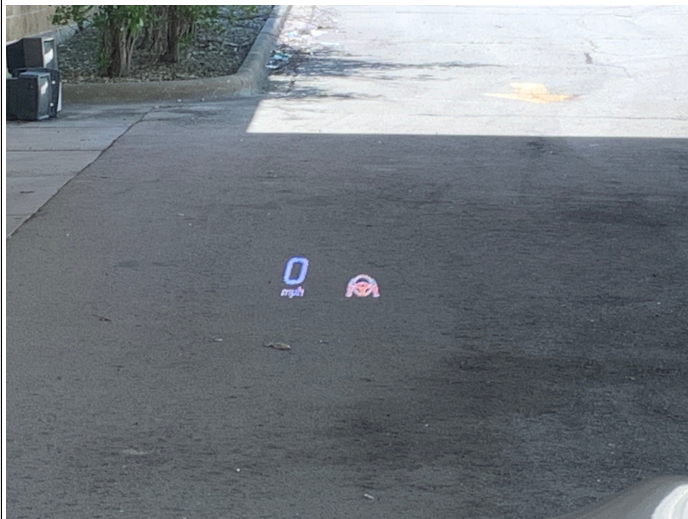
Distorted+HUD+image.jpeg

Distorted image
