The Rear Footwell Lamp Does Not Change Color When Entering And Exiting

Topic number	LI82.20-P-079001
Version	1
Function group	82.20 - Interior lights
Date	3/10/25
Validity	Model 223, 294, 295, 296, 297 with code 891 (Ambient lighting) and NOT 7U2 (Seat type variant 2)
Reason for change	Model series and countries expanded

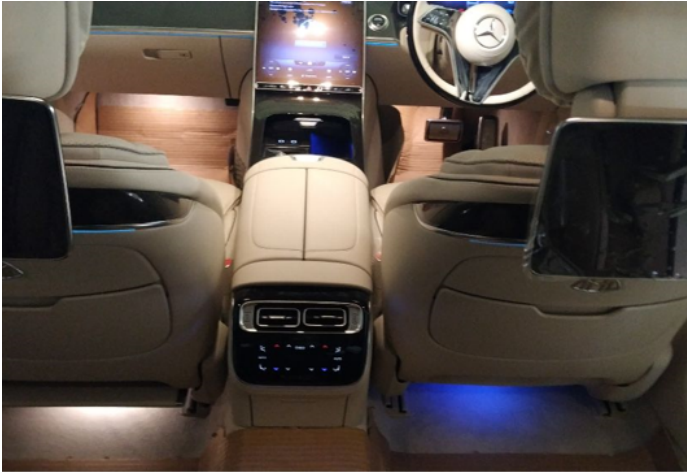
If a door is opened, the color of the footwell lamp under the front seats on one of the two sides does not change to white.

It may therefore be the case that the rear left footwell lamp is illuminated in white and the rear right footwell lamp is illuminated in blue, as shown in the example picture in the attachment.

Attachments	
File	Description
Bild1.png	Fault profile (only for illustrative purposes)

Incorrect SCN coding in control unit N10/6 (Front SAM).

Perform SCN coding in control unit N10/6 (Front SAM).
