Front Right Tire Pressure Sensor Nonfunctional/Not Detected

| Topic number | LI40.15-P-073336 |
| Function group | 40.15 - Tire pressure/tire pressure monitoring |
| Validity | Model series 118, 177, 243 and 247 with code 475 (Tire pressure monitor) |

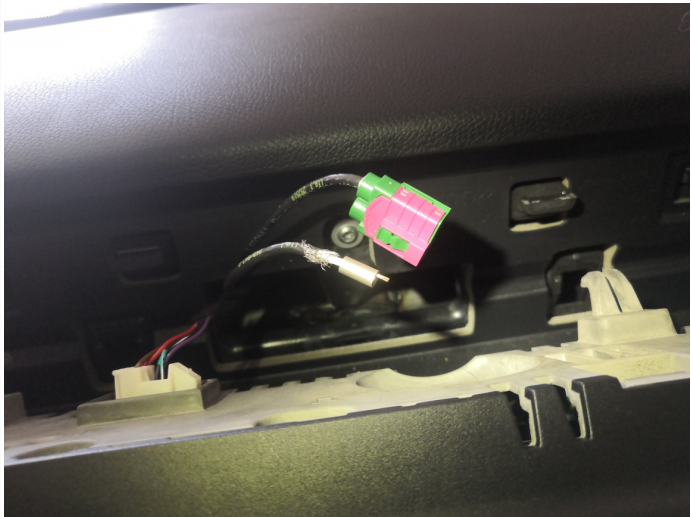
| Attachments | |
|---|---|
| <a href="#">Coaxial Cable Damage.jpg</a> | Coaxial Cable Damaged |

Coaxial cable from instrument cluster to instrument cluster control unit (under driver's seat) damaged.

Check coaxial cable from display cluster for head unit/instrument cluster (A26/17 or A40/16 - depending on equipment variant) to head unit/display cluster control unit (N133/1 or N166).

If the plug contact of the coaxial cable or the connector housing connection is faulty, replace coaxial cable (see XPI).
