TECHNICAL SERVICE BULLETIN

HA24-003

AIR CONDITIONING IS INOPERATIVE WITH LEAK FROM HIGH/LOW SIDE PIPE JUNCTION

APPLIED VEHICLES: 2024-2025 QX60 (L51)
APPLIED DATES: Built on or after December 1, 2023

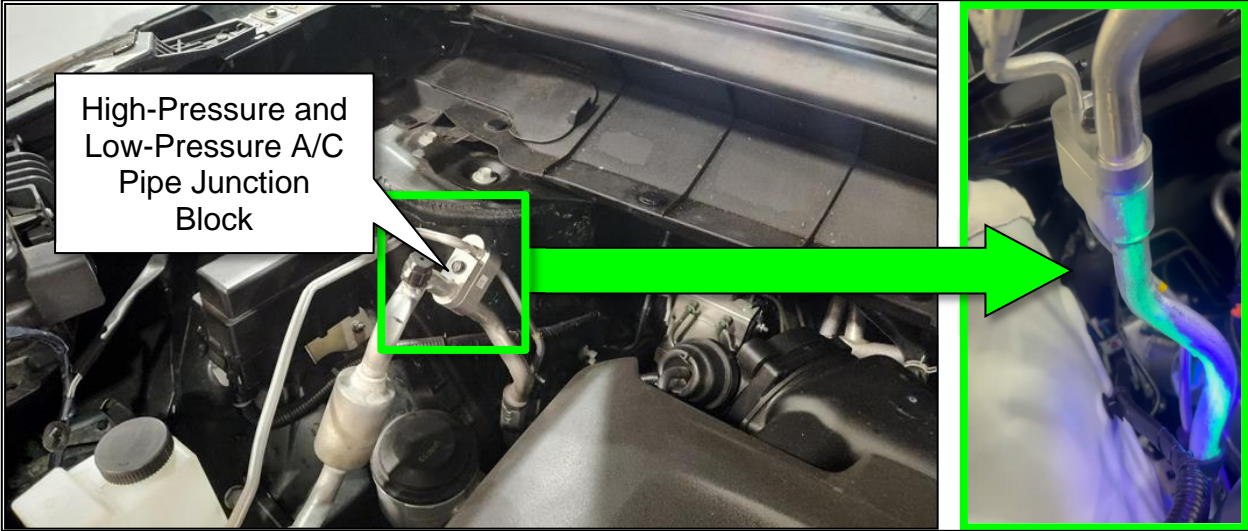
Figure 1

Leak detection dye is confirmed as present on the high-pressure and low-pressure A/C pipe junction blocks.

Refrigerant Leak Examples

Replace the A/C High-Pressure and Low-Pressure Pipe.
