TECHNICAL SERVICE BULLETIN

Moan Noise In The Rear Brakes When Vehicle Is Driven In Reverse In Cold Weather And/Or High Humidity

25-2095

Ford 2021-2025 Bronco Sport	Built on or before 21-Dec-2024
2020-2025 Escape

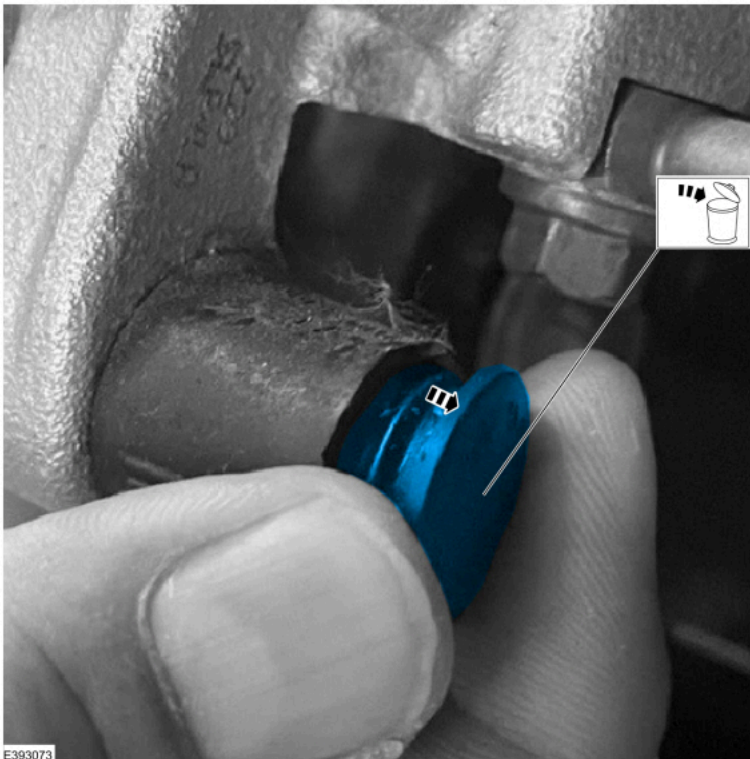
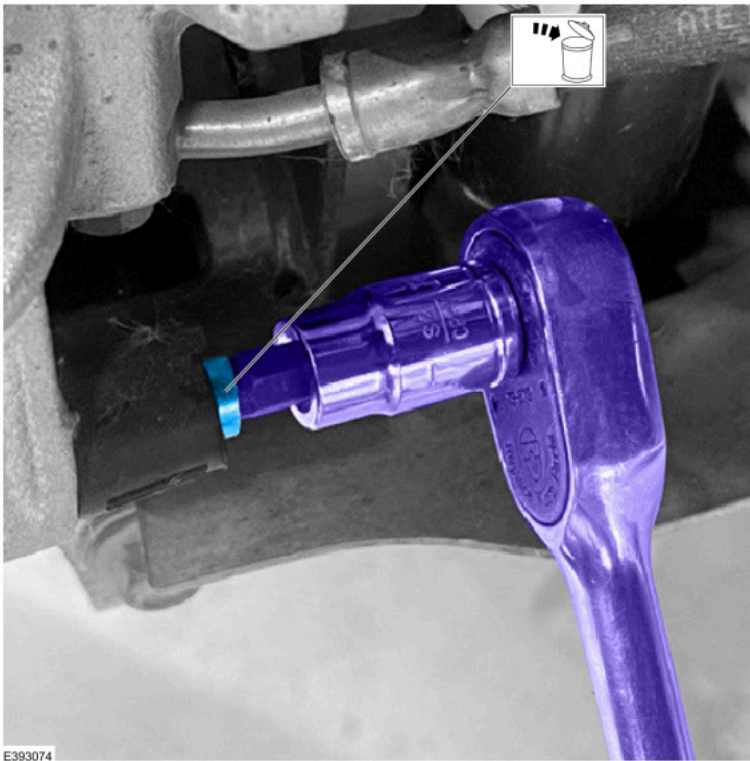
Figure 3

5. Remove and discard the brake caliper guide pin cap and guide pin on the opposite side of the bleeder. (Figures 3-5)

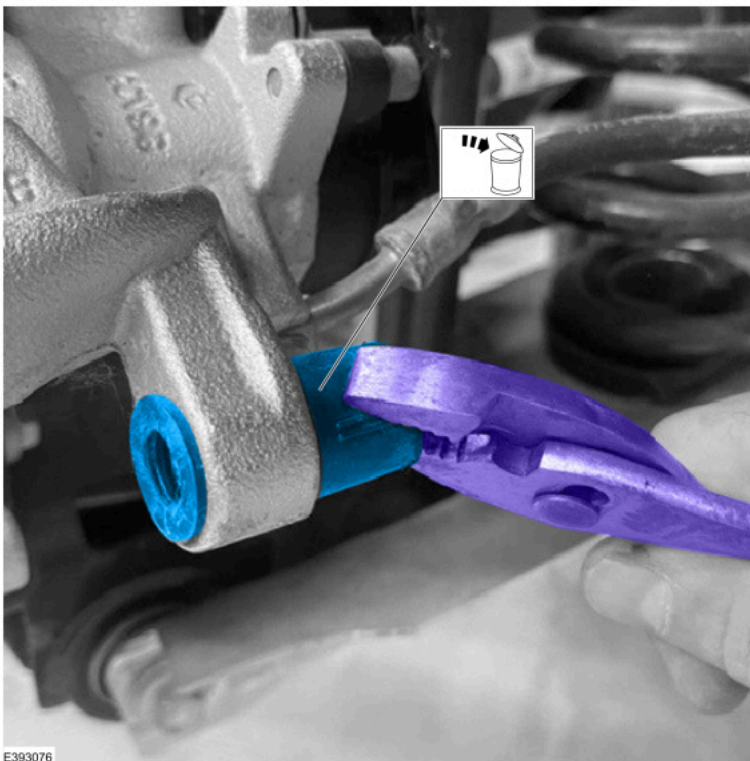
7. Using 6 inch slip joint pliers, remove and discard the standard bushing located on the opposite side of the bleeder. (Figure 7)
Figure 7

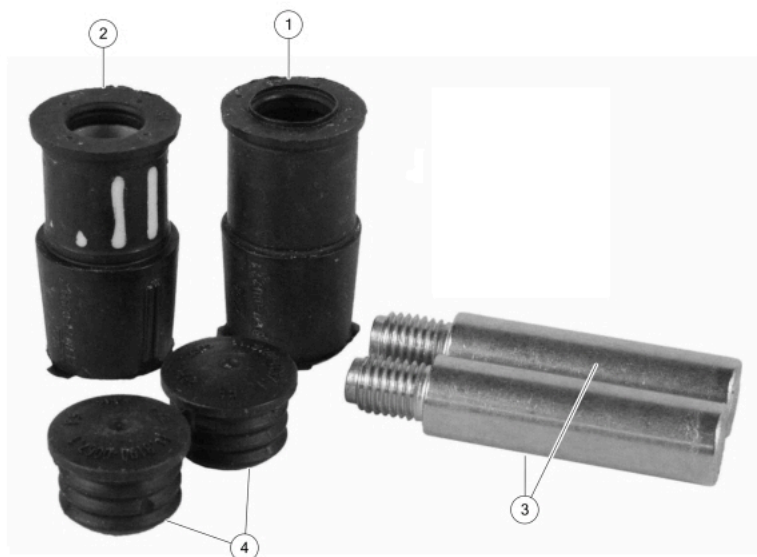
Figure 8

NOTE: The kit includes: (1) standard bushing (Figure 8, Callout 1), (1) reinforced bushing (Figure 8, Callout 2), (2) guide pins (Figure 8, Callout 3), (2) guide pin caps (Figure 8, Callout 4)

Item	Description
1	Standard Bushing
2	Reinforced Bushing
3	Guide Pins
4	Guide Pin Caps

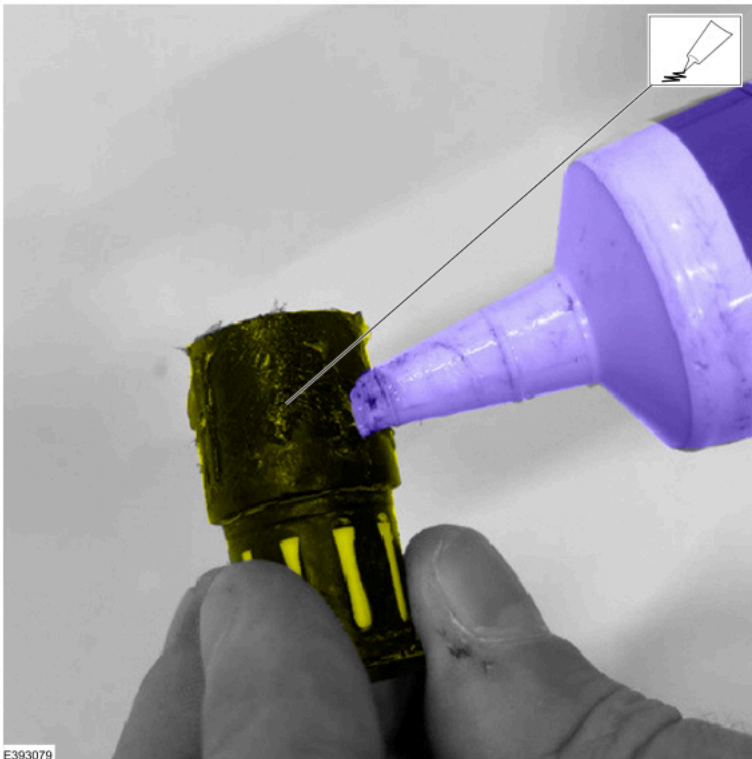
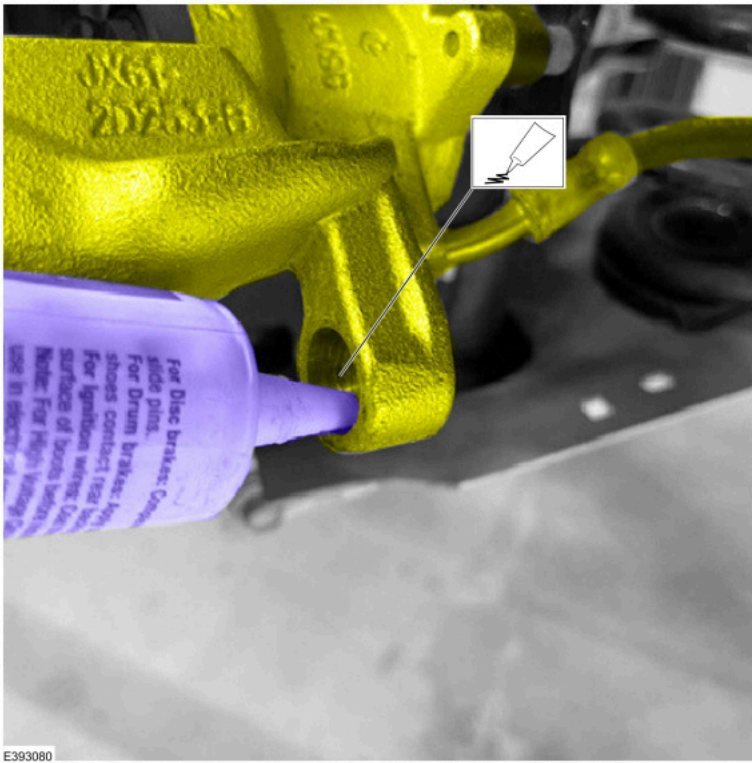
Figure 10

(3). Lubricate the bushing and bushing housing with Motorcraft® Silicone brake caliper grease. (Figures 10-11)

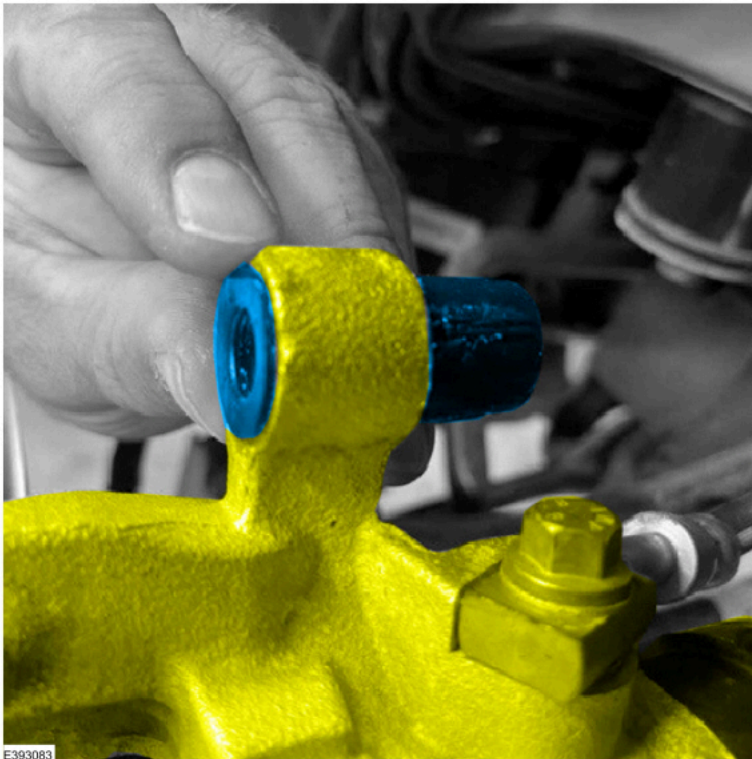
Figure 12

(4). Use an appropriate diameter socket, such as a 13 mm 3/8 drive chrome deep socket, to push the bushing into the caliper bushing housing. (Figures 12-14)

NOTE: Use a plastic trim tool to help guide the bushing into the housing.

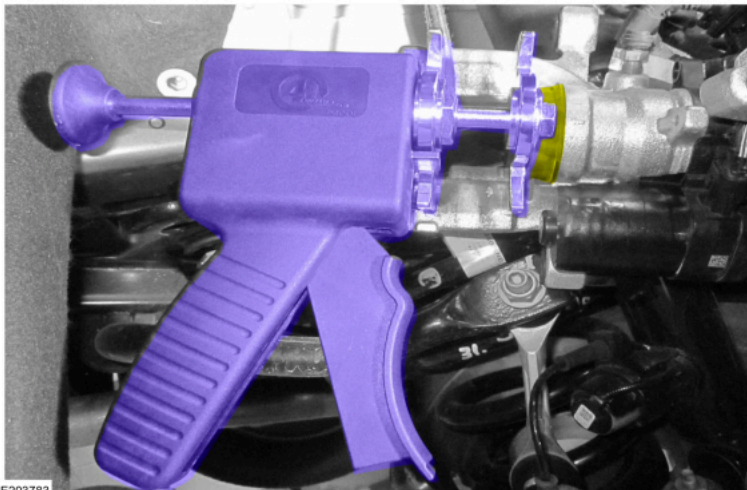
Figure 17

20. Remove and discard the brake pads. Refer to the WSM, Section 206-04 Rear Disc Brake > Removal and Installation
21. Compress the brake caliper piston until the piston bottoms out in the brake caliper bore. (Figure 17)
