SS 3176-FTL ICC5 Erroneous Electric Power Steering Warning Message

All eM2 and eCascadia, and New Cascadia with optional ICC5

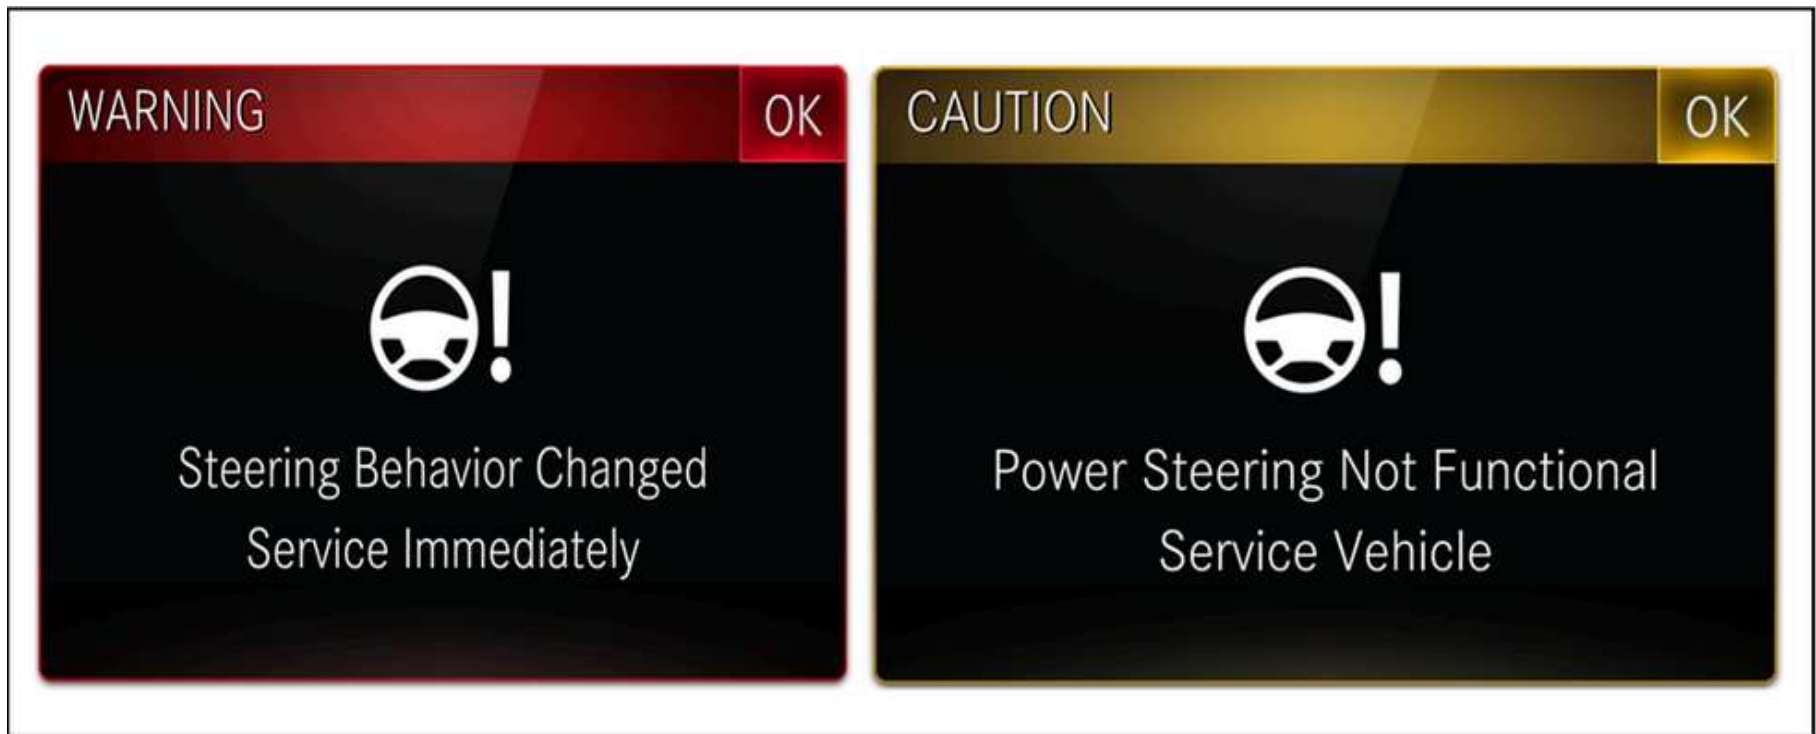
On electric vehicles, there could be one erroneous message ("Steering Behavior Changed..." shown below), which can be cleared as indicated in the Solution section. The other ("Power Steering Not Functional...") indicates a problem that should be repaired.

For vehicles built up to model year 2023 either of the warning messages pictured in Figure 1 could be displayed. The red message "Steering Behavior Changed Service Immediately" was never intended to show up on any of these vehicles.

For all vehicles with the ICC5 built after model year 2023 only the warning message in the amber color "Power Steering Not Functional Service Vehicle" could be displayed.

In both groups mentioned above, the warning messages were never intended to be displayed on the ICC5 for vehicles built with a diesel engine. Only the amber message is intended to be displayed on electric vehicles.

If the vehicle encountering either of the warning message has a diesel engine, then use the middle button on the left side of the steering wheel to clear either message. Both messages should be considered nuisance messages as neither apply to diesel powered vehicles.

If the vehicle is an eM2 or eCascadia and the red message "Steering Behavior Changed Service Immediately" is displayed, then use the middle button on the left side of the steering wheel to clear the message. This message should be considered a nuisance message, as it was never intended to show up on any of these vehicles.

If the vehicle is an eM2 or eCascadia and the amber message "Steering Behavior Changed Service Immediately" then the vehicle should be taken to an authorized service center to have the steering system diagnosed.
