## Preview Solution CBR-2452-1

# Driver Display Popup Error "Door Is Open. Shift Transmission To Neutral." - Instrument Cluster Software Update

Volvo Chassis - VN,VAH,VHD, IC-GEN2

Mack Chassis - AN,GR,PI, IC-GEN2

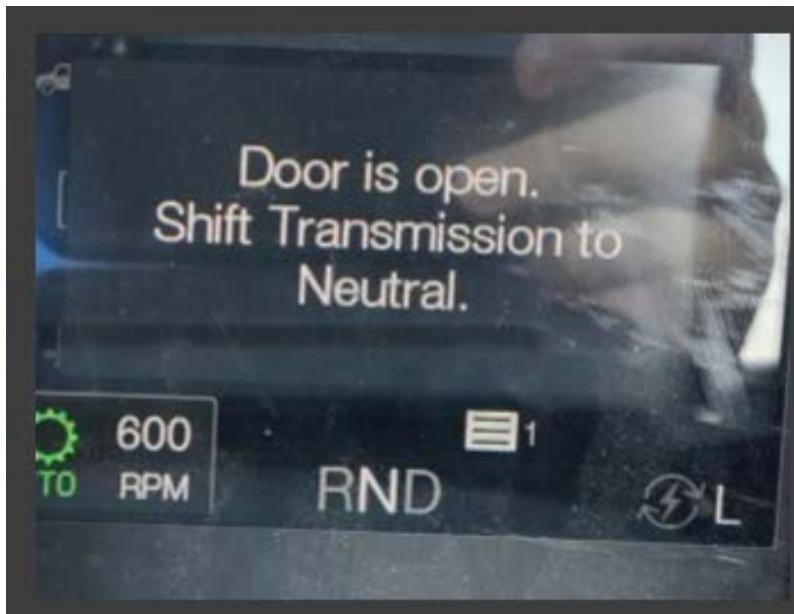
If the vehicle door is open and the truck is in neutral, a popup message may appear on the Driver Information Display (DID) instructing the operator to shift into neutral. If this message appears while the vehicle is already in neutral, the Instrument Cluster (IC) requires a software update.

This condition occurs due to an incorrectly set parameter within the IC software.

- A software update is required to correct the parameter and restore proper operation.
- The software update is available with **Accessory Kit #85171636**.

- Updating the software will modify the parameter to ensure the system functions as designed.

1. Run accessory kit (**#85171636**).
2. Verify the update by checking system operation after programming.
3. Ensure the popup message no longer appears incorrectly.
