STAR ONLINE PUBLICATION

Case Number: S2523000010 Rev. A

Symptom/Vehicle Issue: Exterior Rear View Mirror Stained And Will Not Clean.

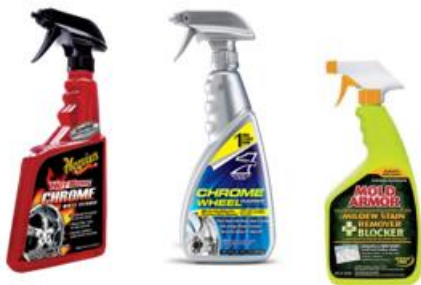
Examples with Phosphoric Acid:

Discussion: Some automotive cleaning products such as chrome wheel cleaner contain phosphoric acid and ammonium bifluoride. These chemicals will cause etching on mirror glass surfaces. The damage can be due to overspray, direct contact, or a contaminated cloth. The glass is likely to be damaged requiring replacement. See product examples below that contain these chemicals

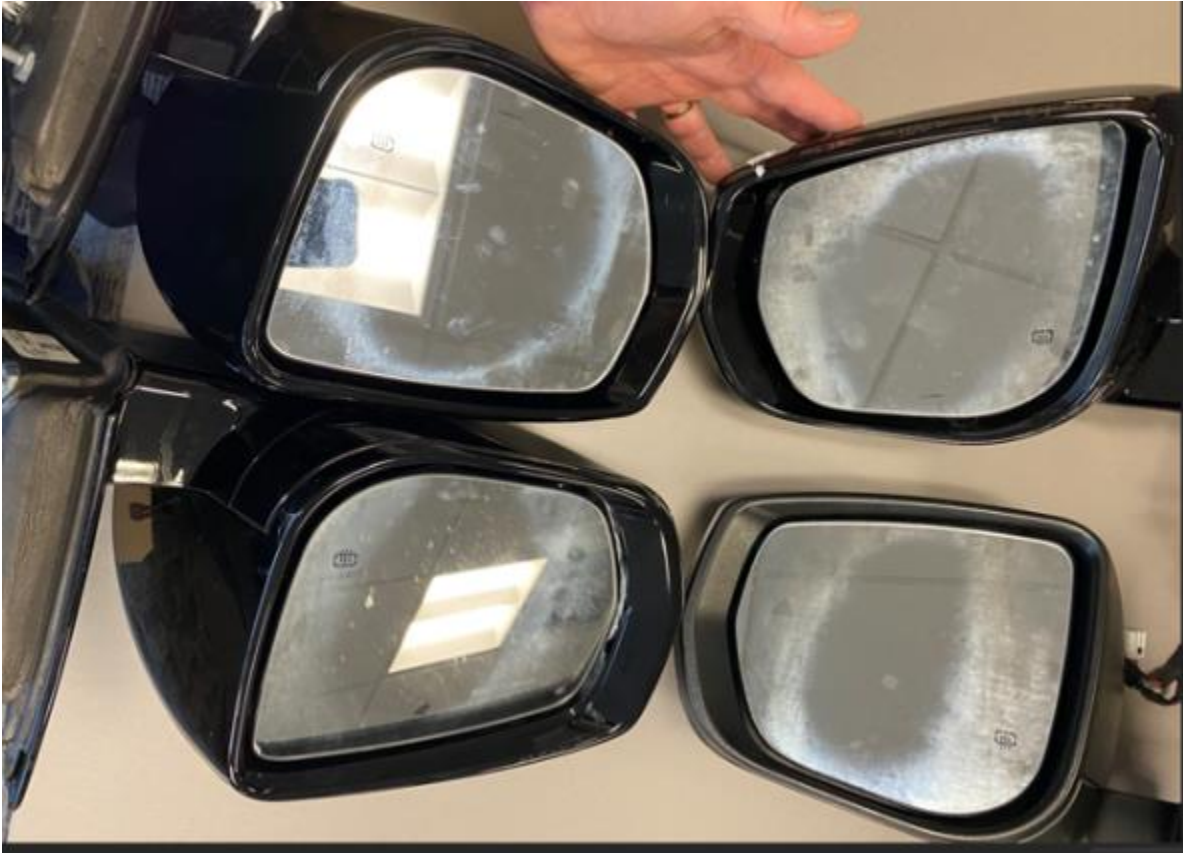
Examples of Damaged Mirrors:

Customer Complaint/Technician Observation: Mirror has water marks or staining that will not come off.
