## STAR ONLINE PUBLICATION

**Case Number:** S2508000025

**Symptom/Vehicle Issue:** Instrument Panel Cluster (IPC) and Radio Compass Display has Dashes (--)

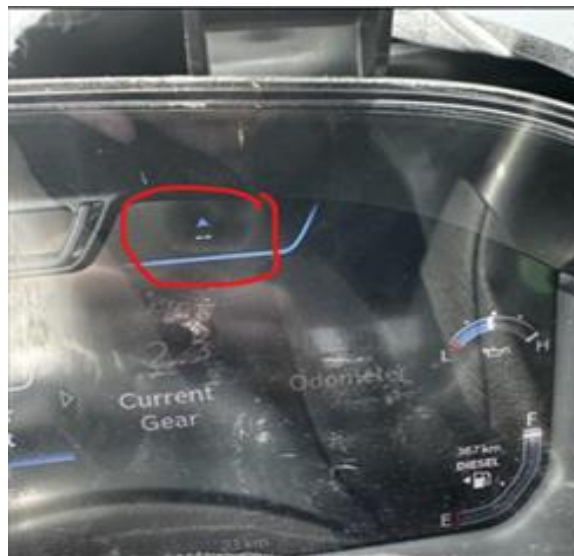
**Discussion:** Customers may experience the compass displays on the IPC and on Radio "ETM/LTM" to display dashes "--". The BCM may set the DTC U147C-00 "Implausible Data Received From ETM" as active fault code until the customer/technician drives the vehicle in an open area. The condition may recover from driving the vehicle or resetting the radio.

The condition may re-appear after a full sleep cycle. Do not replace the radio or the Body Control Module (BCM) for this issue. The field will be notified when updates for the radio become available.
