REFERENCE:	TSB: 14-009-25 GROUP: 14 - Fuel System	Date:	April 5, 2025	REVISION:	—
VEHICLES AFFECTED:	2022 - 2024 (B1) Jeep Renegade 2022 - 2024 (H1) Jeep Commander 2022 - 2024 (M1) Jeep Compass This bulletin applies to the vehicle built on or before March 12, 2024 (MDH 0312XX) equipped with a 1.3L I4 Turbo MAir DI Engine w/ESS (Sales Code EYF).	MARKET APPLICABILITY:			
		<input type="checkbox"/> NA <input type="checkbox"/> MEA		<input type="checkbox"/> IAP	
		<input checked="" type="checkbox"/> SA <input type="checkbox"/> CH			
CUSTOMER SYMPTOM:	<p>Customers must experience a Malfunction Indicator Lamp (MIL) illumination and the vehicle must exhibit/set one or more of the following Diagnostic Trouble Codes (DTCs):</p> <ul style="list-style-type: none"> ● P0087-00 - Fuel Line Pressure Sensor - Bank 1 - Pressure Below Limit. ● P0300-00 - Multiple Cylinder Misfire. ● P0301 - Cylinder 1 Misfire. ● P0302 - Cylinder 2 Misfire. ● P0303 - Cylinder 3 Misfire. ● P0304 - Cylinder 4 Misfire. ● P006C-00 - Air Pressure and Temperature Sensor - Correlation. <p>Customers may also comment on one or more of the following:</p> <ul style="list-style-type: none"> ● Unstable idle. ● Abnormal engine nois

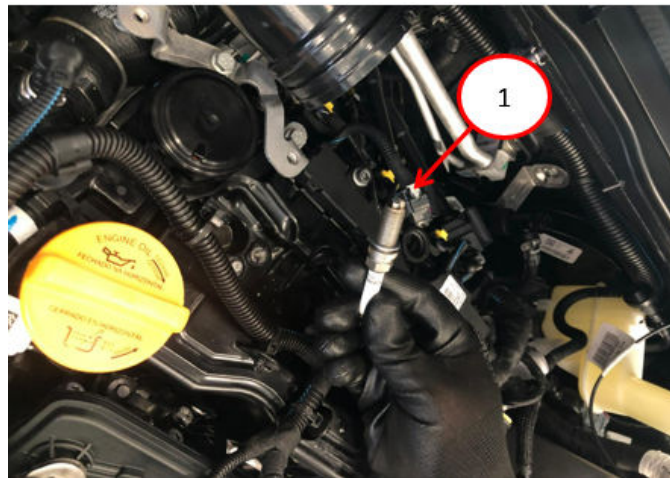
Fig. 1
Spark Plugs

1. Remove the spark plugs [Fig. 1](#). Refer to the detailed service procedures available in DealerCONNECT/ Service Library under: Service Info> 5510D10 – Velas de ignição – Remoção e Recolocação.

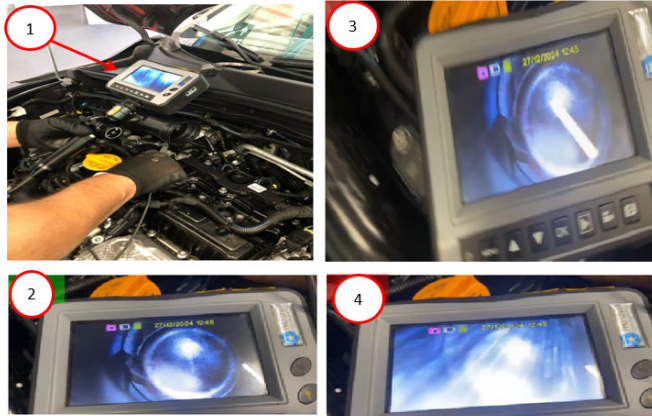
Fig. 2
Endoscope

If the customer describes any of the symptoms listed above in the customer symptom section and a fuel injector leak is verified using the Endoscope, perform the Repair Procedure.

- Using an Endoscope, check all injectors Fig. 2. With the help of a collaborator, ask him/her to turn the ignition key without starting the vehicle. Keep the ignition on for one minute per injector.

- 1 - Endoscope
- 2 - Injector Inspection Okay
- 3 - Injector Inspection Not Okay
- 4 - Injector Inspection Not Okay

- Replace all fuel injectors and the high pressure tube. Refer to the detailed service procedures available in DealerCONNECT/Service Library under: Service Info> 1056F60 - Tubo Coletor de Combustível Único - Completo de Eletroinjeter Remoção/Recolocação.
- Clear DTCs.
