- Subject: N242484500 Service Update Rear Door Latch Ajar Malfunction
- Models: 2024 Chevrolet Silverado EV

# Service Update N242484500 Rear Door Latch Ajar Malfunction

#### Release Date: April 2025

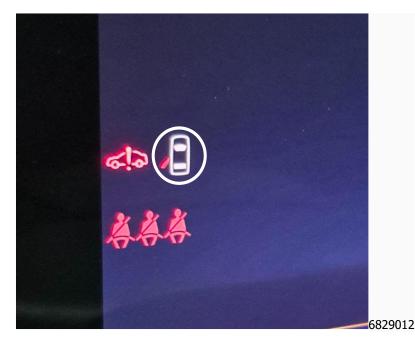
- 1. Put the vehicle in service mode. To place the vehicle in service mode:
  - Ensure the vehicle is off, the driver door is open, and the brake pedal is not applied.
  - Press and release the accelerator pedal three times within five seconds, keeping the accelerator pressed on the third time.
  - The instrument cluster and infotainment systems will now turn on and operate normally, and you can release the accelerator pedal.

- 2. Open both rear doors, then check the instrument panel cluster (IPC) to see if the door ajar indicator is working for each of them.
  - If the IPC does NOT show both rear doors open, proceed to step 3.
  - If the IPC DOES show both rear doors open, no further action is required.
- 3. Vehicle off.
- 4. Replace the Rear Side Door Wiring Harness for whichever door(s) do NOT show as open. Refer to *Rear Side Door Wiring Harness Replacement* in SI.
