MAS004491 RU 25-06

Rapid Update 777 Granturismo Folgore – Internal pillar trim replacement

DATE: April 2 2025

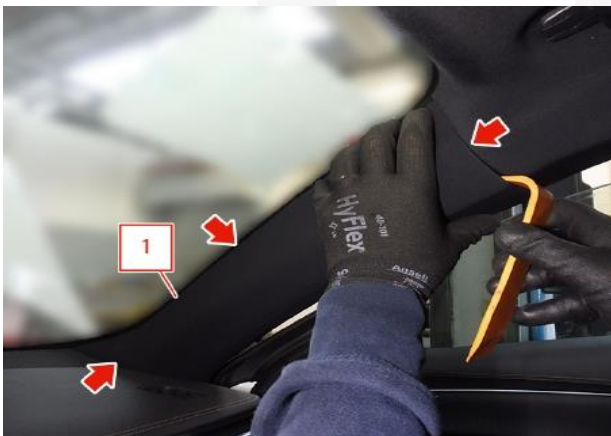
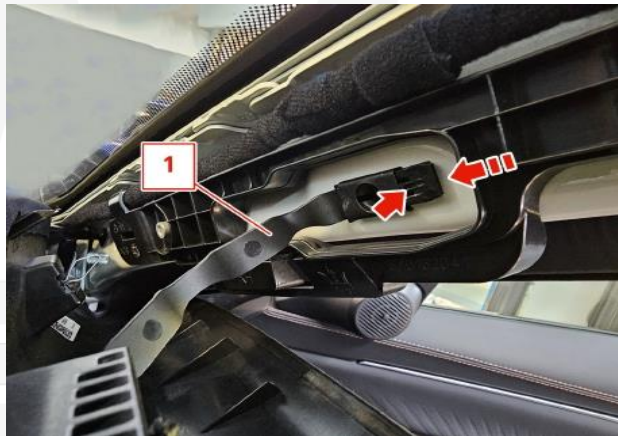
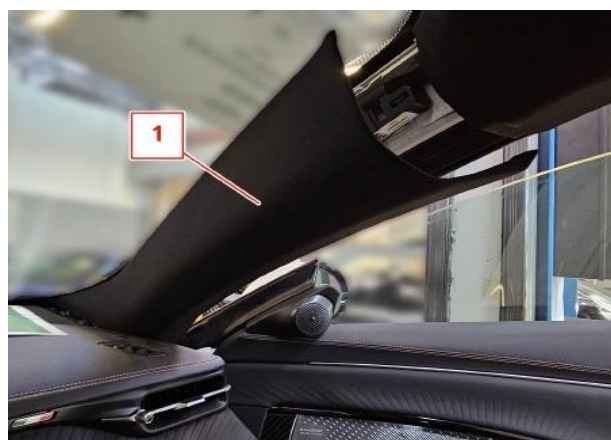
3. Make sure you use all the interior protection/precautions to work inside the vehicle.
4. If the VIN list states to replace the A-pillars, both front side trims must be replaced, following the procedure in the workshop manual:
 - a. **9.44.001 RH WINDSCREEN PILLAR COVER.** Removal-Refitting or Replacement
 - b. **9.44.002 LEFT WINDSCREEN PILLAR COVER.** Removal-Refitting or Replacement
5. Perform the operation on **both sides of the vehicle (Driver side and passenger side).**

6. If **only the replacement of the front pillars is planned**, the procedure is concluded and the vehicle can be approved, otherwise continue with the **replacement of the rear pillars**.
7. To replace the C-pillar, follow the procedure given in the workshop manual:
 - **9.44.007 REAR PILLAR PROTECTION COVER RH.** Removal-Refitting or Replacement

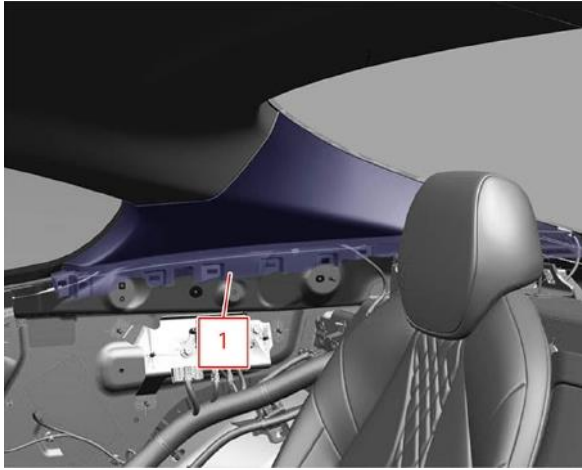
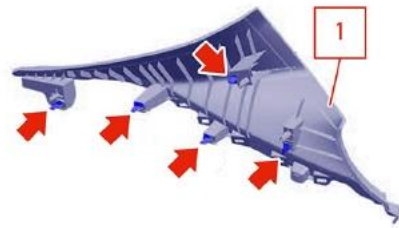
▪ 9.44.008 LEFT REAR PILLAR PROTECTION COVER. Detachment-Reattachment or Replacement

8. Reassemble all removed parts following the procedure in reverse order.
9. Procedure completed.
