STAR ONLINE PUBLICATION

Case Number: S251400001

Symptom/Vehicle Issue: Fuel Odor/Leakage

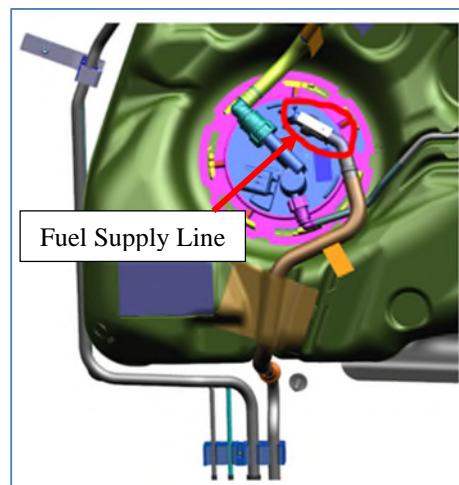
Fig. 1

Customer Complaint/Technician Observation: Customer's complaint may include a fuel odor or fuel leakage under the vehicle. Upon investigation, the technician may find fuel leakage on top of the fuel tank.

Discussion: If the fuel leakage is suspected of coming from the top of the fuel tank, follow published Service Information procedures to remove the rear seat to access the right-side fuel pump cover. Remove the right-side cover to access the top of the right-side fuel pump module. Check the fuel supply line connection to the fuel pump module by performing a "pull/push" at the connector.

If the fuel supply line is not properly connected, ensure connection of the line and install the safety retainer in place. The fuel pump module or the fuel supply line should not be replaced unless found to be damaged.
