April 18, 2025

Version 1

Warranty Extension: 2014–17 MDX Moisture in the Inner Taillights (6 Months)

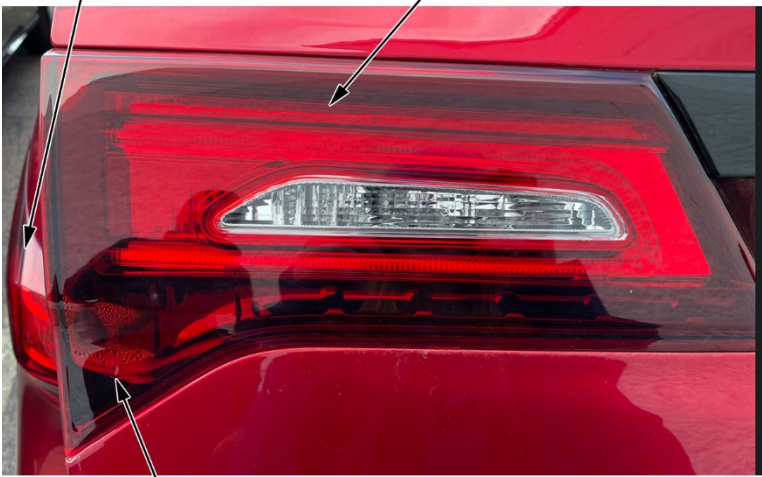
2. Inspect for any signs of water intrusion into the inner taillight assemblies.
 - If water intrusion is found, replace the affected taillight(s). Go to REPAIR PROCEDURE.
 - If no water intrusion is found, no further action is required.

WATER TRAPPED IN INNER TAILLIGHT

Inspect and, if necessary, replace the inner taillight(s).

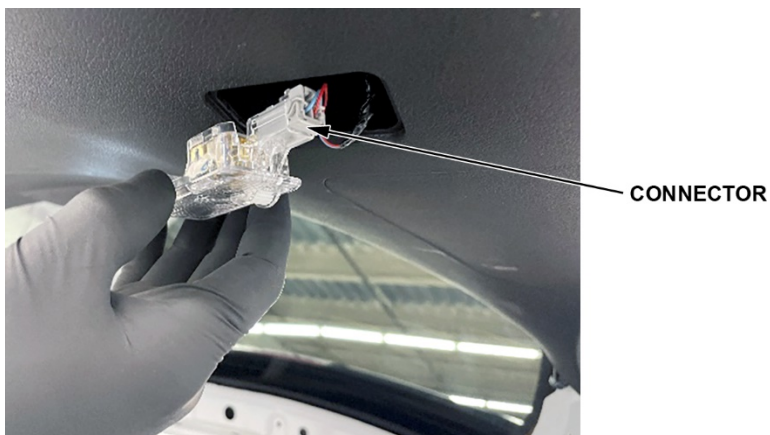
4. Remove and disconnect the tailgate light connectors.

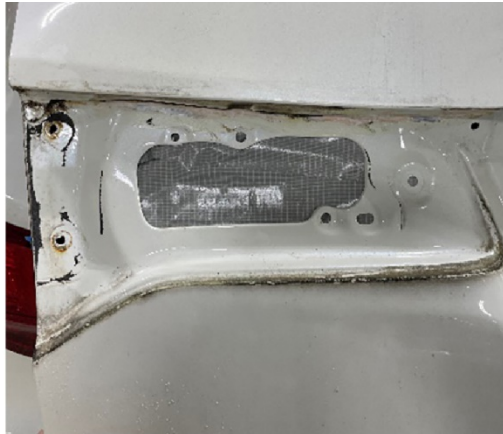
11. Once the dust sealer removal area has been marked, remove the template.
12. Seal the tailgate before doing the dust sealer removal:
 1. Place tape over the opening for the lid light.
 2. From the inside of the tailgate, place tape over the opening for the inner taillight.

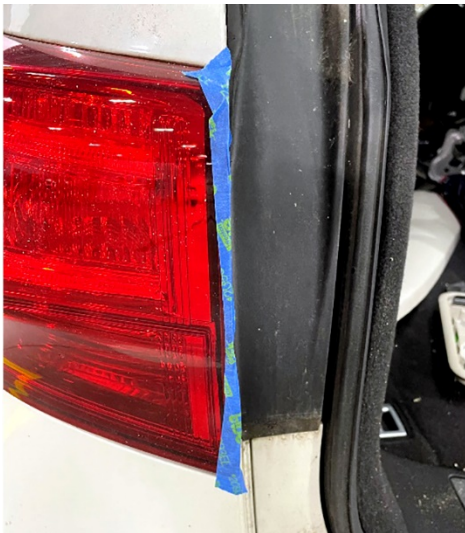
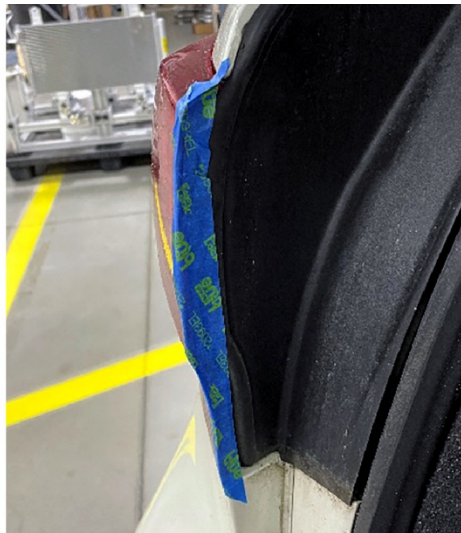
13. Place tape over the edge of the outer taillight to keep debris from getting into the housing.

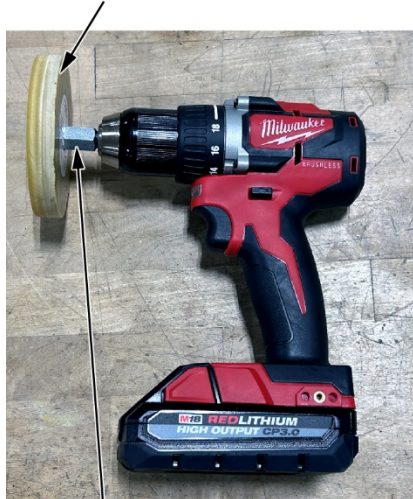
14. With the tailgate closed, and while wearing proper eye protection and gloves, use a drill (or equivalent rotary tool) with the 3M Stripe Off Wheel to remove the dust sealer between the markings.

- Ensure that the power tool being used is appropriate for the type of stripe off wheel being used.
- The maximum RPM for the recommended 3M Stripe Off Wheel is **4,000 RPM**.
- The stripe off wheel only remove paint where there is sealer underneath the paint.

3M STRIPE OFF WHEEL

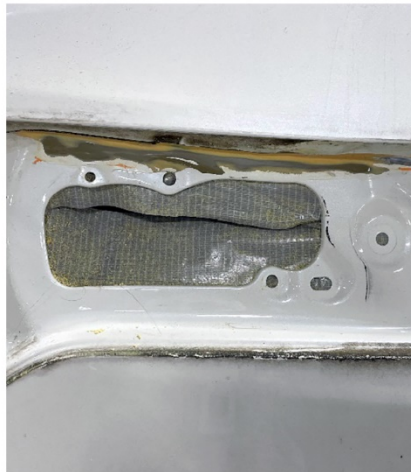
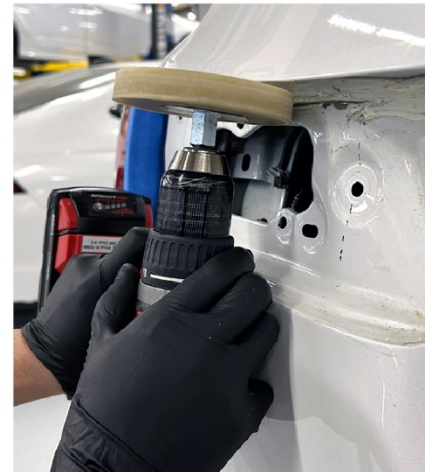
HARDWARE (SCREW)

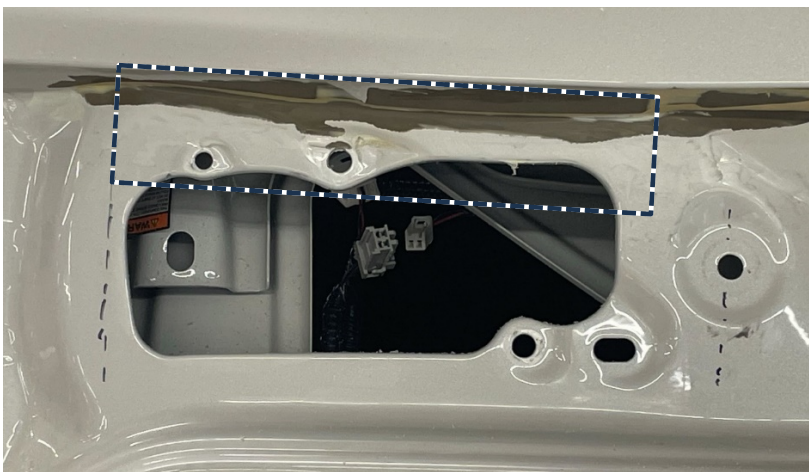
Example of finished sealer removal:

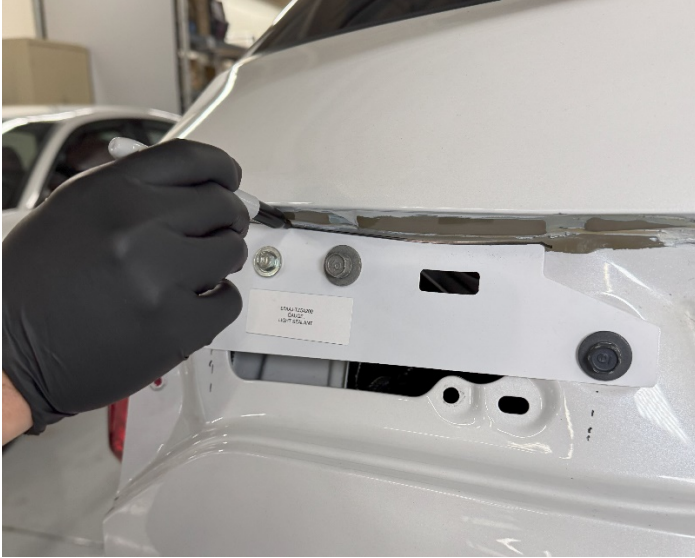
17. With the template installed, use a marker to make a line across the top edge of the template, then remove the template.

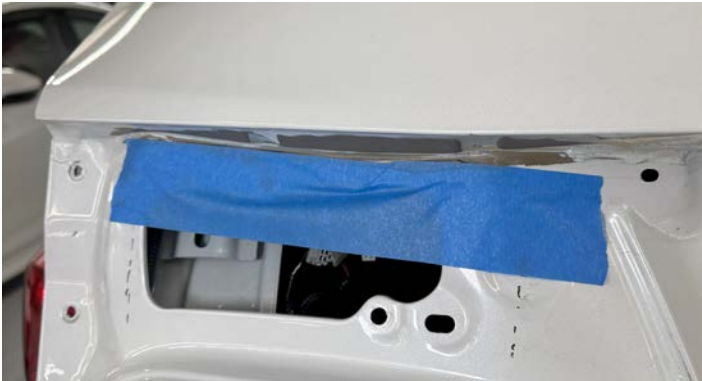
18. Place tape along the underside of the line that was drawn in the previous step.

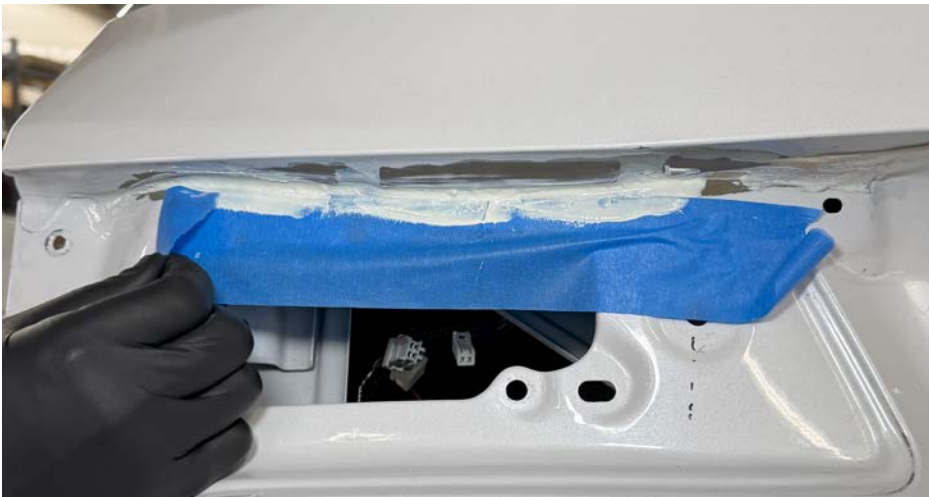
19. Apply a thin bead of Penguin Seal 353 to the area above the tape where the tailgate panels meet. While wearing a glove, run a finger along the new sealer to seal the panel joint and smooth the sealer across the area where the old sealer was removed.

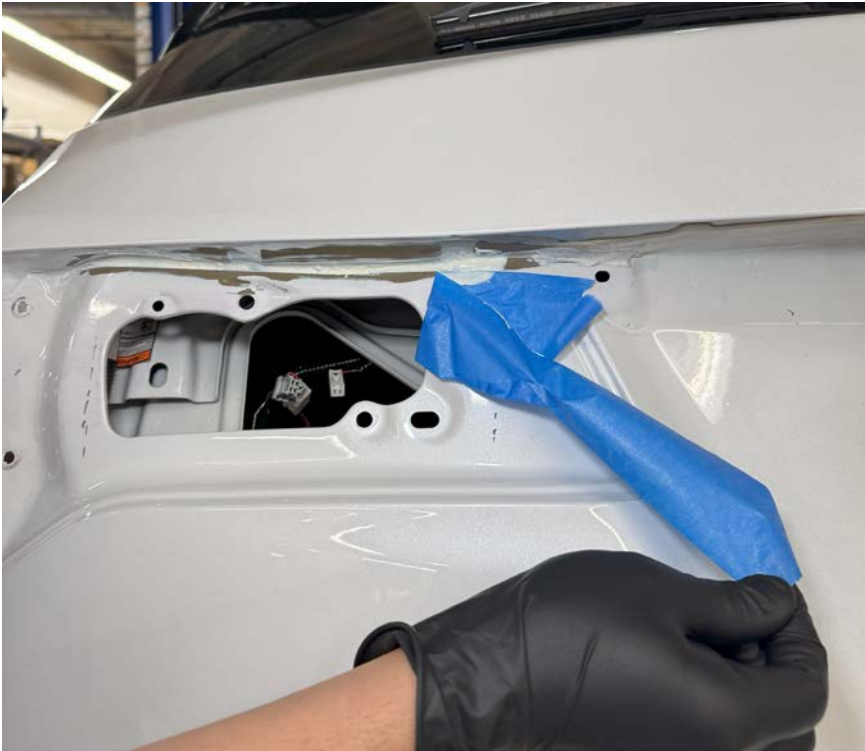
20. Immediately remove the tape below the sealer and allow 15 minutes for the sealer to dry.
