Subject: E-Fan Connector Corrosion Problem

Bulletin Nu: TS45-FC-2505

Vehicle Model: TS45

Description of the modification: E-fan connector terminal replacement bulletin within the scope of corrosion problems.

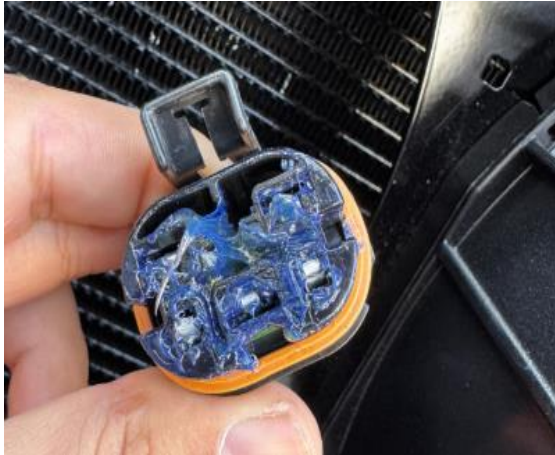
OK

NOTE: If you see the corrosion on the part like below image, you must apply this bulletin.

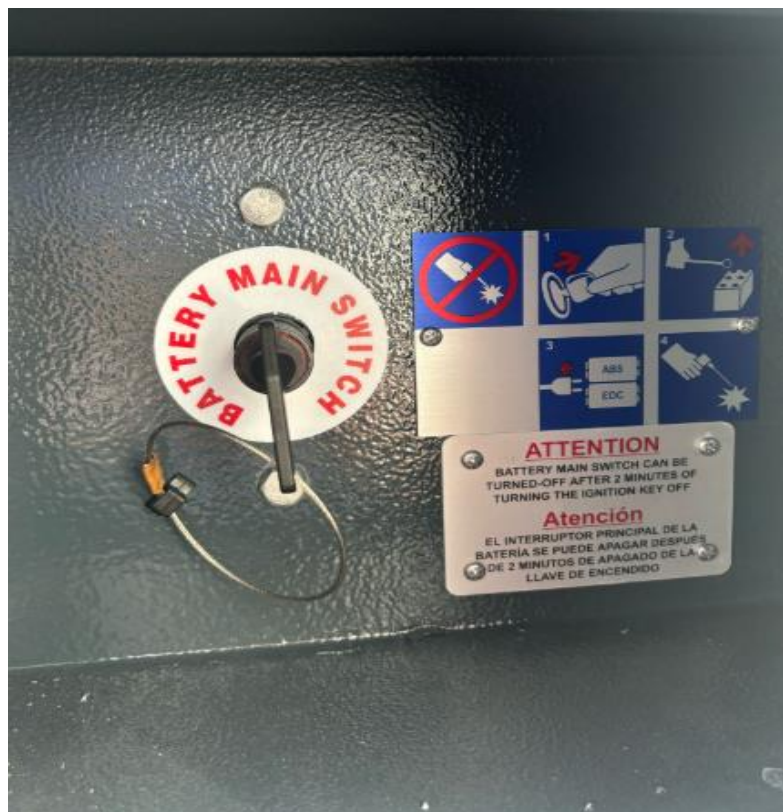
1. Open the cover of the E-fan.

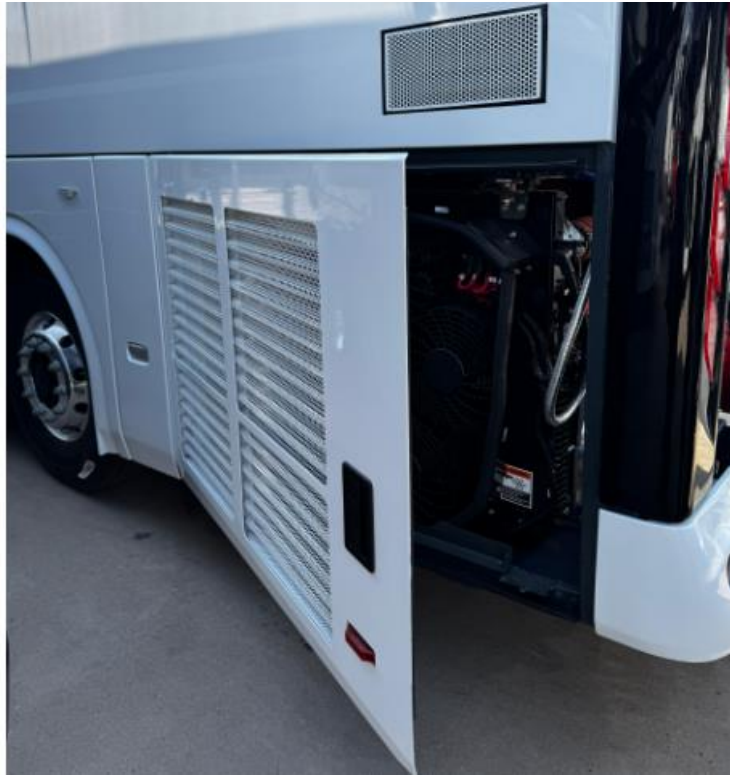
2. Remove the protection bracket using a cordless drill with a star bit.

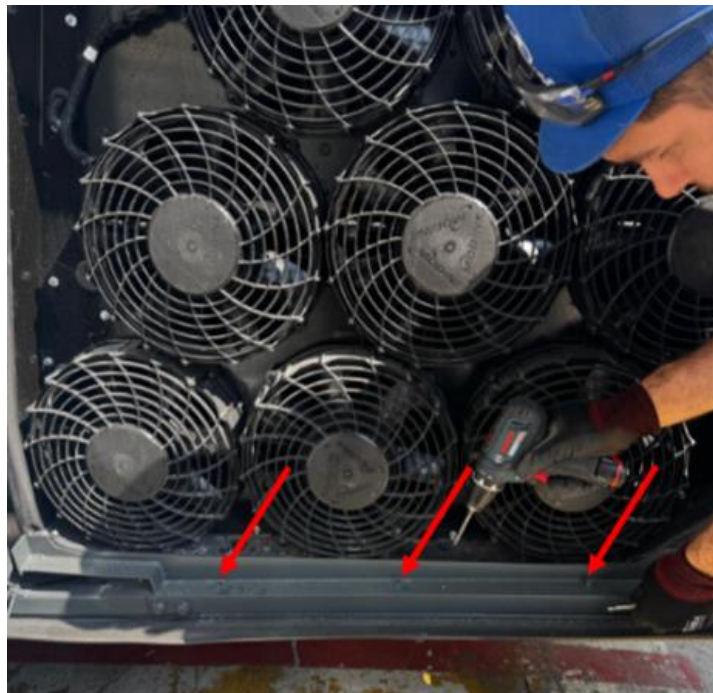
3. Remove the fans on the E fan from the specified areas using a 10 apex socket.

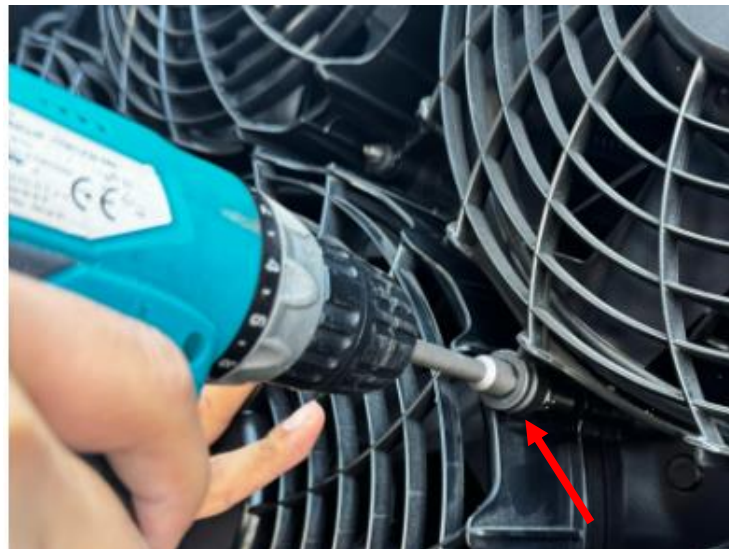
4. Locate the clip attached to the socket. Release it from the area shown and cut open the locking clip using the side incision.

NOTE: Use this same clip while assemble the connector again.

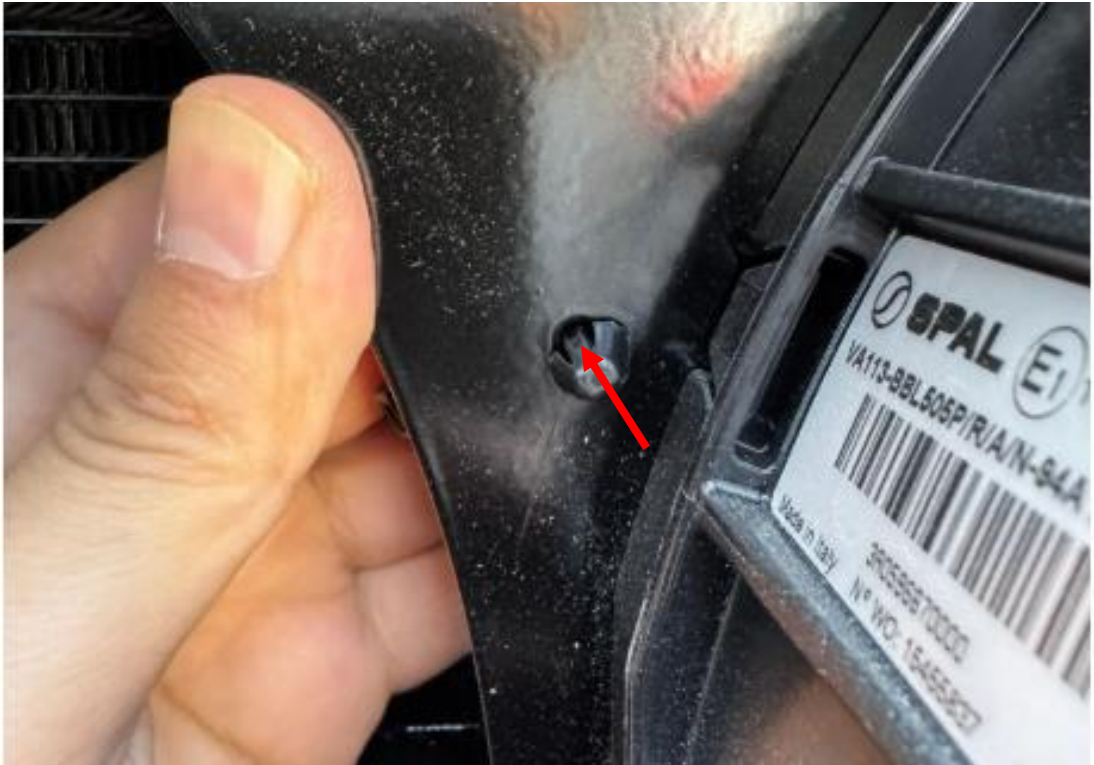
5. Separate the sockets from each other.

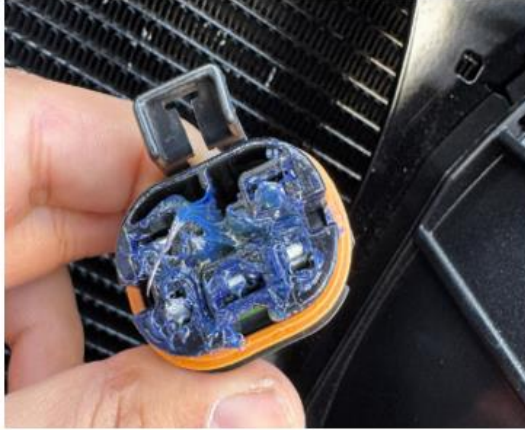
OK

NOTE: If you see the corrosion on the part like below image, you must apply this bulletin.

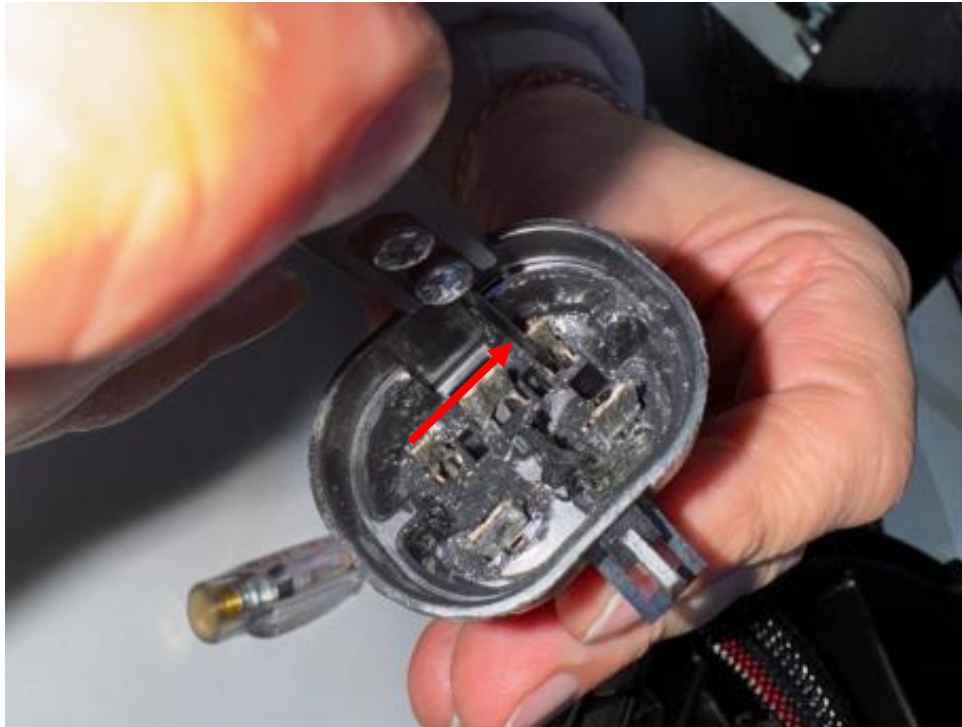
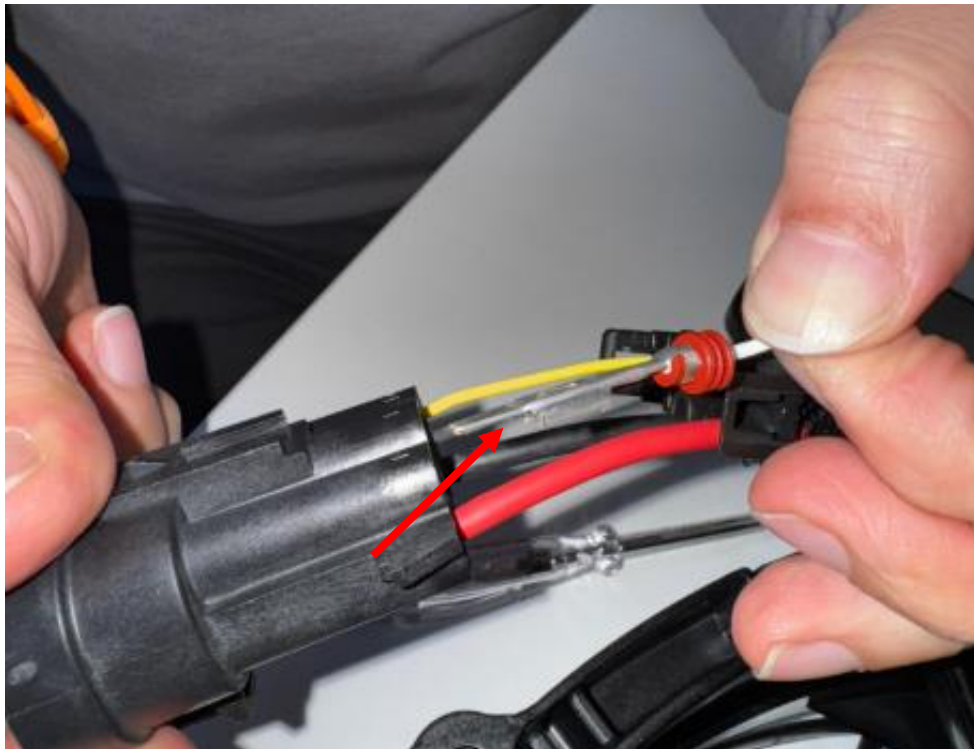
10. Cut off the removed rusty terminal using side cutters. Do not damage the sealing gasket on the terminal.

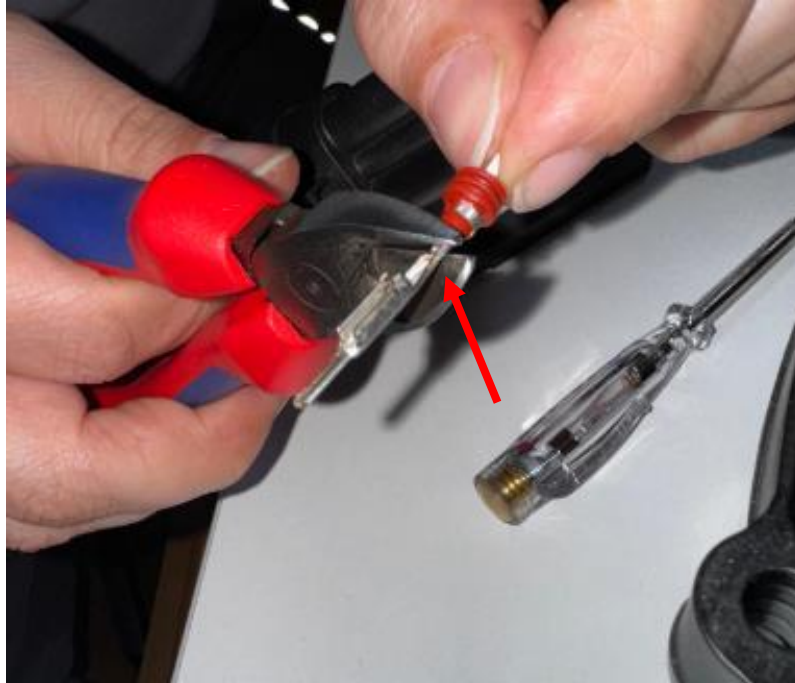
11. Assemble the new terminal with the sealing gasket attached using terminal pliers.

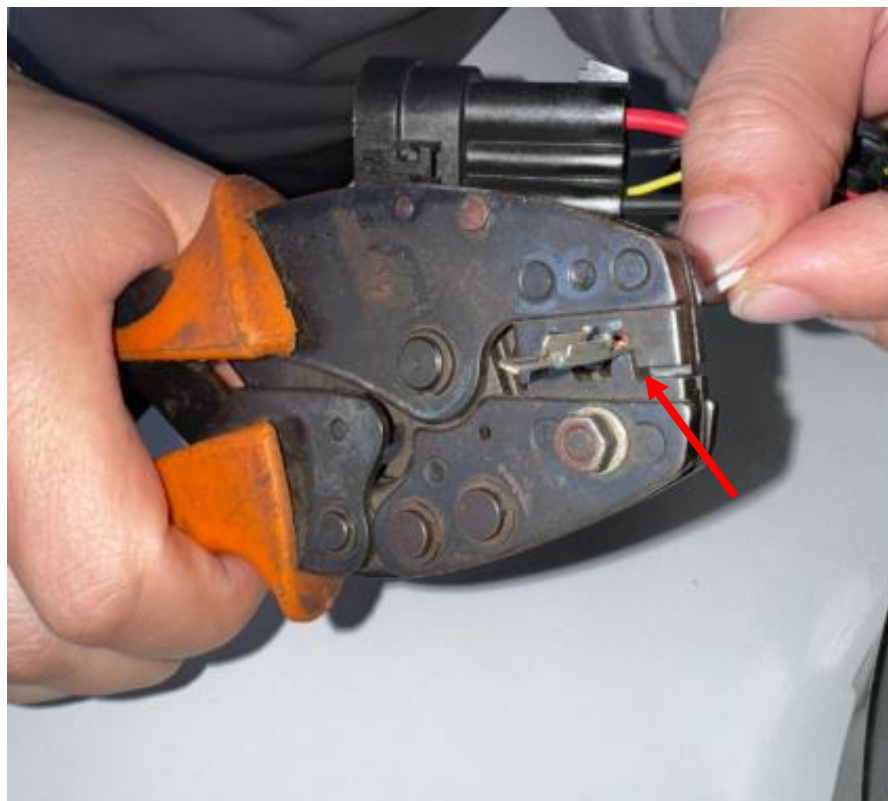
12. Assemble the terminal into the socket.
