SERVICE BULLETIN

APPLICABILITY: 2025MY Forester

NUMBER: 12-263-25

SUBJECT: Loose Fitting Rear Side Door Garnish

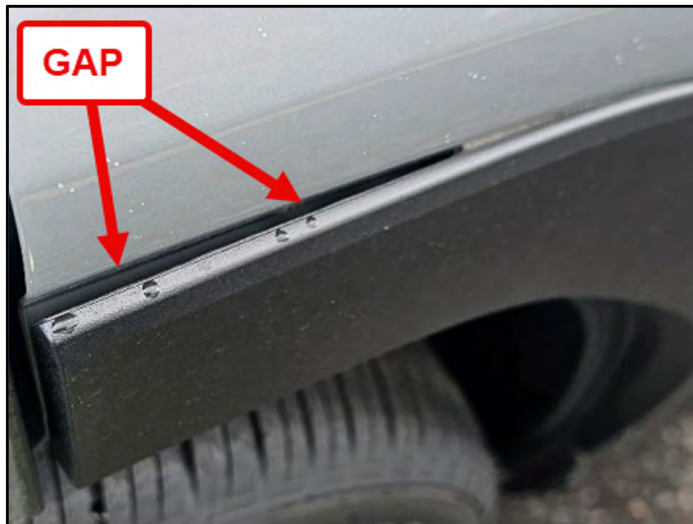
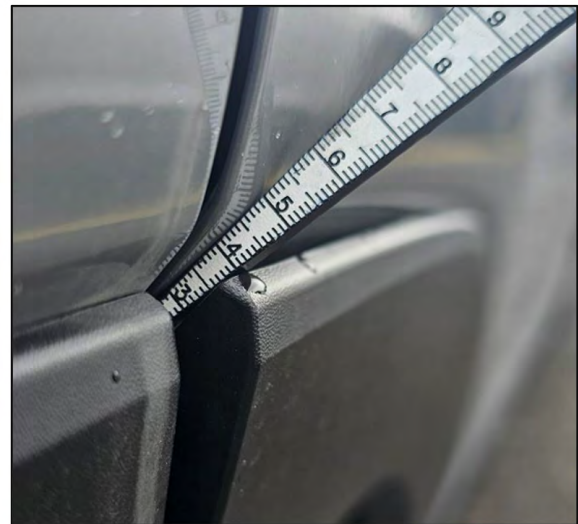
EXAMPLES OF LOOSE FITMENT:

This bulletin announces repair procedures to address cases of a loose fitting exterior rear door garnish. In some cases, the mounting clips may not be fully secured and / or the double-sided tape may have poor adhesion leading to gap between the garnish and the body (approximately 2.5-4mm). If this condition is duplicated, replace the affected door garnish.

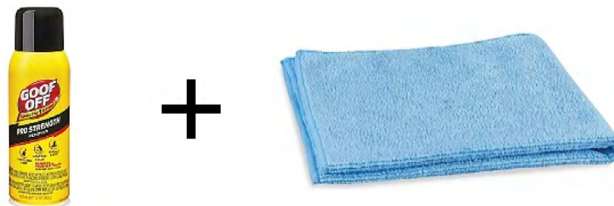
1. Confirm the painted surface has no remaining double sided tape from the original garnish and the painted surface is free of dust/grease of any kind. If required, Goof Off® and a lint-free microfiber cloth can be used to aid the removal of the double-sided tape.

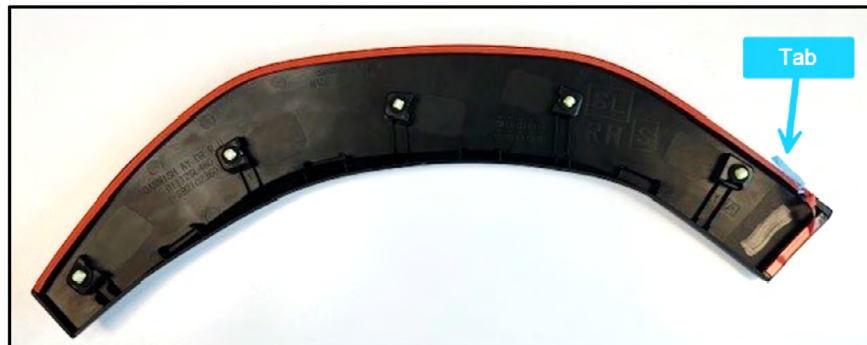
2. Remove any remaining residue with an alcohol wipe.
3. Prepare the new garnish by slightly pulling the blue double sided tape tab. DO NOT remove the adhesive backing at this point.

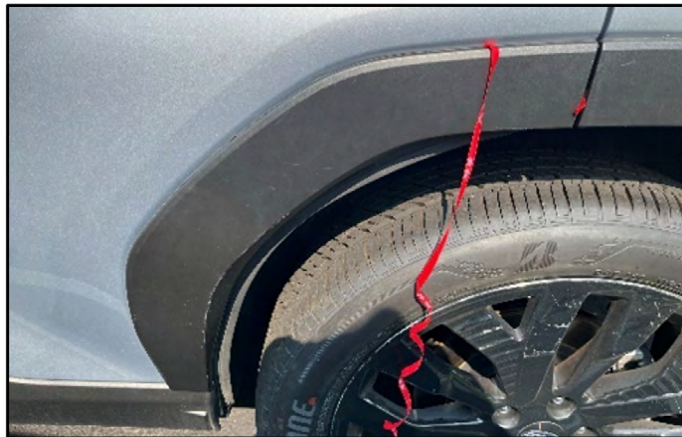
4. Install the side door garnish and confirm the clips are fully seated.
5. Using the exposed blue tab, **CAREFULLY** remove the double-sided tape backing.
