SERVICE INFORMATION BULLETIN

APPLICABILITY: All FA and FB Engines

NUMBER: 02-192-24R

SUBJECT: Engine Oil Leak Diagnostic Procedures

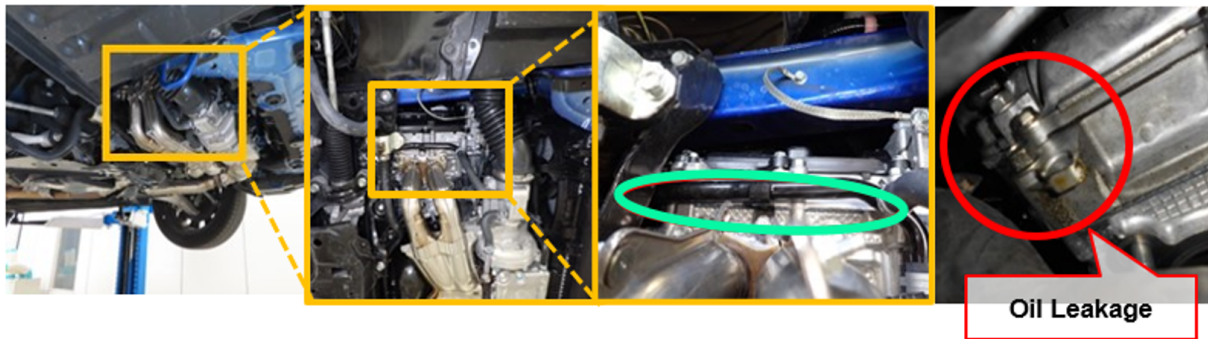
- 2. Cam Carrier – Cylinder Head:** Reseal the mating surfaces between the Cam Carrier and the Cylinder Head.

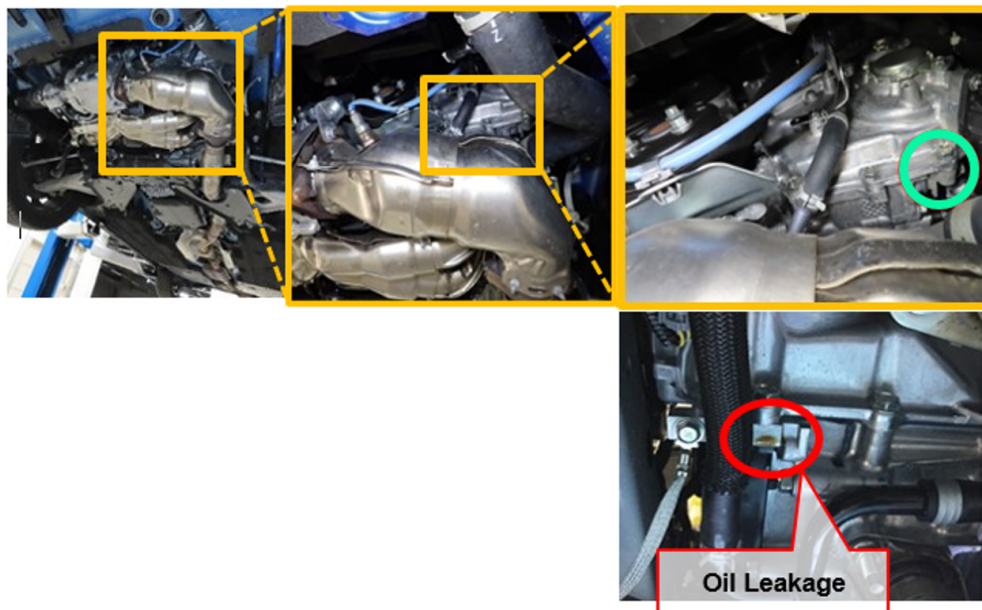
- 3. Chain Cover – Cam Cap – Cam Carrier Seal Surfaces:** Reseal the mating surfaces between the Chain Cover, Cam Cap, and the Cam Carrier.

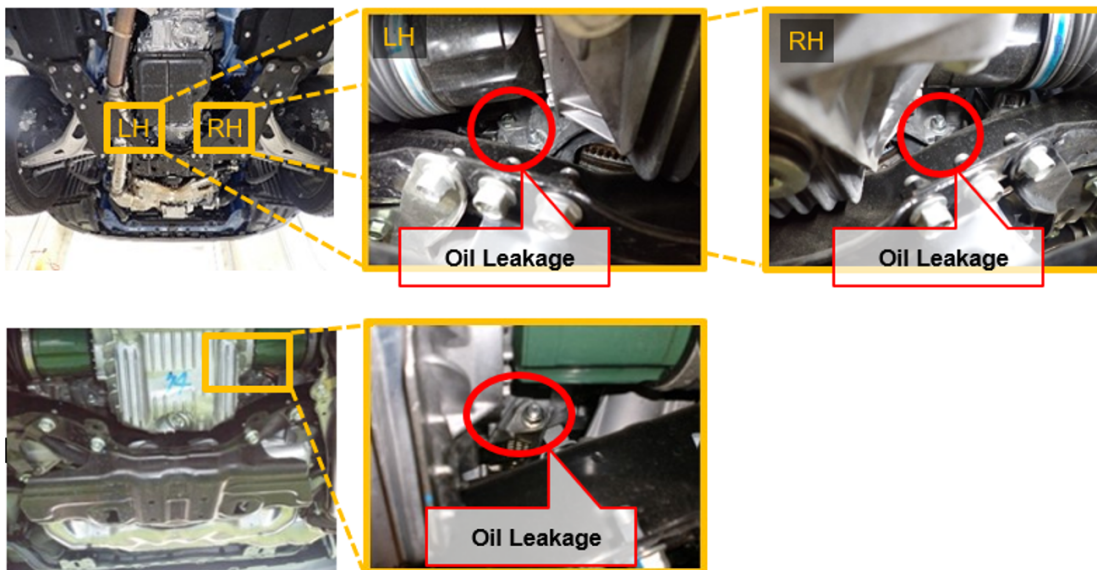
1. **Engine / Transmission Mounting Area:** Reseal the mating surfaces between the Upper Oil Pan and the Engine Block.

Important: For areas 5 and 6, if oil is found adhered to the oil level sensor, the sensor must be replaced.

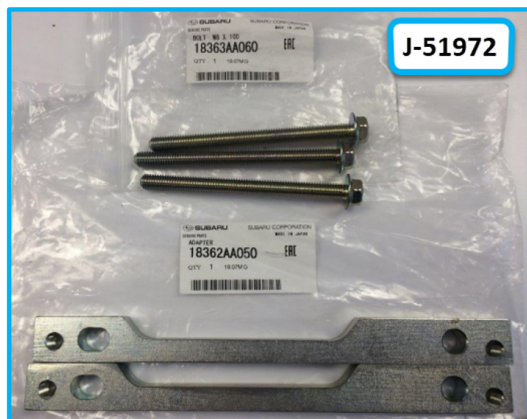
When removing and installing the timing chain cover it is important to using the Subaru special tools J-51972 & J53038. Using these tools will help reduce the possibility of damaging the chain cover during removal while also ensuring better Three Bond sealing during installation.

Detailed on the usagae of these tools is outlined in TSB [14-26-20](#)

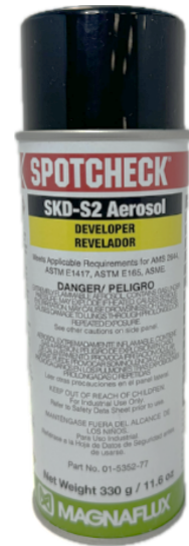
- **Spotcheck SKD-S2** can be used to aid in the oil leakage inspection process. SKD-S2 is a fast drying solvent that provides a white opaque coating when applied. This gives a contrasting background for the inspection area.

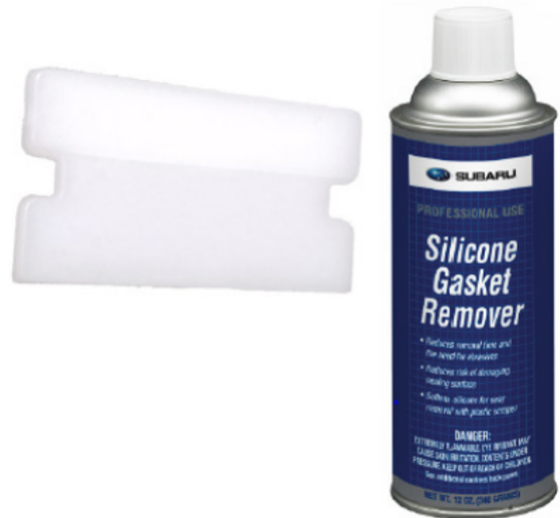
- Use of aerosol Subaru Silicone Gasket Remover (p.n. **SOA868V9175**) along with WHITE plastic razor blades and / or a sharpened plastic trim removal stick to use as a non-marring scraper make sealer removal easier. Applying the Gasket Remover spray and allowing it to “soak” also helps. NEVER use steel razor blades or abrasive discs as they can easily damage the machined aluminum sealing surfaces.

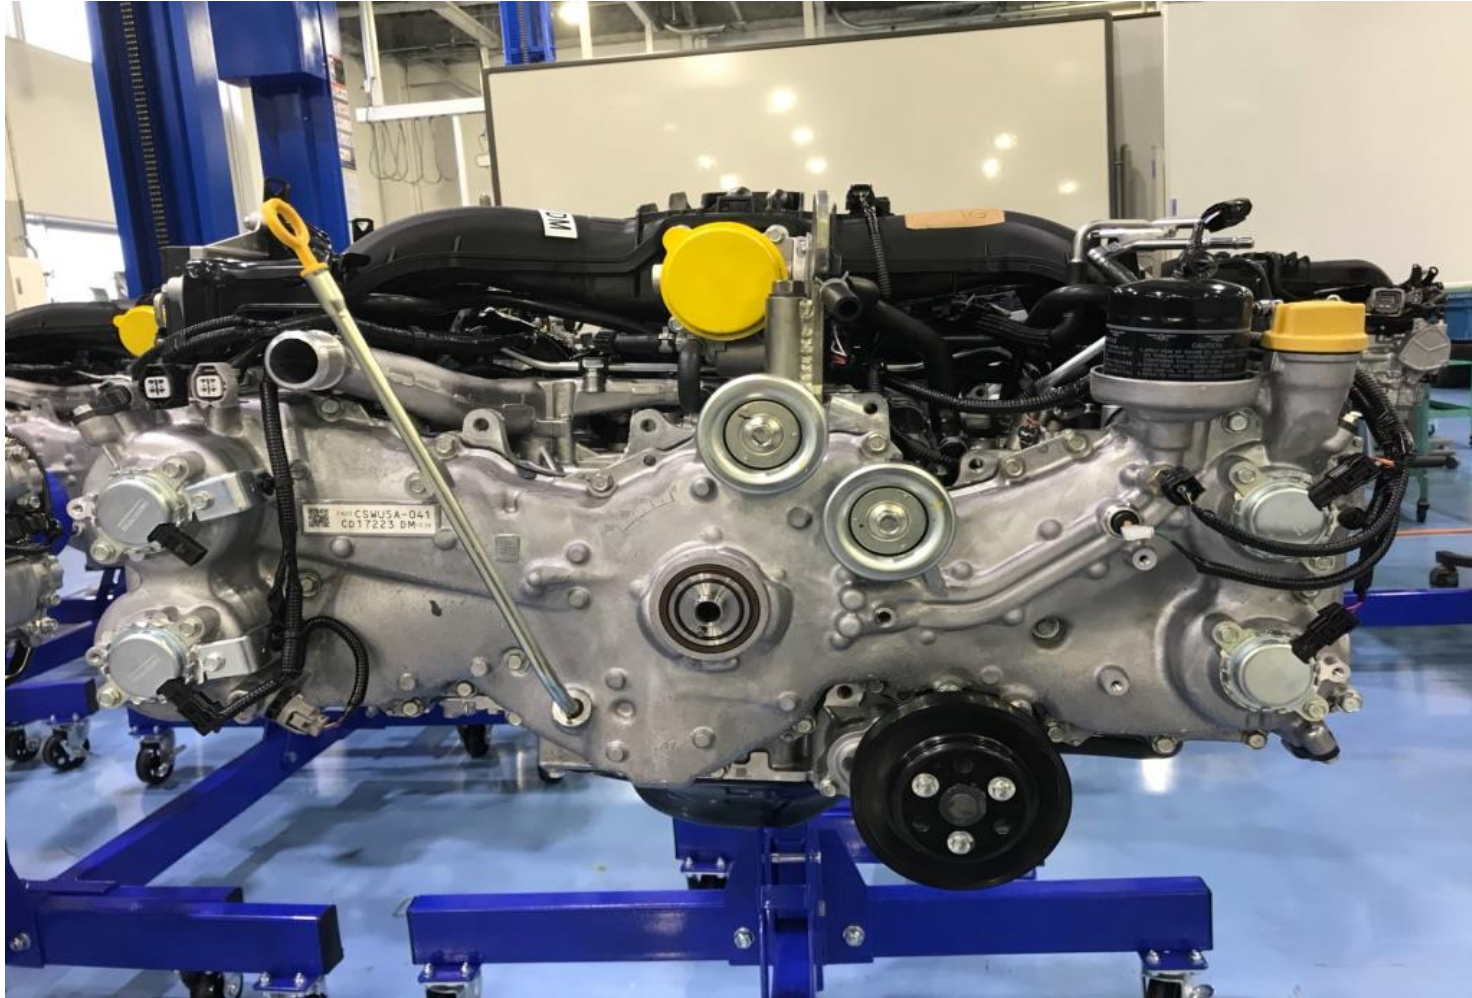
FIPG*1 Application Procedure

This document shows the application procedure when resealing the engine with FIPG. Please refer to this material to accomplish repair work in case of oil leakage on FB/FA engine.

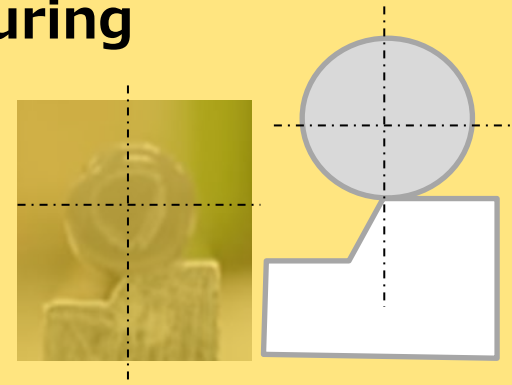
Quality Compliance Items

- ①: **Clean and degrease the seal surface thoroughly.**
- ②: **Apply FIPG in the proper position and amount.**
- ③: **Install the parts within 5 minutes after applying FIPG.**
- ④: **After assembly, allow sufficient time for curing before refilling engine oil.**

※ **Approximate curing time after assembly @20°C: FA/FB (2.2H or more)**

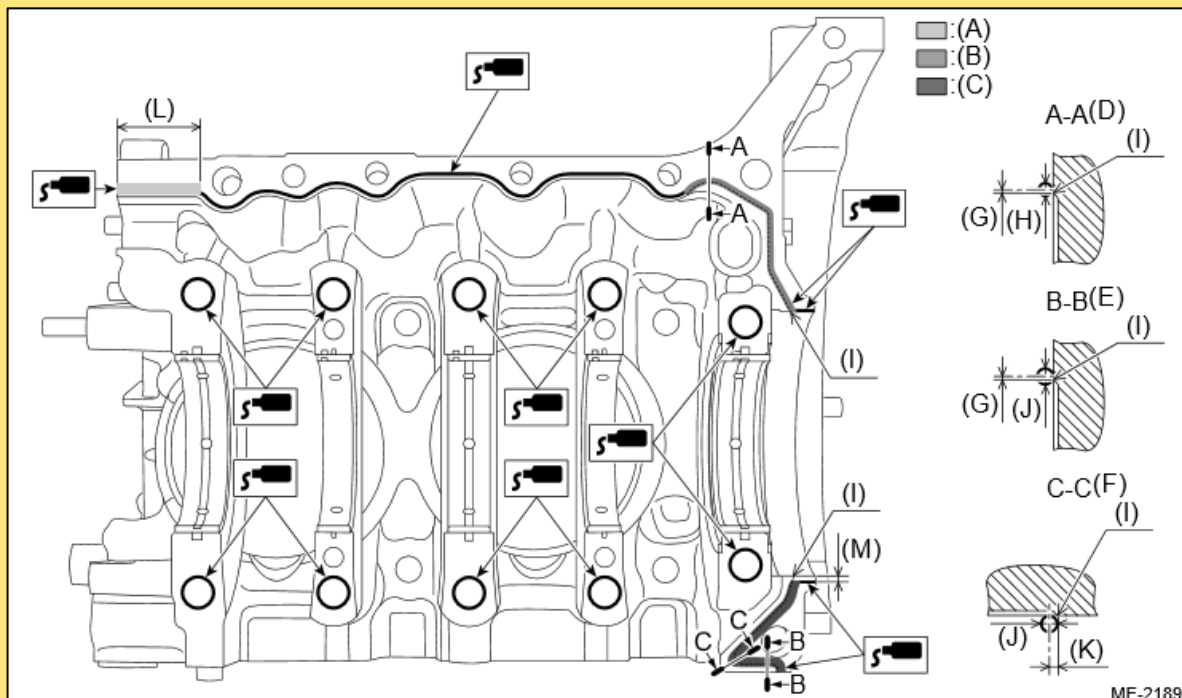
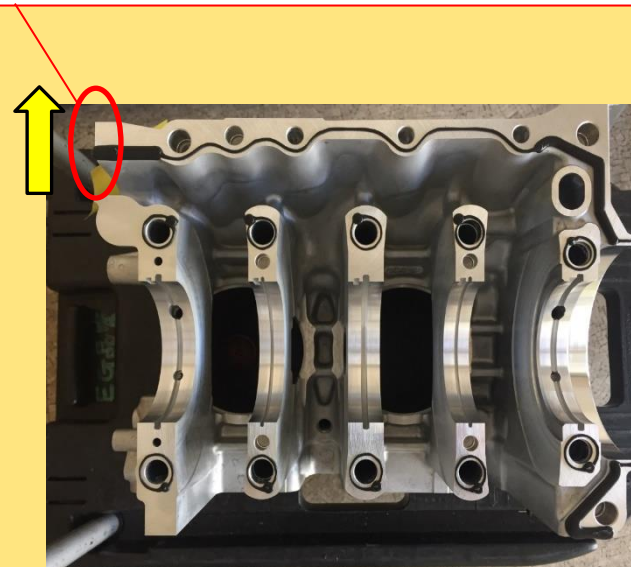
Engine Block mating surface (FA/FB)

If extra FIPG sticks out from the sealing surfaces of the Chain Cover after installation, remove the extra FIPG completely with scraper, etc. to the directions indicated by arrows in the chart below before hardening.

- (A):Range A (B):Range B (C):Range C
- (D):FIPG application position on mating surface in range B
- (E):FIPG application position of the mating surface part (other than the tip) of range C
- (F):FIPG application position of the mating surface part (tip) of range C
- (G):Within 1mm (H): $\Phi 3.2 \pm 0.5\text{mm}$ (I):Chamfer edge
- (J): $\Phi 4 \pm 0.5\text{mm}$ (K):2mm (L):36mm (M):2.5mm

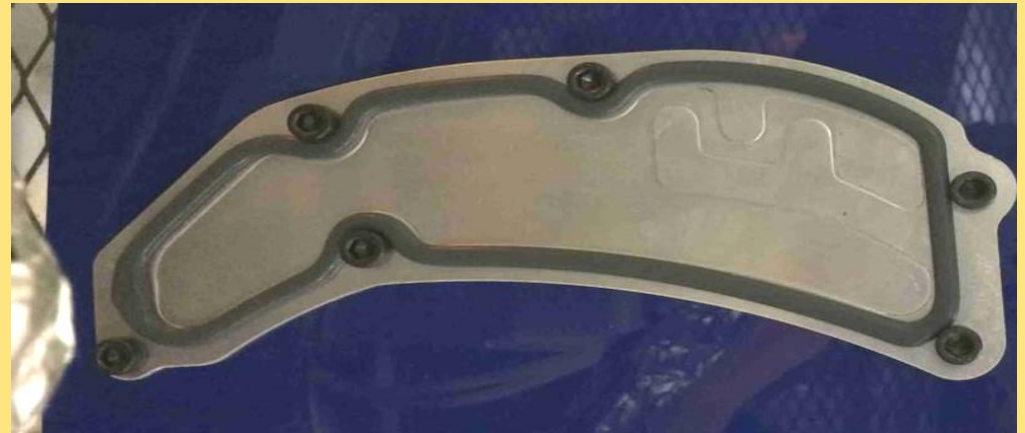
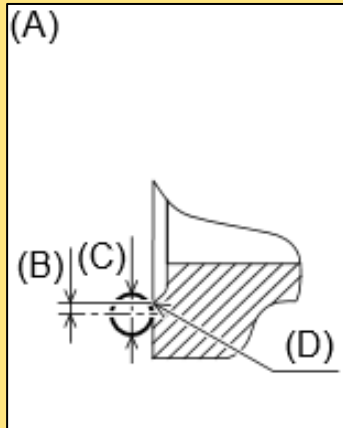
Separator cover (FA/FB)

The photo shows the condition when FIPG is applied to the separator cover side.

(A): FIPG application position
(B): Within 1mm
(C): $\Phi 4 \pm 1\text{mm}$
(D): Chamfer edge

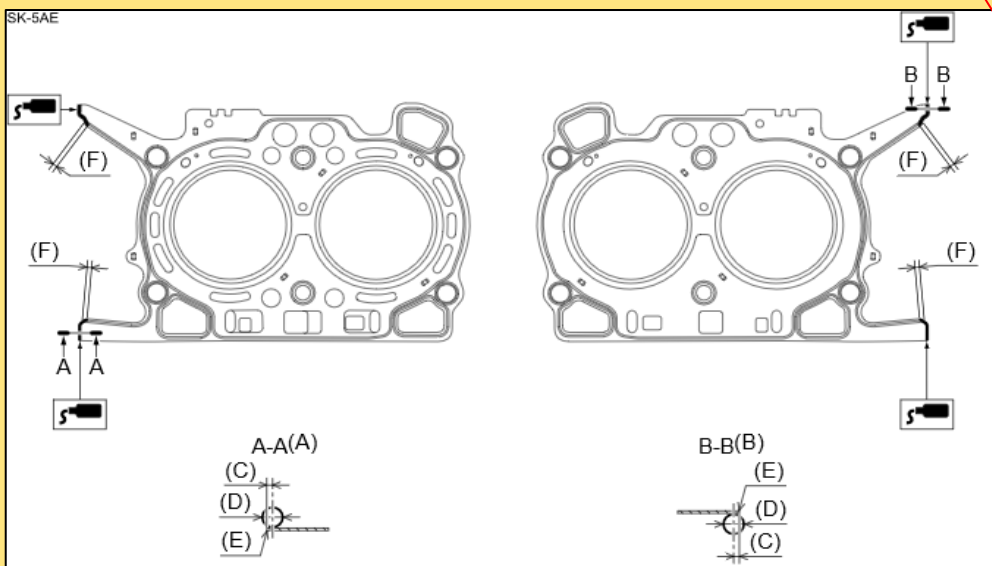
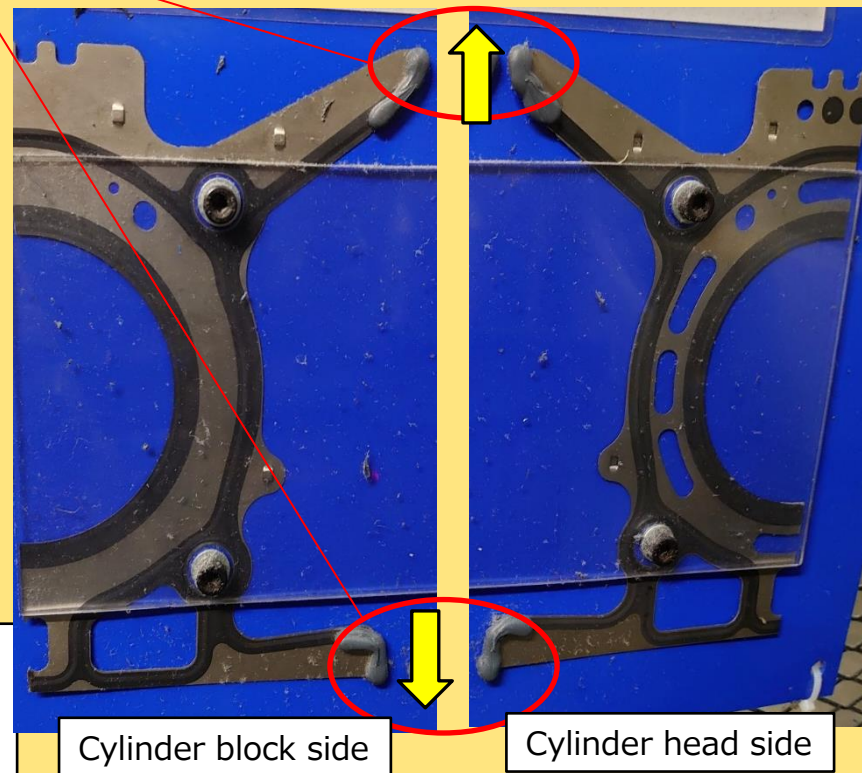
Head gasket LH (FA/FB)

If extra FIPG sticks out on the sealing surfaces of the Cylinder Head after installation, remove the extra FIPG completely with scraper, etc. to the directions indicated by arrows in the chart below before hardening.

- (A): FIPG application position on Cylinder head side
- (B): FIPG application position on Cylinder block side
- (C): Within 1mm
- (D): $\Phi 3 \pm 1$ mm
- (E): Cylinder head gasket end
- (F): Overlap between bead end and FIPG 3 to 10mm

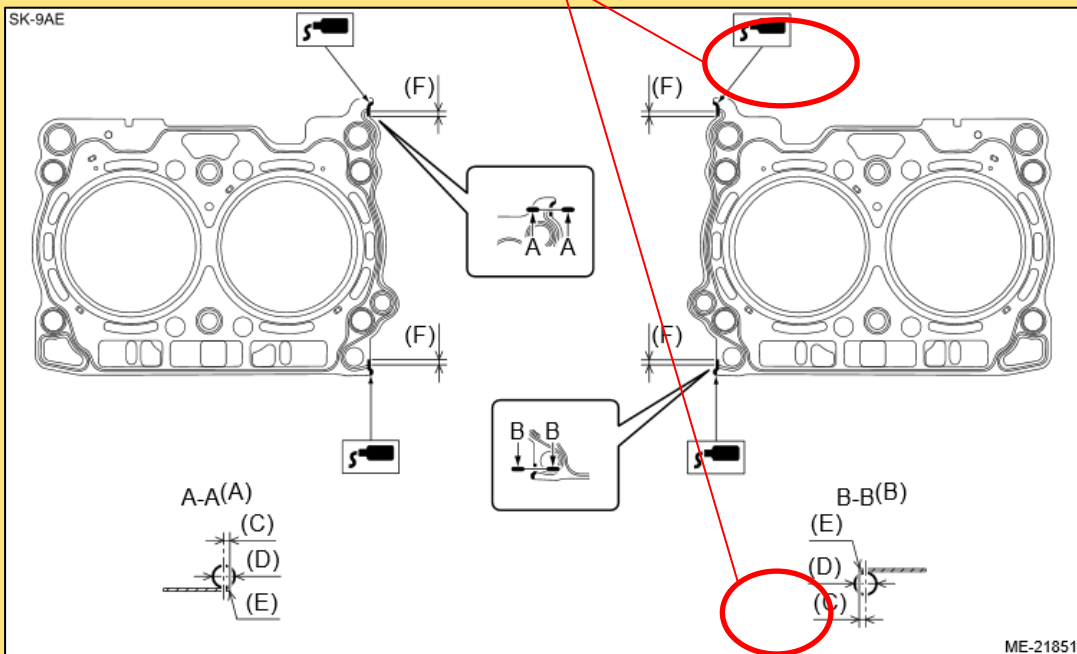
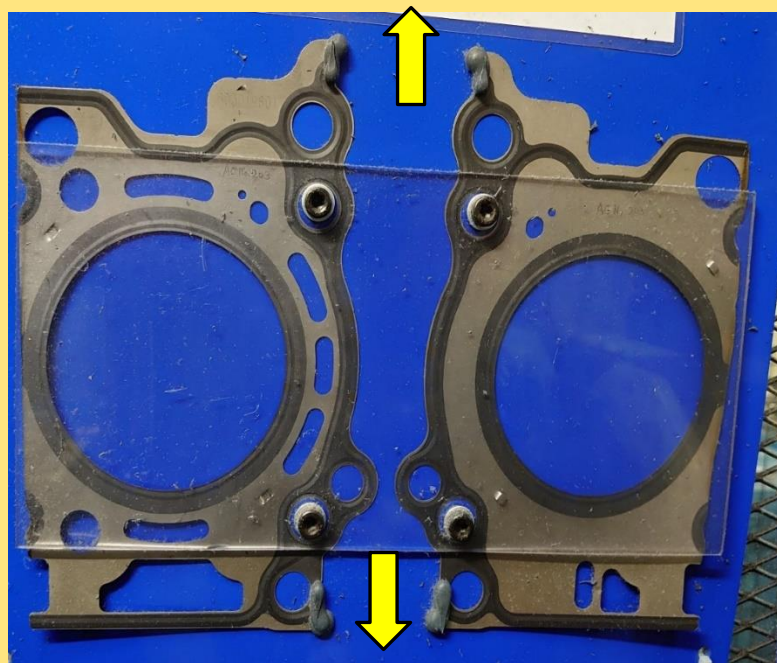
Head gasket RH (FA/FB)

If extra FIPG sticks out on the sealing surfaces of the Cylinder Head after installation, remove the extra FIPG completely with scraper, etc. to the directions indicated by arrows in the chart below before hardening.

- (A): FIPG application position on Cylinder head side
- (B): FIPG application position on Cylinder block side
- (C): Within 1mm
- (D): $\Phi 3 \pm 1$ mm
- (E): Cylinder head gasket end
- (F): Overlap between bead end and FIPG 3 to 10mm

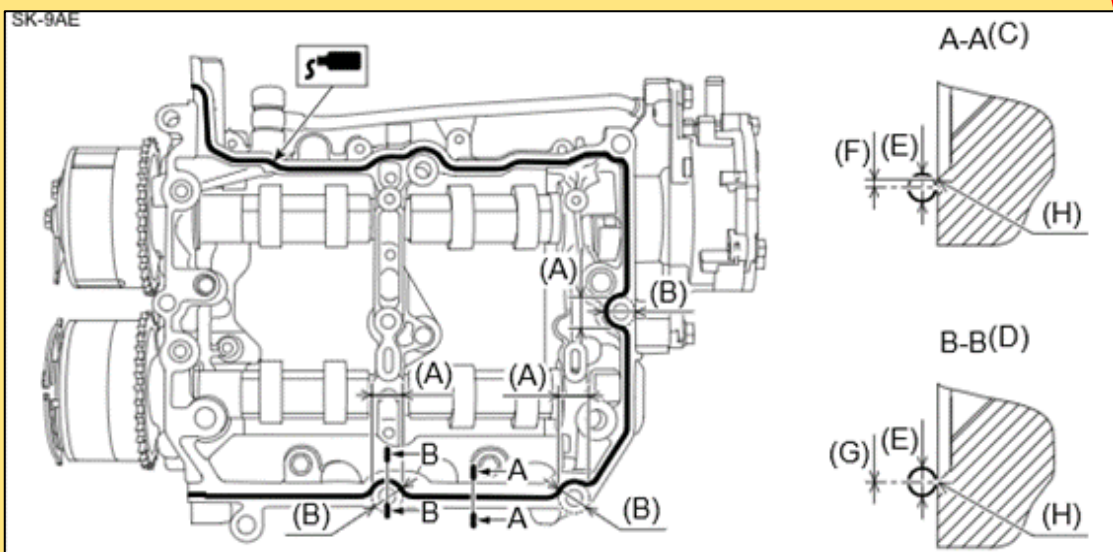
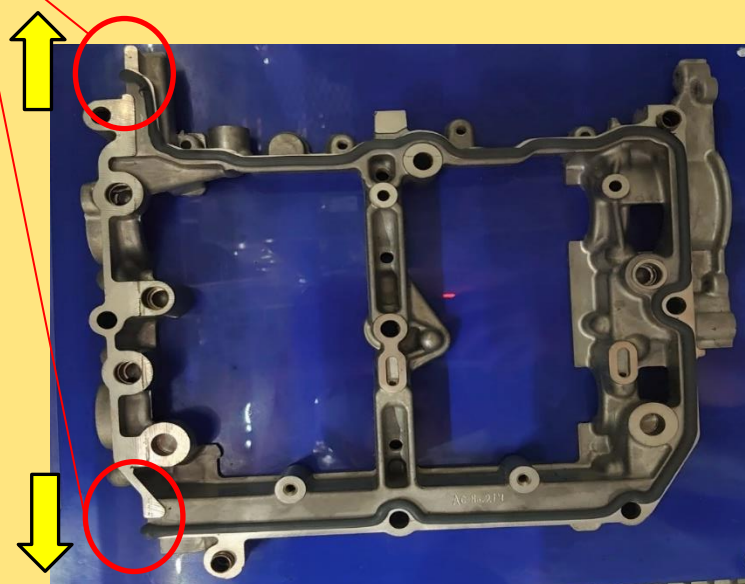
Cam Carrier RH (FA/FB)

If extra FIPG sticks out on the sealing surfaces of the Cam Carrier after installation, remove the extra FIPG completely with scraper, etc. to the directions indicated by arrows in the chart below before hardening.

- (A):Range A (B): $\Phi 18\text{mm}$
- (C):FIPG application position of mating areas other than Range A
- (D):FIPG application position of mating areas in Range A
- (E): $\Phi 4 \pm 0.5\text{mm}$ (F): $1 \pm 1\text{mm}$ (G): $0 \pm 0.5\text{mm}$ (H):Chamfer edge

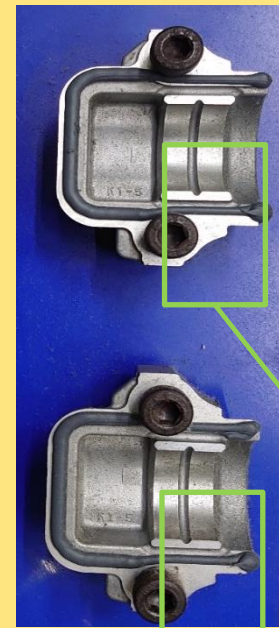
Camshaft Cap LH (FA/FB)

If extra FIPG sticks out on the sealing surfaces of the Camshaft Cap and High-pressure Fuel Pump Drive Case after installation, completely remove the extra FIPG with scraper or the like in the directions indicated with arrows in the chart below before curing.

- (A):28.5mm (B):8.5mm (C):5.5mm (D):Range A
- (E):FIPG application position of mating area in Range A
- (F):FIPG application position of mating area other than range A
- (G):1mm (H): $\Phi 3 \pm 0.5$ mm
- (I):Chamfer edge (J): $\Phi 2 \pm 0.5$ mm

Be careful not to apply too much FIPG, otherwise the overflowed FIPG can be bitten by the journal and cause seizure.

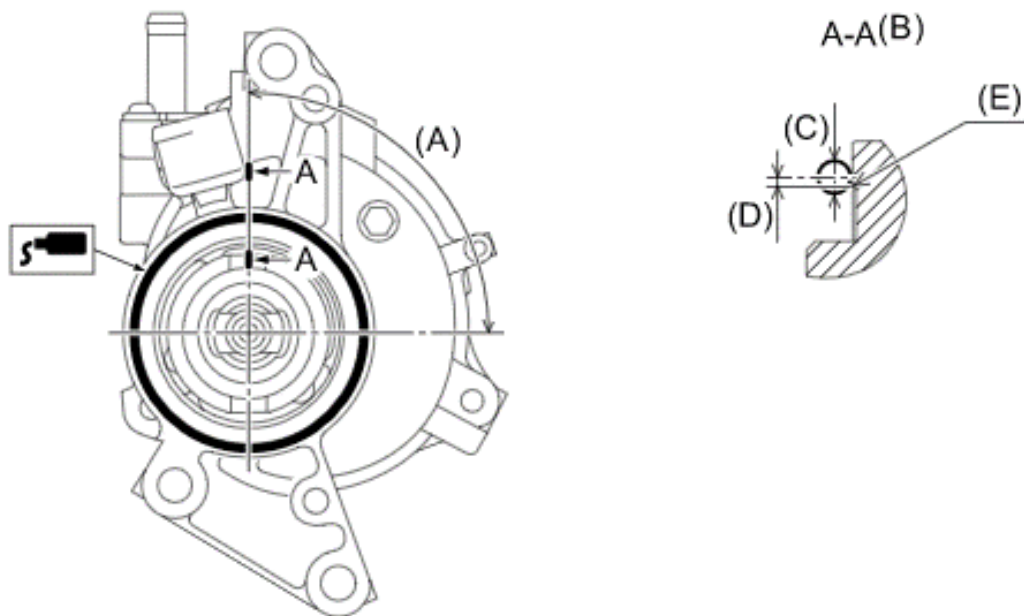
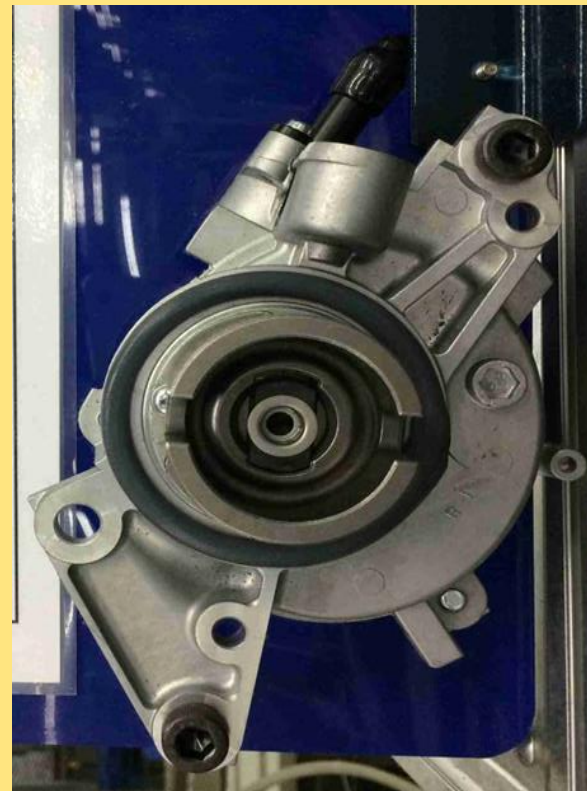
Vacuum pump ASSY (FA/FB)

- (A):Range A (possible starting range of application)
- (B):Location of FIPG application on mating surfaces
- (C): $\Phi 3 \pm 1\text{mm}$
- (D):1mm
- (E):Chamfer edge

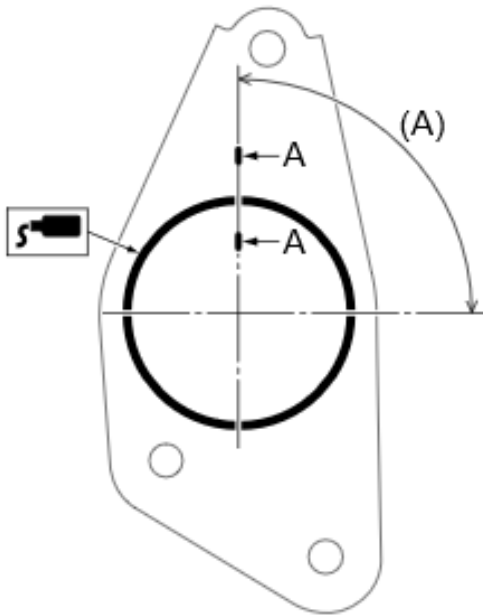
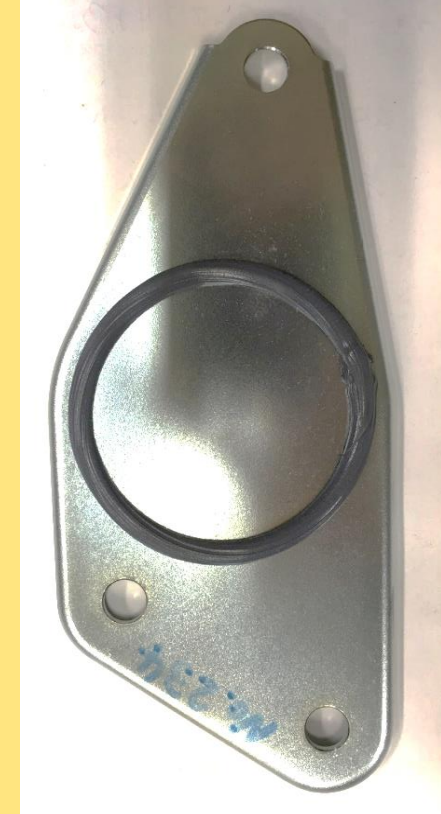
Plate (FA/FB)

Aim at the chamfer shape of the plate and apply the FIPG.

- (A): Range A (possible starting range of application)
- (B): Location of FIPG application on mating surfaces
- (C): $\Phi 3 \pm 1\text{mm}$
- (D): 1mm
- (E): Chamfer edge

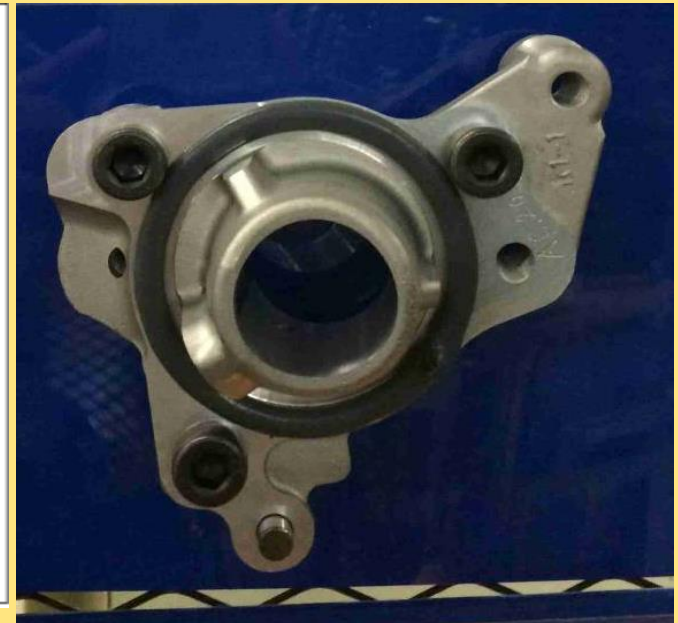
High-pressure Fuel Pump drive case ASSY (FA/FB)

- (A): Within 1mm
- (B): $\Phi 3.5 \pm 1\text{mm}$
- (C): Chamfer edge
- (D): FIPG
- (E): Oil passage

Be careful not to apply too much FIPG as it may block the oil passages.

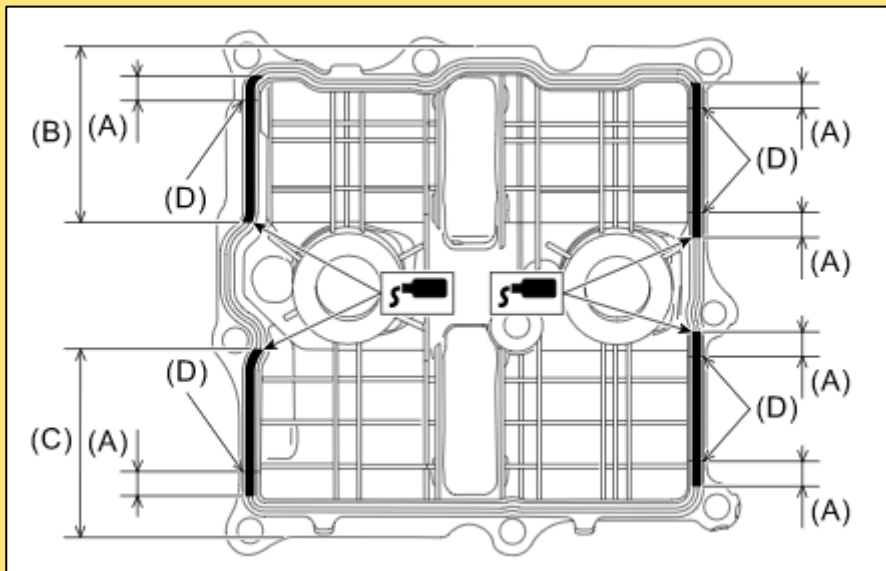
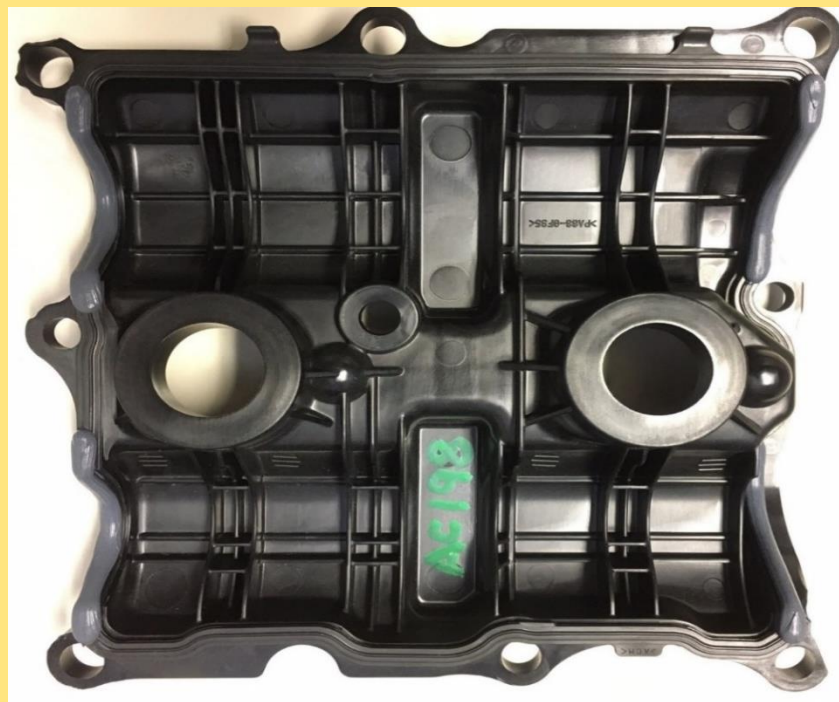
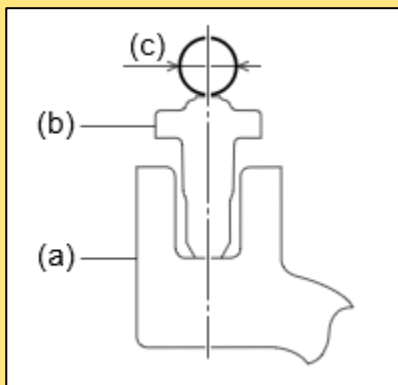
Rocker cover RH (FA/FB)

(A):10.0mm or more (B)74mm or less
 (C):71~73mm (D):Starting point of arch
 ※ Please refer to the service manual of each vehicle system.

(a):Locker cover
 (b):Locker cover gasket
 (c): $\Phi 3 \pm 1$ mm

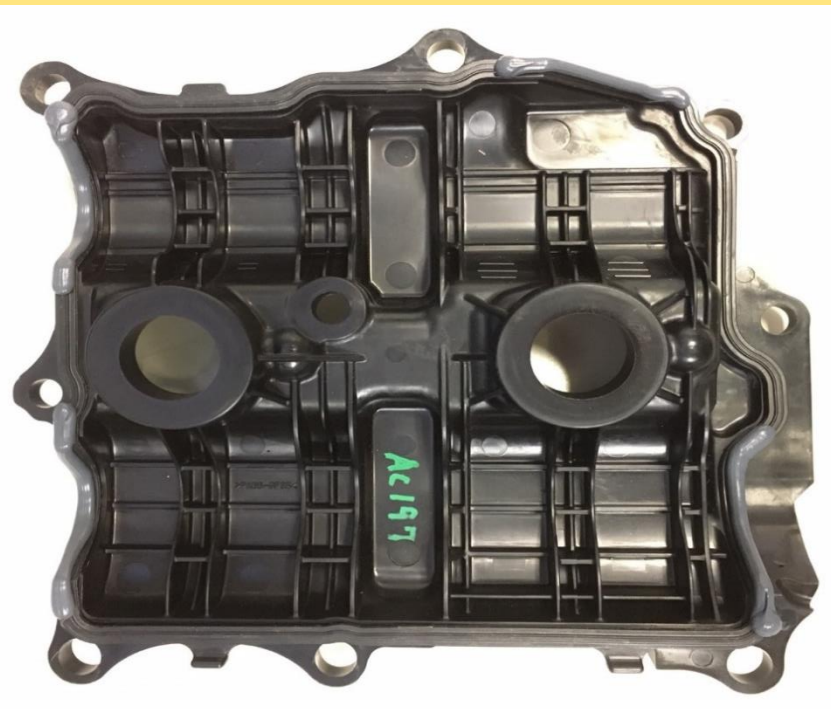
Rocker cover LH (FA/FB)

(A):10.0mm or more (B):17.3mm or less
 (C):70.7mm or more (D):Starting point of arch
 ※ Please refer to the service manual of each vehicle system.

(a):Locker cover
 (b):Locker cover gasket
 (c): $\Phi 3 \pm 1$ mm

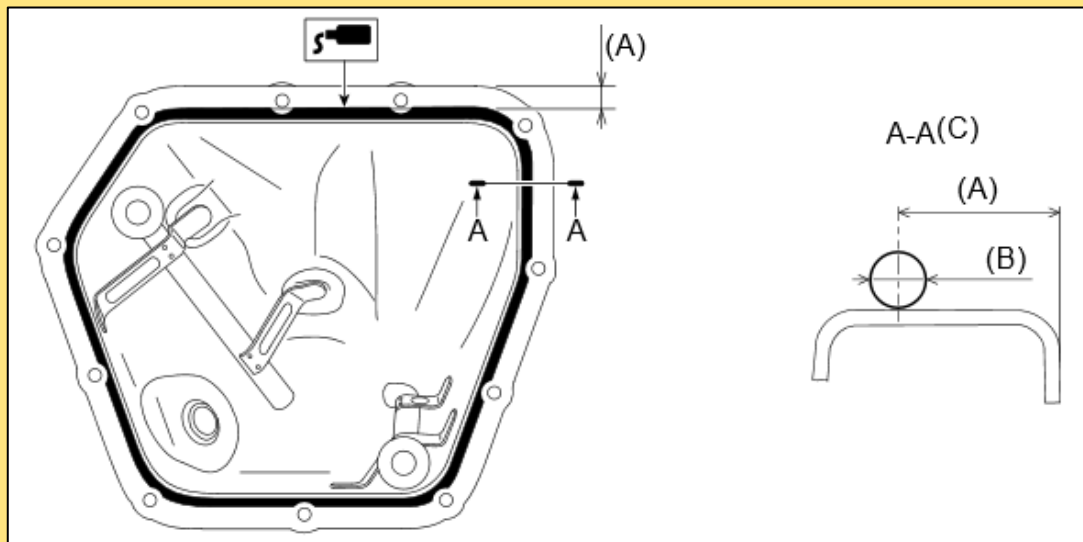
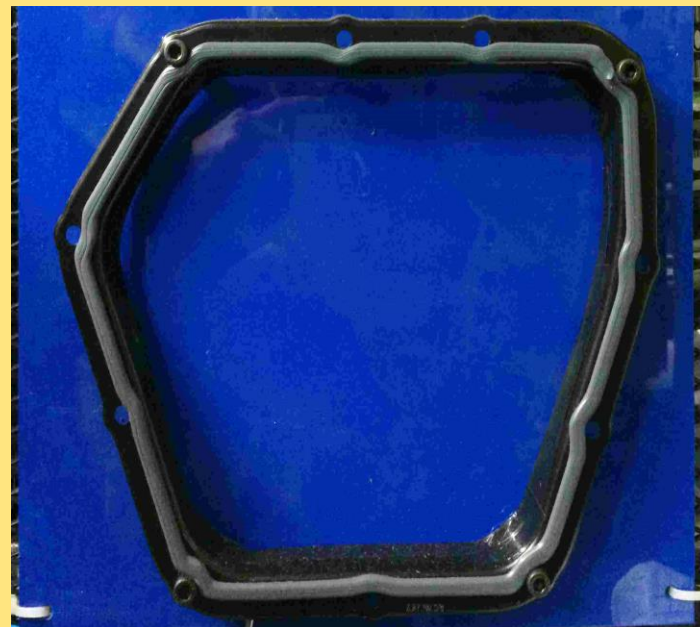
Oil pan (FA/FB)

- (A): 10.5mm or more but less than 13.5mm
- (B): $\Phi 4.5 \pm 0.5\text{mm}$
- (C): FIPG application position of aligned surface area

For convenience of photography, the bottom of the oil pan has been cut off.

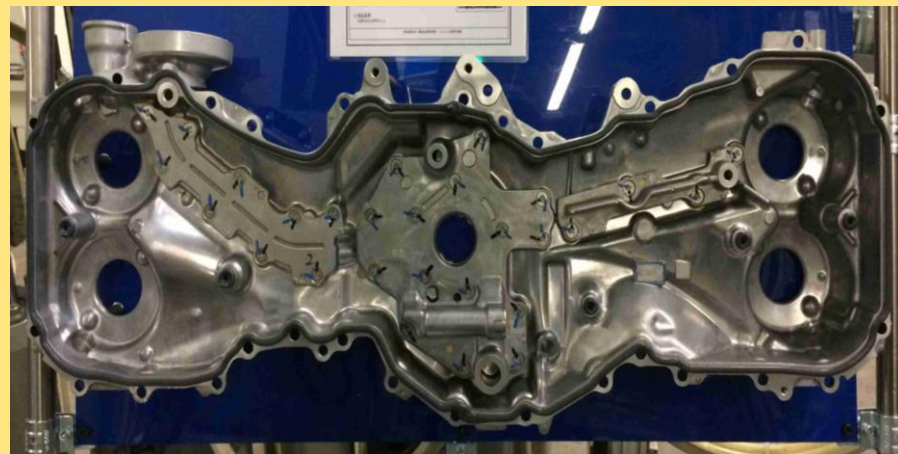
Chain cover (FA/FB)

- (A):14.5mm (B):17.5mm (C):Range A (D):316.2mm
 (E):24.5mm (F):18.5mm (G):127mm (H):Range B
 (I):FIPG application position at the mating area in range A
 (J):FIPG application locations on central boss (5 locations)
 (K):FIPG application position at the mating area in range B
 (L):FIPG application locations on mating surfaces other than Range A and Range B
 (M): $\Phi 4 \pm 0.5$ mm (N):2.3mm (O): $\Phi 12$ mm (P):2.8mm (Q):1mm
 ※ Refer to the service manual of each vehicle system for values.
