Check engine light illuminated - Fault code current P04DB79 The crankcase ventilation system is interrupted.

Topic number	LI01.20-N-079115
Version	1
Function group	01.20 - Crankcase ventilation, cylinder head cover
Date	4/3/25
Validity	447 and 907 with M274
Reason for change

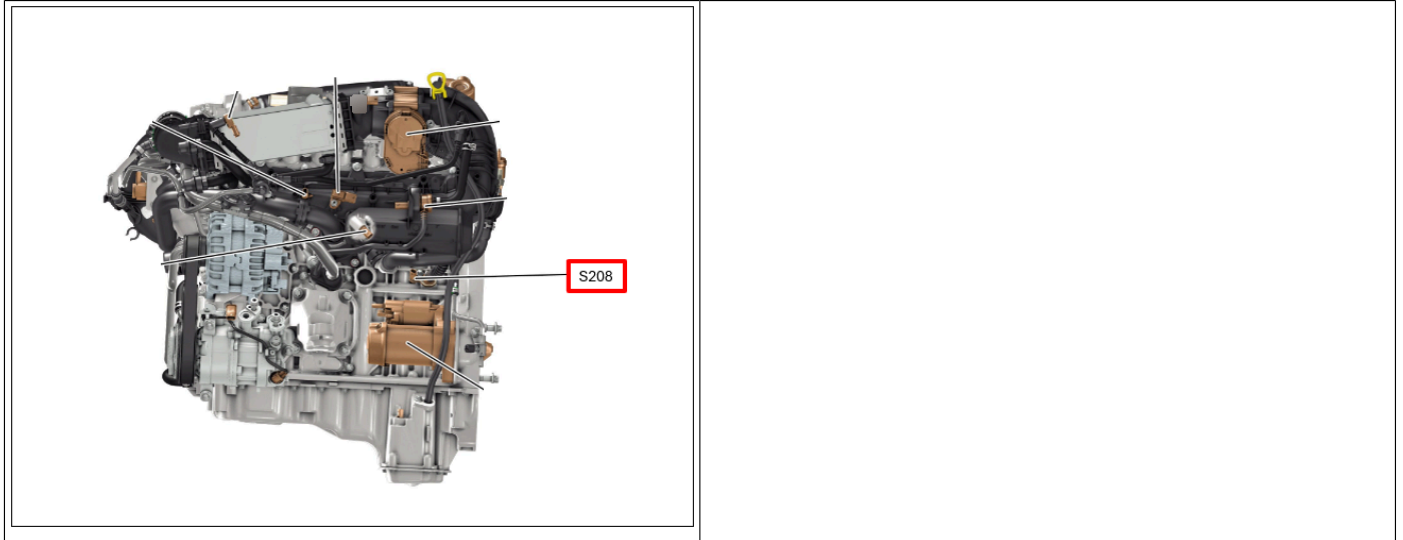
Attachments	
File	Description
M274 S208.png

Open circuit or high resistance to crankcase vent line contact

Control unit	Fault text
N3/34 - Motor electronics 'MED40' for combustion engine 'M274' (ME) (MED40)	P04DB79 - The crankcase ventilation system is interrupted. The mechanical connection has failed.

1. Check the electrical connector for S208 vent line contact switch. Refer to attached photo of connection location.
 2. Ensure the bolted connection is secure and bolt can be torqued (9Nm).
 3. Check continuity from vent line connection to ME control unit. Repair wire if damage is found.
- The circuit from ME provides 5V and is pulled to 0V when the ground connection is intact.
