| <b>Topic</b> | 91 PSS MMI sound: Settings for surround sound via head restraints are missing |
| <b>Brand</b> | Audi |
| <b>Transaction No.</b> | 2077615/1 |

### Q6 with headrest speakers

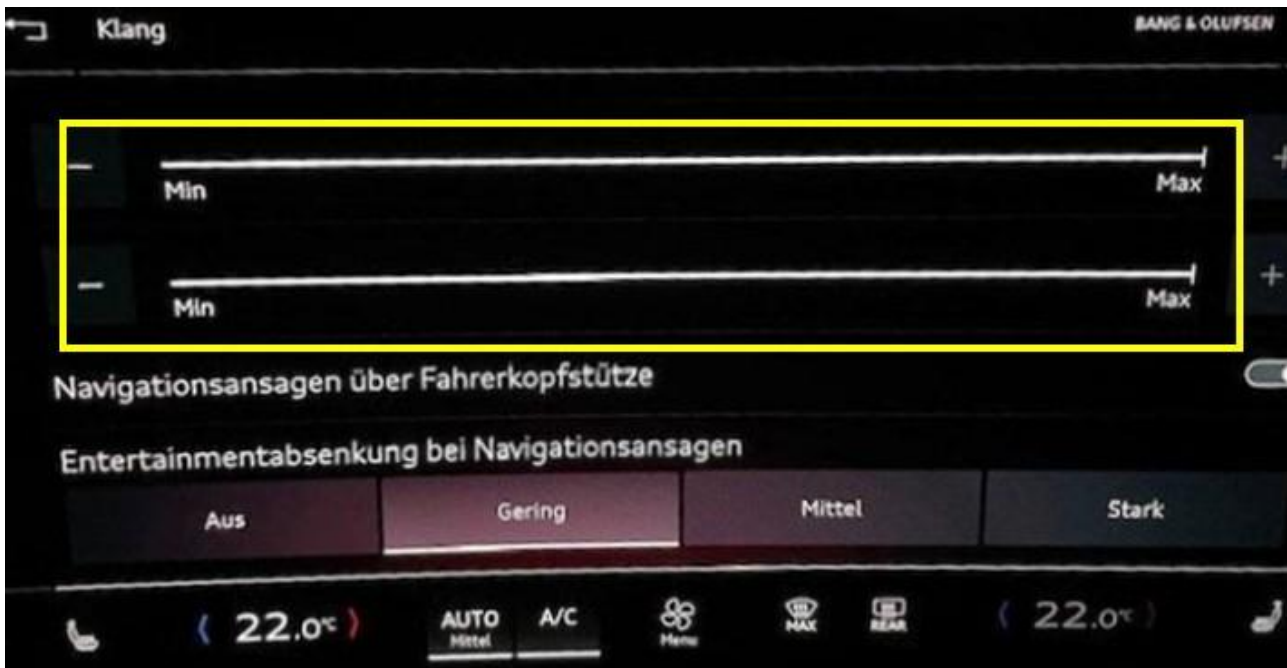
The buttons for surround sound in the driver and passenger head rests are missing in the MMI sound settings; two unmarked bars (Figure 1) are shown instead. Operating these bars does not affect the sound settings.

**Figure 1.** Two unmarked bars are shown instead of buttons for surround sound in the head rests.

The concern occurs sporadically. The buttons for surround sound may be displayed again after a bus sleep cycle.

Software issue.

1. Explain to the customer that a solution is expected to be available by the end of the 3rd quarter of 2025 (subject to change) and that no repairs are necessary at this point.
2. Do not replace any components for this condition since this will not resolve the customer's concern.
3. Create a PSS record in the PSS application through the Pending Service Solutions (PSS) link in AccessAudi (under *Related Links >> Service*).

If the complaint is made, it can possibly be remedied by performing a soft reset (pressing and holding the volume control) or a bus sleep cycle.
