| <b>Topic</b> | 91 PSS myAudi app: auxiliary air conditioning starts in vehicle but negative response in app |
| <b>Transaction No.</b> | 2077207/2 |

### Q6 e-tron and SQ6 e-tron

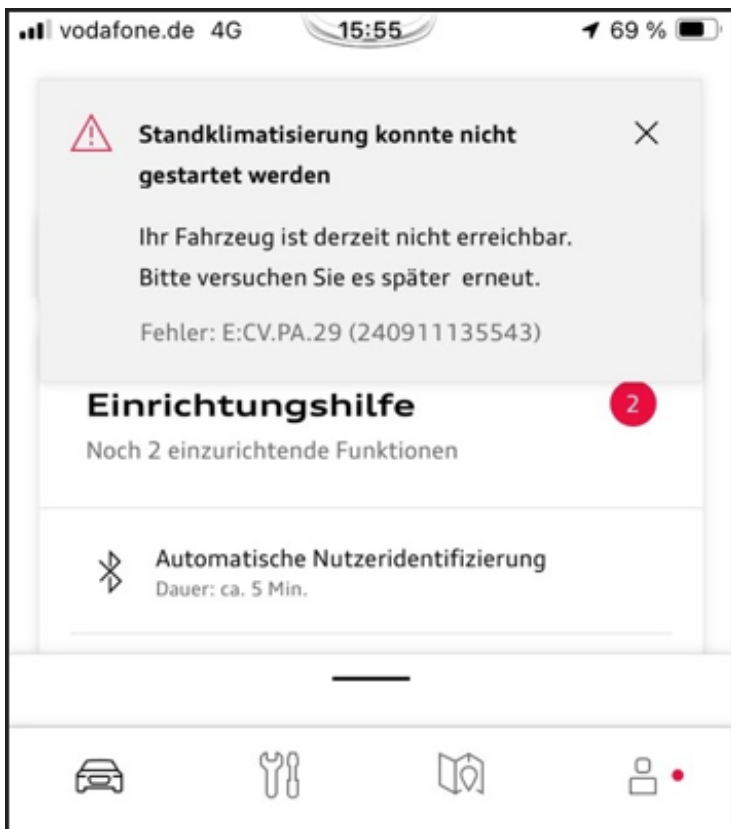
- The auxiliary air conditioner is started via the myAudi app. However, the myAudi app displays a negative response.
- After 1 to 2 minutes, the myAudi app also indicates that the auxiliary air conditioner is running.
- This issue occurs intermittently.

### Translation:

**Auxiliary air conditioner could not be started.**

Your vehicle currently cannot be reached.

Please try again later.

Error: E:CV.PA.29

Due to multiple backend-related issues, the myAudi app may intermittently receive no response when the air conditioning is started and may therefore display a negative response.

1. Explain to the customer that a solution is expected to be available by the end of the third quarter of 2025 (subject to change) and that no repairs are necessary at this point.
2. Do not replace any components for this condition since this will not resolve the customer's concern.
3. Create a PSS record in the PSS application through the Pending Service Solutions (PSS) link in AccessAudi (under *Related Links >> Service*).
