Can-Am Spyder 2024-25 Backup Camera Retrofit / Turn Off- 144022

Help document on retrofitting the backup camera to some MY 2024-25 Can-Am Spyder or turning it off after software update

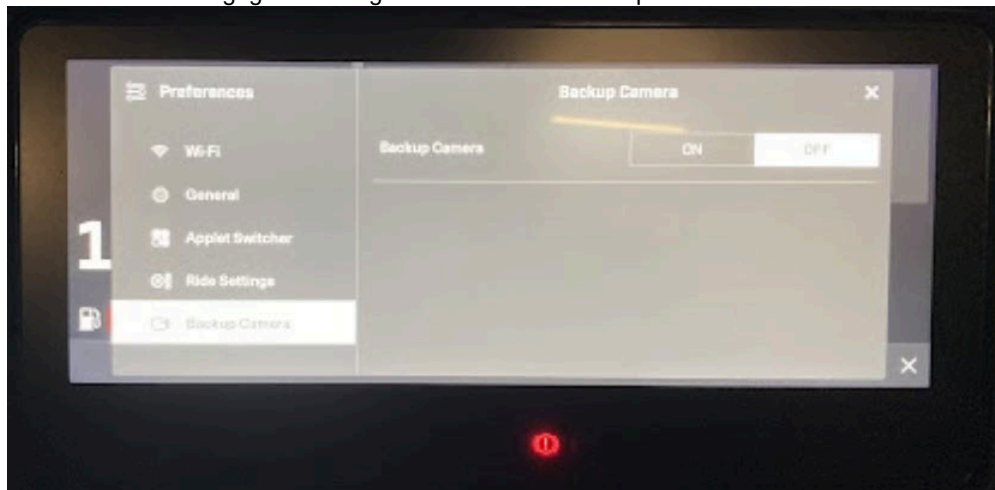
Its possible the cluster was updated to the latest software 710010643 and the unit is not equipped with the backup camera creating a blue screen when reverse gear is engaged

(see image in inspection section, camera needs to be turned OFF)

After installation and software update access the **Backup camera tab** through the **Preference** menu **(this also applies to MY25 that the camera was not factory installed)**

Switch the camera to **ON**

Start the unit and engage reverse gear to confirm camera operation

Retrofit the corresponding MY25 rear fender along the backup camera kit 219401199 (refer to shop manual for procedures)

Cluster will need to be updated the to MY25 software 710010643 or BRP Connect V3.1.0 if done Over The Air
