**WSAO - Replacing Coolant Pump (Workshop Campaign)**

Model Line: **Boxster (986)**  
**911 (996)**

Concerns: **Coolant pump**

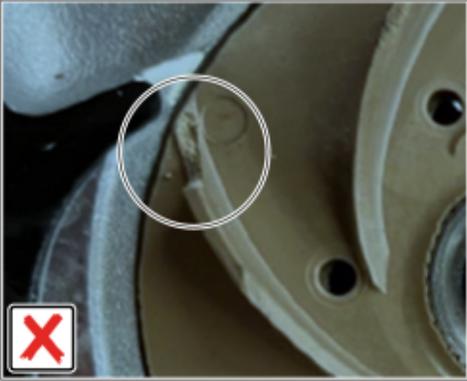
Cause: **It is possible that a coolant pump installed on the affected vehicles does not meet the required specifications.**  
If this is the case, the pump wheel can break during operation and plastic parts of the impeller can enter the cooling system. This impairs cooling performance and displays a warning message on the instrument cluster.

Assessment		Action
(✓)	The impeller of the coolant pump is <b>not damaged</b> .	Cooling system is <b>OK</b> . Install <b>new</b> coolant pump. <i>Removing and installing coolant pump (engine installed)'</i> <b>End of action.</b> Invoicing for <b>Scope 1</b> .
(x)	The impeller of the coolant pump is <b>damaged</b> .

<i>Example illustration of a damaged impeller</i>	Cooling system is <b>not OK</b> , Continue with Step ⇒ 4.

Fragments of the impeller can collect in the cooling system in areas with low flow speed, e.g. at the intake and outlets of the coolers.

- 4 Loosen and pull off coolant hoses on the radiators.
- 5 Check inlets and outlets on the radiators for fragments and remove if necessary.
- 6 Fasten coolant hoses at the radiators.
- 7 Install **new** coolant pump, do **not** fill cooling system.  
For work procedure, see: *Removing and installing coolant pump (engine installed)'*
- 8 Clean the cooling system with water.  
For work procedure, see: *Cleaning the cooling system'*
- 9 Fill with coolant and bleed the cooling system.  
*Draining and filling coolant (includes bleeding)'*
- 10 Enter the campaign in the Warranty and Maintenance Logbook.
