TO: Mercedes-Benz Dealer Principals, General Managers, Sales Managers, Service Managers, Parts Managers	FROM: Gregory Gunther, Senior Manager, Vehicle Compliance and Analysis, Engineering Services
RE: Emission Service Campaign Launch Notification Perform Software Update – 48V Battery Management System MY 2019 – 2022 C-Class, CLS, E-Class, GLE, GLS, and GT (206, 257, 213, 238, 167 and 290 platforms)	DATE: May 8, 2025

Perform Software Update – 48V Battery Management System

CAMPAIGN NO.	2025050001
CAMPAIGN DESC.	23P5498819
SUBJECT	Update 48V Battery Control Unit
MODEL(S)	C-Class, CLS, E-Class, GLE, GLS, and GT (206, 257, 213, 238, 167 and 290 platforms)
MODEL YEAR(S)	2019 – 2022
CAMPAIGN POPULATION	100,866

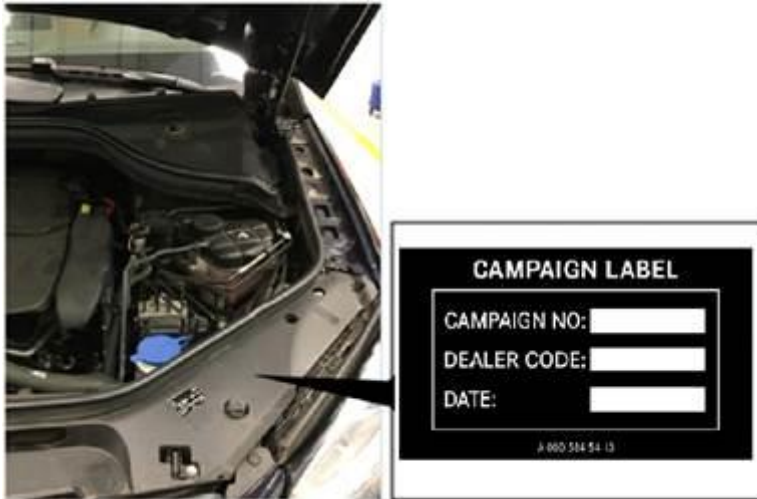
Figure 1

Apply Proof of Correction Label (A 000 584 54 13) to area identified in **Figure 1**. Fill in the blank areas of the label. The “**Campaign No.**” for the California Proof of Correction is unique and must be entered as such (250724), your “**Dealer Code**”, and the “**Date**” of the repair, using a black permanent marker.

i Note: Clean bonding surface prior to affixing label.
