**SIB 64 05 25**

**HVAC FLAP LINKAGE NOT FULLY CONNECTED**

# G45 HVAC: Air Vent Flaps/Kinematic & Stepper Motor Master Info.

B64 05 25 Attachment

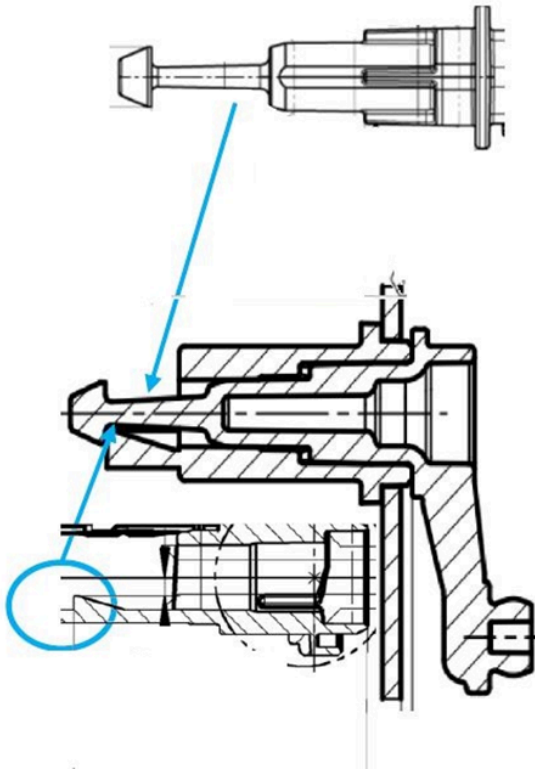
Check that the linkage has not come loose from the flap in the heating, ventilation, and air conditioning (HVAC) system.

This can occur to ANY of the flaps in the HVAC system.

See attached video for one example

There is a push-in end on the linkage that can be reinserted into the flap and fully seated.

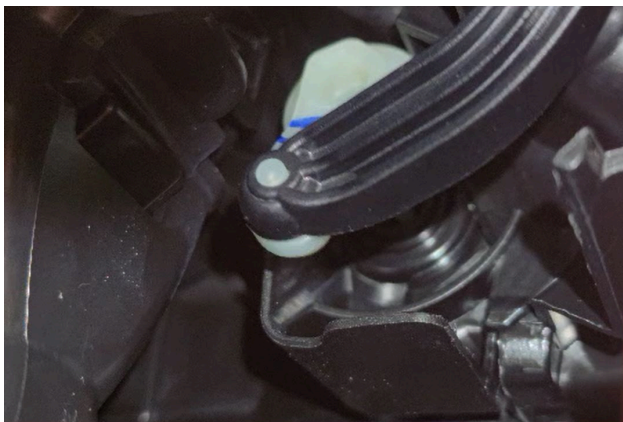
To test if the mechanism is fully seated into the HVAC flap assembly, perform a wiggle test of the white plastic (in/out). Here you can see the white plastic mechanism has backed out of the HVAC case and is not locked into the flap.

There is a push in end on the linkage that can be reinserted into the HVAC flap and fully seated. The white plastic mechanism push pin can be reinserted into the HVAC flap and fully seated.

**Make sure to push in until you can feel the white plastic mechanism push pin mushroom shaped end engage into the flap ramp.**

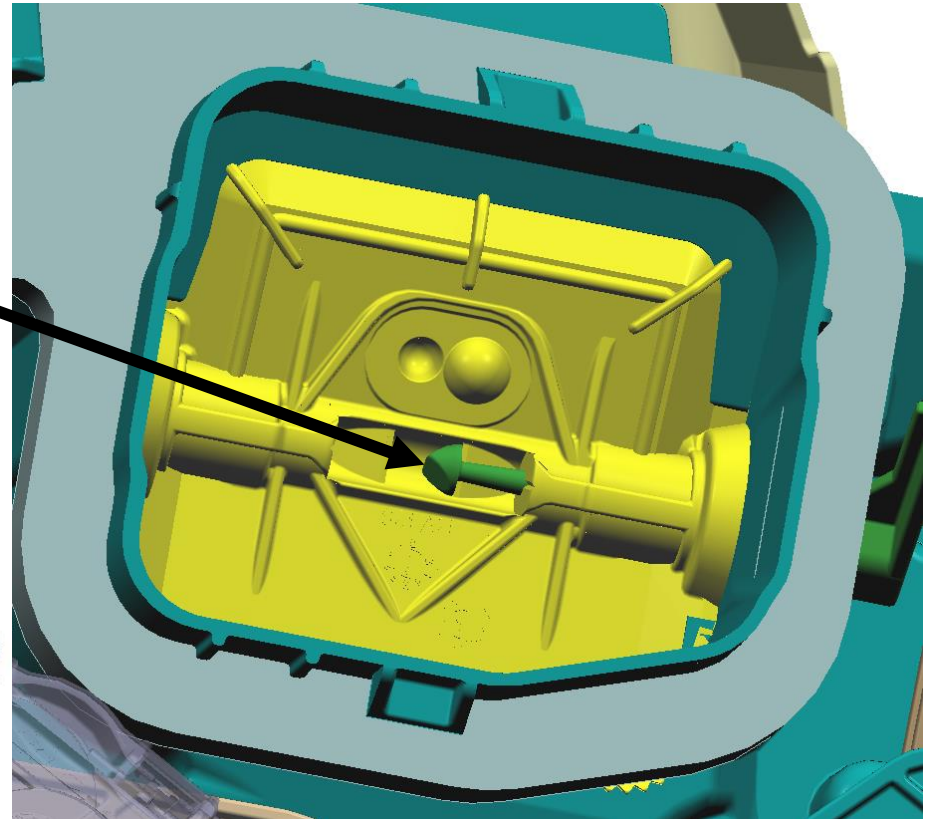
## FLAP #8A/8B: Front Side Vent Air Flap LEFT (Mirrored Left to Right)

8A shown.

TWO Push Pins (one on LEFT side flap & one on RIGHT side flap)!

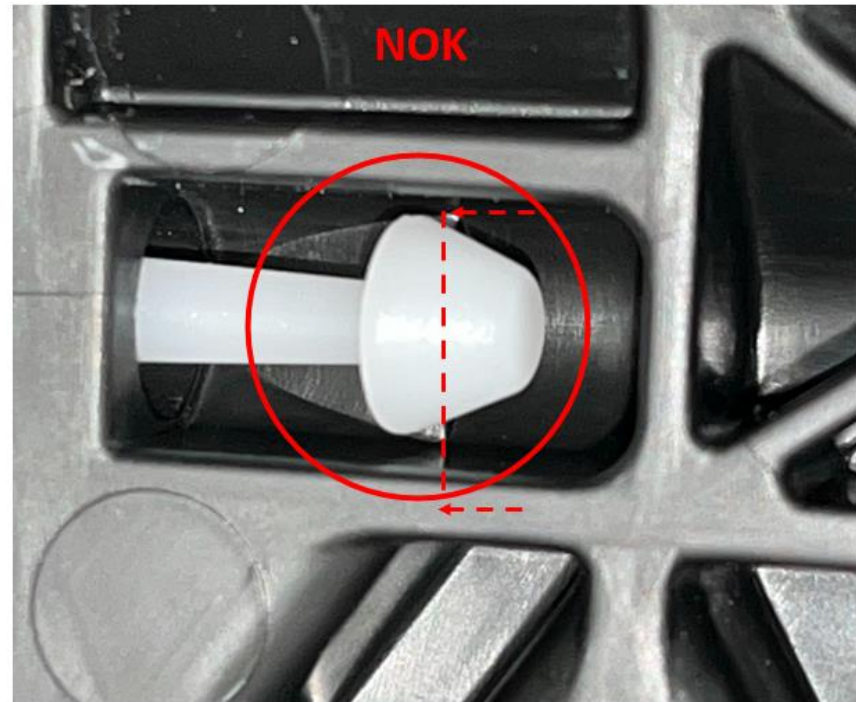
**NOK part – Push pin mushroom head NOT over the flap ramp (not snapped)**
