Technical Information

Grecale Axle Shafts Characteristics

DATE: MAY 26, 2025

MODELS: M182 Grecale 2.0 L4 MHEV (All MY).

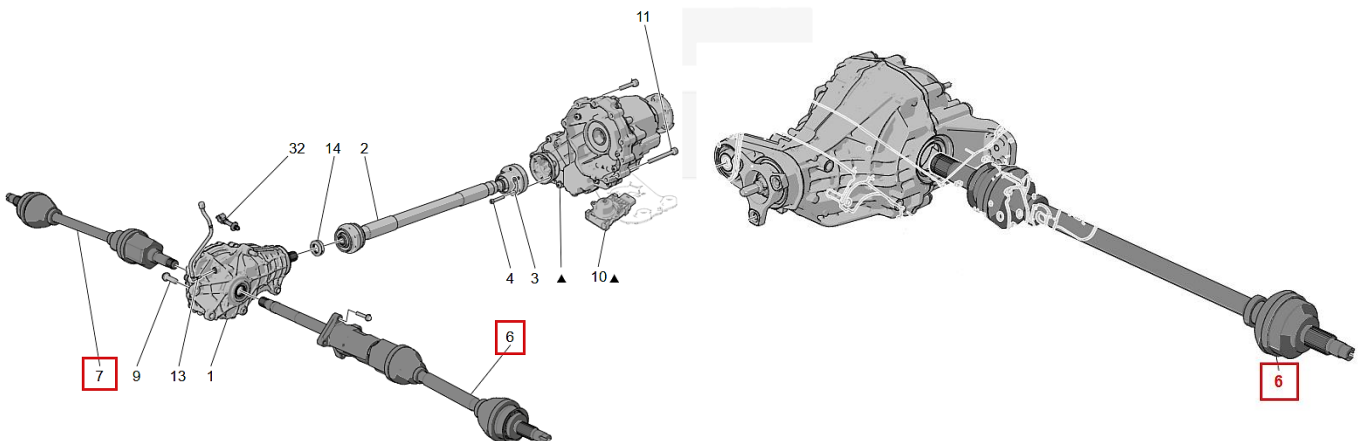
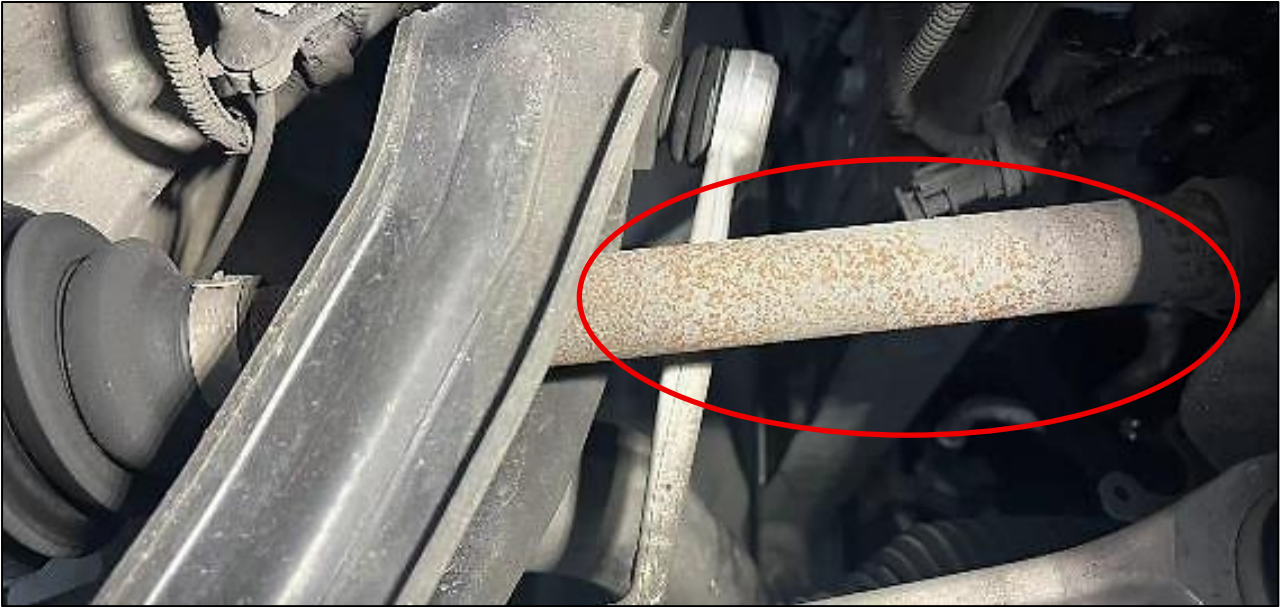
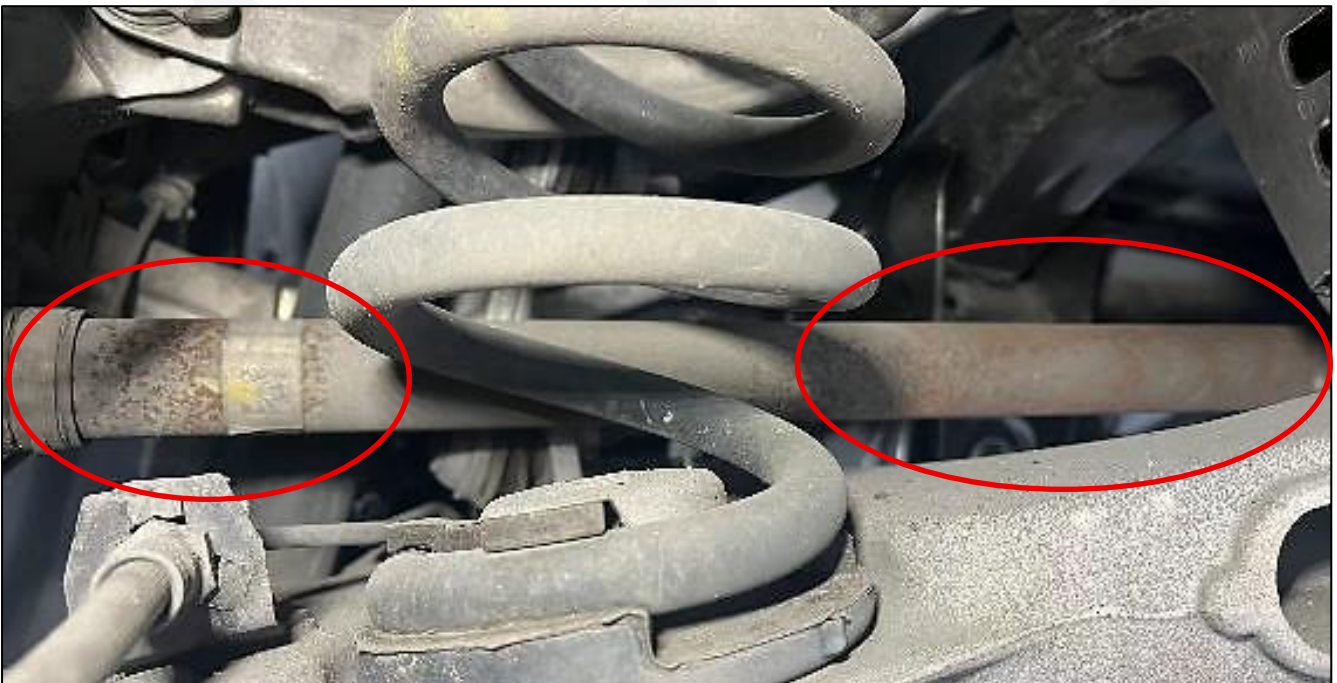
Please be advised that the front and rear axle shafts on the M182 MHEV model are **not painted during production**. As a result, **surface oxidation may be visible**. This is an expected cosmetic condition and does **not affect the performance, safety, or durability** of the component.

Such cosmetic oxidation is considered **normal and fully compliant**. These components should **not be replaced** unless a functional defect is present.

- When inspecting axle shafts, reference the attached photos for examples of acceptable surface conditions.
- Do not initiate parts replacement based solely on cosmetic oxidation.
