Technical Service Bulletin

GROUP	NUMBER
CAMPAIGN	25-01-026G
DATE	MODEL(S)
MAY 2025	GV80 (JX1) GV80 COUPE (JX1)

SUBJECT: ECU UPDATE – P0461/ P2066 FUEL LEVEL SENSOR LOGIC (SERVICE CAMPAIGN 912G)

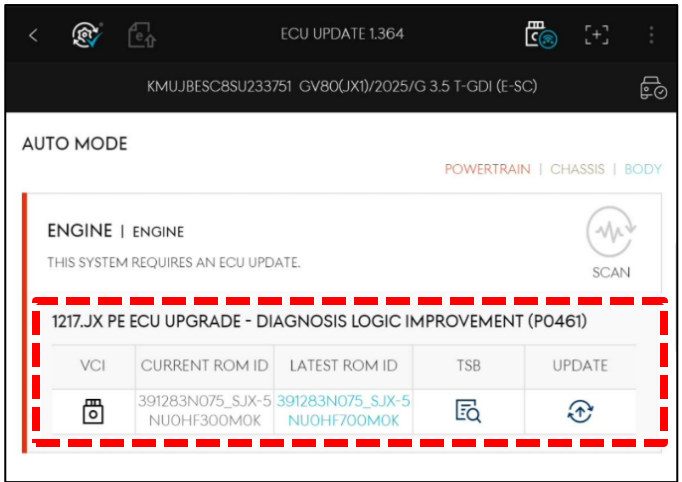
2. Select the **ECU** system to scan the vehicle’s current ROM ID.

Check the current ROM ID version and compare it to the ROM ID Information table before attempting to perform the software update.

If the update fails, please remove the power connector or the battery (–) connector from the indoor fuse box for at least **5 seconds** and reassemble it to retry the update.

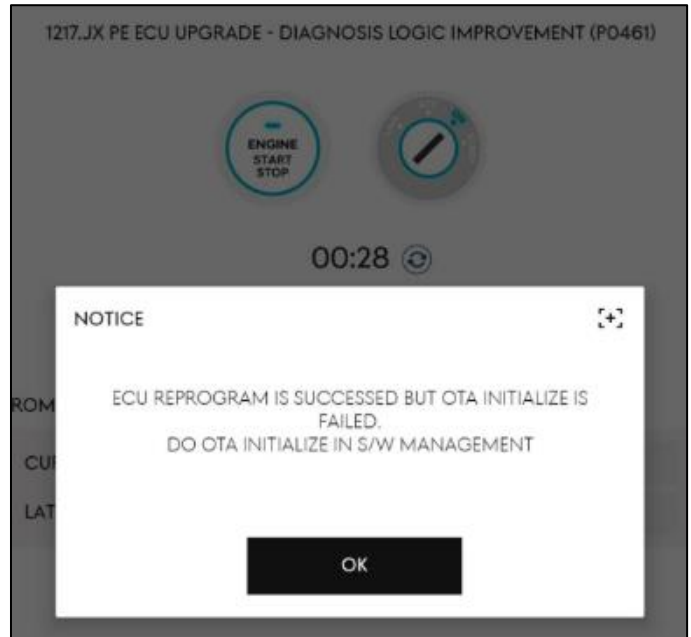
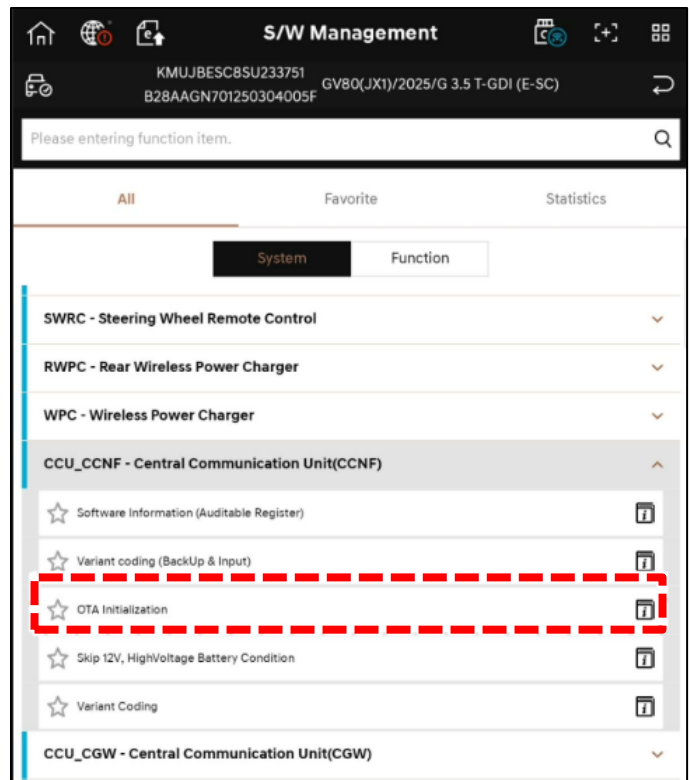
5. Certain vehicles may experience a notice message stating the ECU reprogram was successful, but the OTA initialization has failed.

If the message is shown, perform the OTA initialization manually under S/W Management.

- **S/W Management > CCU_CCNF – Central Communication Unit (CCNF) > OTA Initialization**

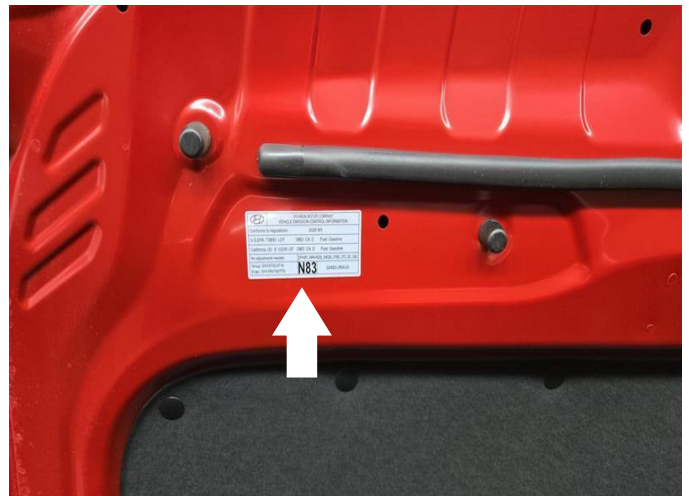
1. Fill in the Dealer Code and Date on the Campaign Sticker, and apply adjacent to the existing Emission Label, on the underside of the hood, as shown.

Clean the mounting surface to ensure proper label adhesion.
