Technical Service Bulletin

Subject: CREAK OR SQUEAK NOISE FROM LOWER CONTROL ARM AT FRONT SUSPENSION WHEN TRAVELING OVER A BUMP WHILE TURNING AT LOW-SPEED	Bulletin No.: 02-001/25
	Last Issued : 05/29/2025

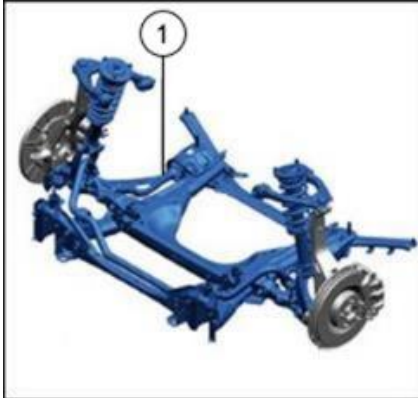
Some vehicles may exhibit a creaking or squeaking noise from the lower control arm at the front suspension when traveling over a bump while turning at low-speed. A stick-slip phenomenon may occur between the stopper rubber (2) and the bracket (3) in the front lower arm (rear) (1).

- Grease has been applied to the stopper rubber.
- Dust covers have been installed to the lower arm.
- The mounting hole size of the lower arm bracket has been modified.

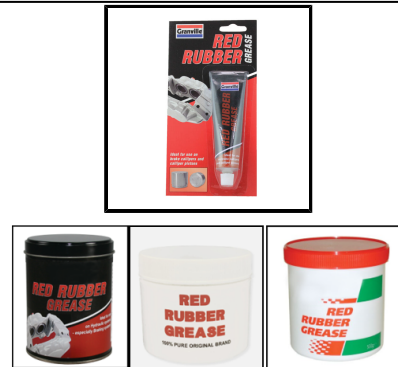
Grease type: RED RUBBER GREASE

Worked penetration: 9.5 - 11.0 (.004 in (grease consistency) [240 - 280 (0.1 mm (grease consistency))])

High viscosity and infusible

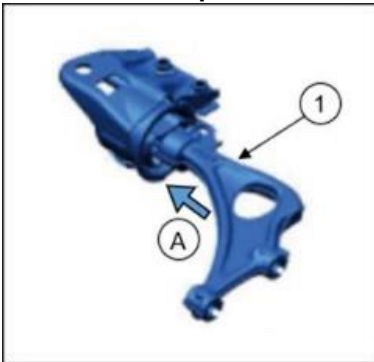
(1) Front Lower Arm (Rear)

b. Apply the grease **using the putty knife**, aiming at the yellow highlighted area (4) in View of B and C, which is the contact surface between the stopper rubber (2) and bracket (3) on both left/right sides of the front lower arm (rear) (1).

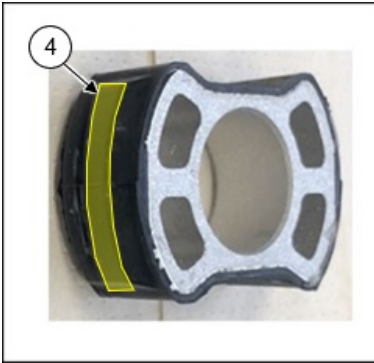
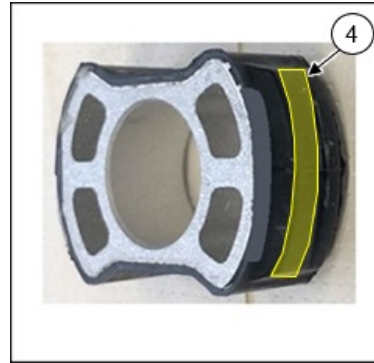
VIEW of A

VIEW of B (Stopper rubber)

VIEW of C (Stopper rubber)

ATTENTION: Ensure that enough grease is applied to the specified area (4) on the stopper rubber to completely fill the area (4), otherwise the noise may occur.

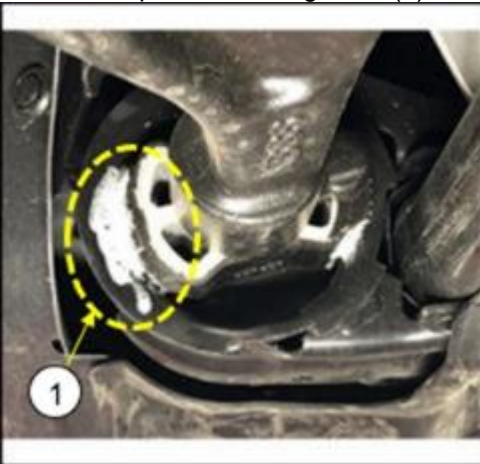
c. Wipe off excess grease (1) from external surfaces.

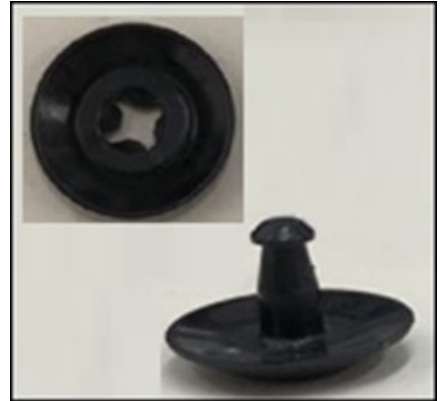
Female Rivet
Male Rivet
(3 each for one side)

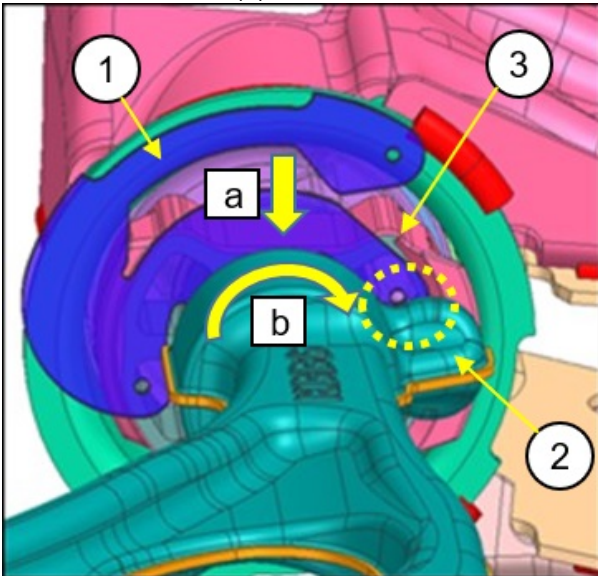
- 1) Insert the dust cover A (1) into the gap between the lower arm and the stopper rubber (3) in the direction of arrow (a).
- 2) Insert the dust cover A (1) under the protrusion (2) of the lower arm while rotating it in the direction of the arrow (b).

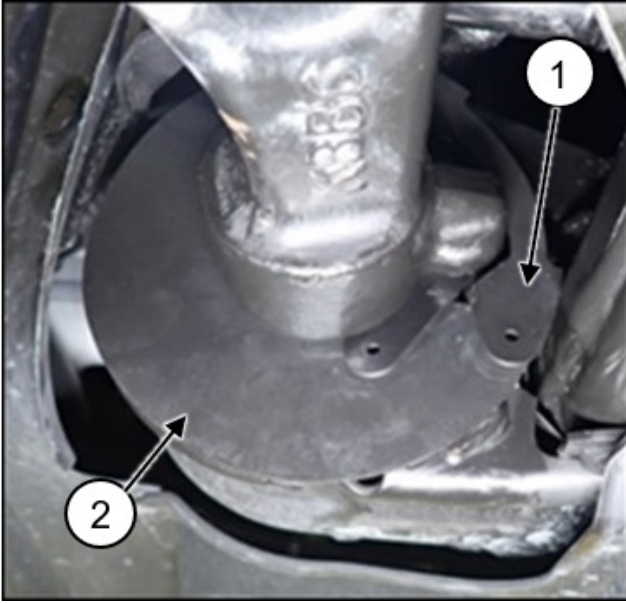
b. Install Dust Cover B (2) so that Dust Cover A (1) is on the vehicle front as shown.

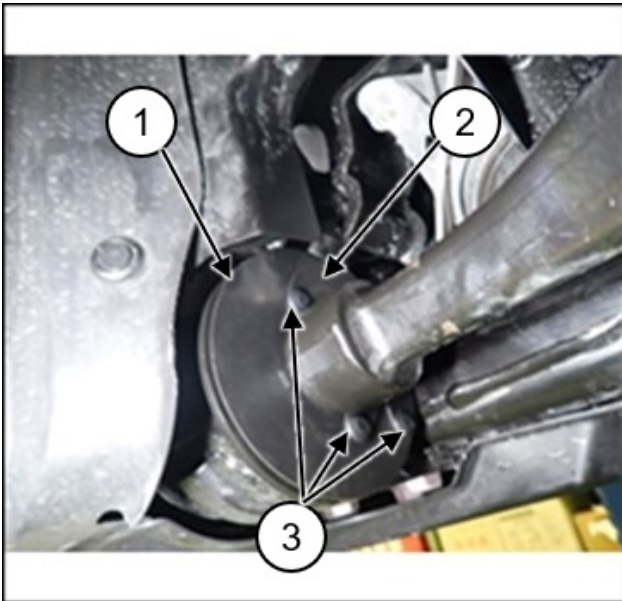
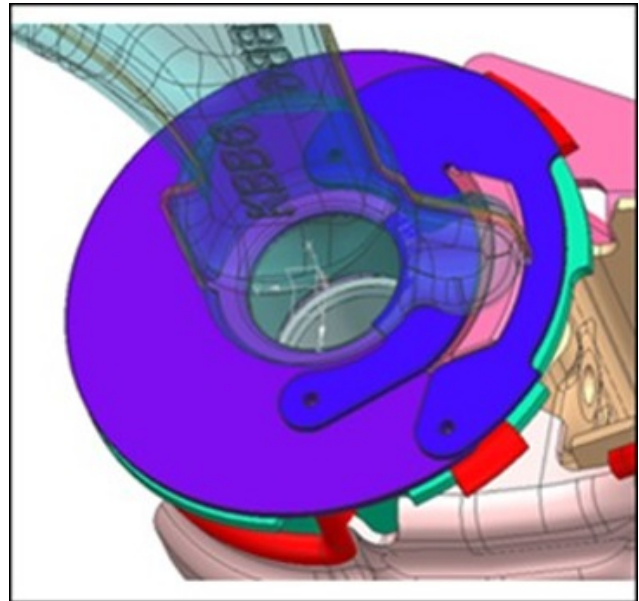
Images of the completed repair

c. Install the female and male rivets (3 pcs. each) so that the male rivets are on the vehicle front.
NOTE: Push the rivets until they are seated completely.

- (1) Dust Cover A
- (2) Dust Cover B
- (3) Rivets

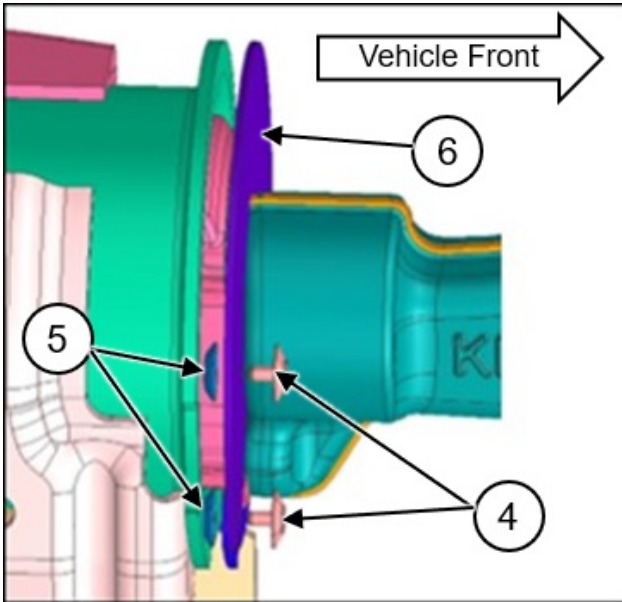
Rivets installation direction

- (4) Male rivet
- (5) Female rivet
- (6) Dust cover

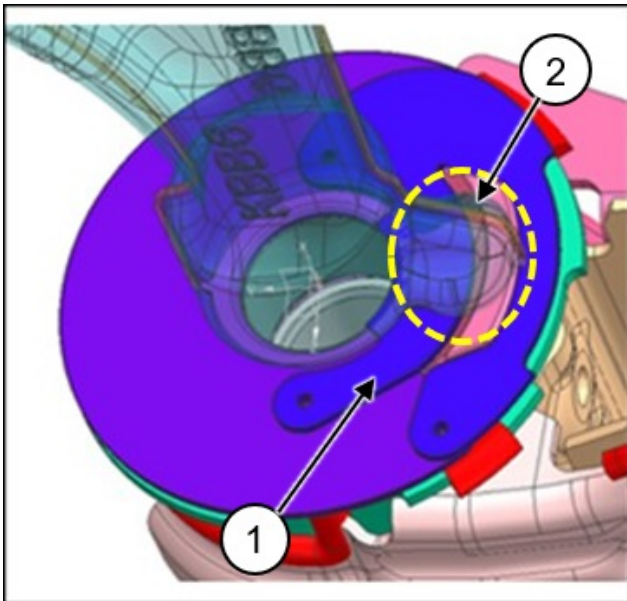
d. After the installation, check if Dust Cover A (1) is under the protrusion (2) of the lower arm.

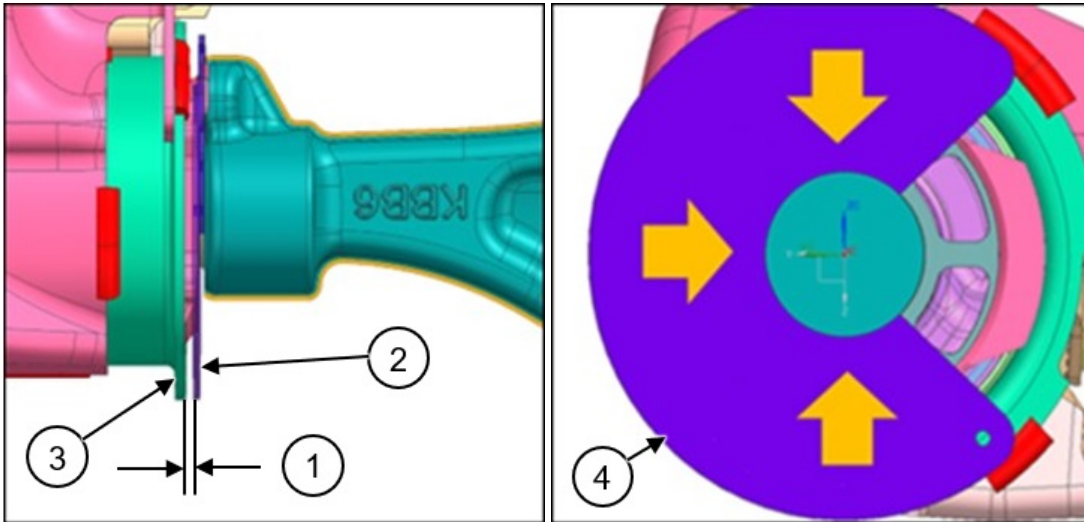
- Ensure the space (1) of 3-5 mm {0.1-0.2 in.} between the dust cover (2) and the bracket (3).
- If the space (1) is wider than 10 mm {0.4 in.}, the mounting position may be incorrect.
- If the space (1) is wider than 5 mm {0.2 in.}, push the dust cover B (4) into the direction of the shaft (yellow arrows) and adjust the gap.
