TECHNICAL SERVICE BULLETIN

Classification: BT25-009	Reference: NTB25-031	Date: June 16, 2025
-----------------------------	-------------------------	------------------------

CLICKING NOISE WHEN OPENING DRIVER DOOR

APPLIED VEHICLES: 2025 Murano (Z53)
APPLIED DATES: Built on or before May 30, 2025

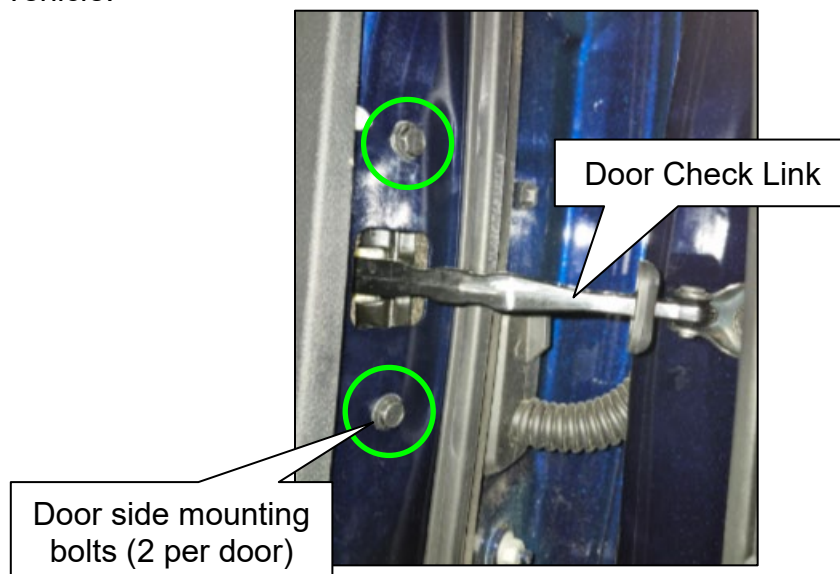
Figure 1

If a popping / clicking noise is present from one or more of the Door Check Links (Figure 1) when opening the associated door:

First confirm that the torque of the door side mounting bolts of the related Door Check Link is at the correct specification, and then retest for popping / clicking before considering replacing the Door Check Link.

- Refer to the ESM: **BODY EXTERIOR, DOORS, ROOF & VEHICLE SECURITY - DOOR & LOCK - REMOVAL AND INSTALLATION - DOOR - DOOR CHECK LINK**
- There are two (2) door side mounting bolts per door and a total of eight (8) per vehicle.
