CAL FTL 20-007

**Subject: New Cascadia Vehicles Equipped with Cummins Engines—Inspection for Properly Torqued Engine Mounting Bolts**

**Make: Freightliner**

**Model: New Cascadia**

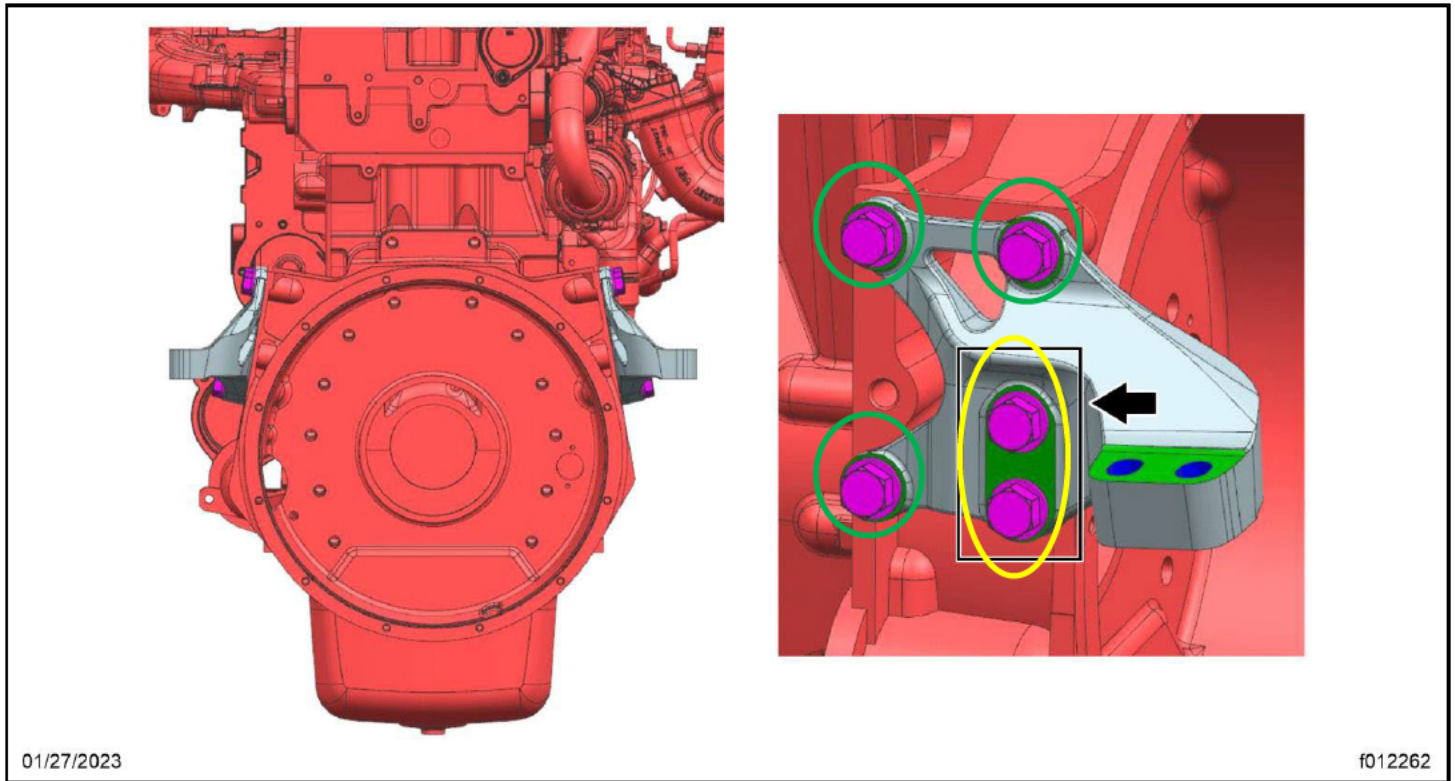
Fig. 4, Bolt Identification

Part Numbers for the Correct Bolts		
Green Circle	23-09446-225	SCREW-CAP,HEX3/4-10X2.00 GR8PO
Yellow Circle	23-09446-300	SCREW-CAP,HEX3/4-10X2.75 GR8PO

10. If bolts are missing, replace the bolts as needed following steps 9 and 10, See **Fig. 4**, bolt identification.  
Part numbers for the correct bolts are shown in **Table 2**.
11. Position the splash shield so that the cab studs align with the splash shield holes. Install the two backing plates and the four nuts on the studs. Tighten the nuts 15 lbf·ft (21 N·m).
12. Install the screw that attaches the splash shield to the front-wall mounted bracket.
