Service Bulletin

Bulletin No.: PIT6396

Subject: SES MIL with DTC P2535 / P12A6 / P10DA / C111B / P157A After Fuel Pump Driver Module Replacement 13565642

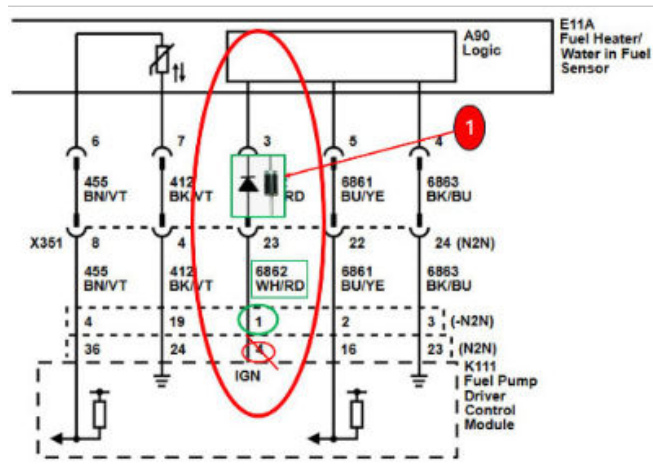
6954816

Engineering is working on design improvements for a new fuel pump driver module. In the meantime, a diode can be installed in line with the water-in-fuel sensor circuit 6862, shown below (1), to correct the issue.

1) Locate either the K111 fuel pump driver module connector terminal 1 OR the E11A Fuel Heater/Water In Fuel sensor connector terminal 3, whichever is the most convenient to install a mini inline fuse holder. Next, cut circuit 6862 a few inches from the connector. Then connect a mini fuse holder, see parts sections for details, in line with circuit 6862 using two salmon splice sleeves, as shown below (3). In the example below, the repair is being done at the K111 fuel pump driver module (2) end, but it could be done at the E11A Fuel Heater/Water In Fuel Sensor connector end, whichever is most convenient.

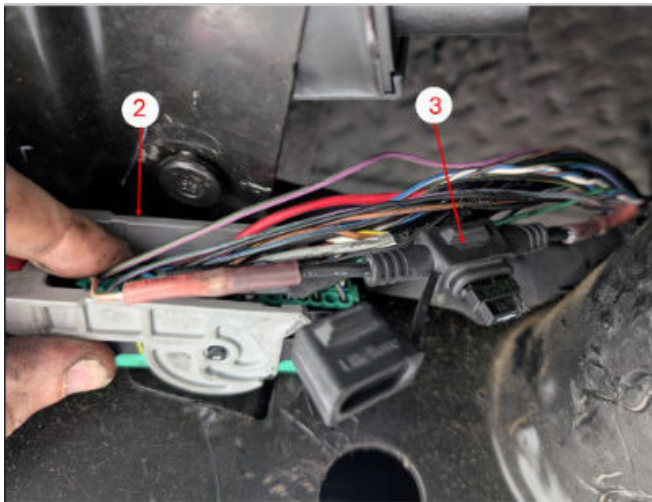
6956149

2) Install a fuse style diode, GM P/N 12135037, into the mini inline fuse holder so the arrow on the diode is pointing towards the E11A Fuel Heater/Water In Fuel Sensor, as shown above (1).

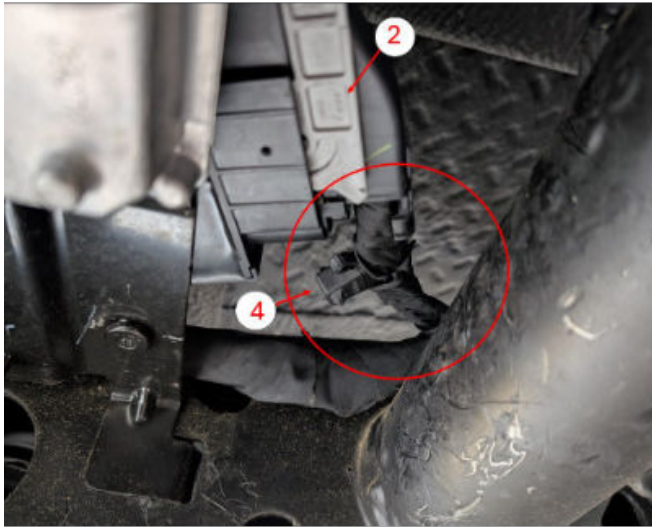
6956150

3) After installing the diode close the weather seal cap on the mini inline fuse holder and then wrap tape around the cap to help keep it closed. Then retape the wiring harness as shown below (4). In the example below, the weather seal cap was not taped close, but it needs to be to help keep it from opening.

4) After the repairs are completed use GDS2 to verify the ECM Ignition 1 voltage now drops to near 0 volts when the ignition is turned off.
