Technical Service Bulletin (TSB)
Front Bumper Paint Is Dull

REFERENCE:	TSB: 23-027-25 GROUP: 23 - Body	Date:	June 27, 2025	REVISION:	—
VEHICLES AFFECTED:	2020 - 2022 (DS) RAM 1500 Pickup This bulletin applies to vehicles built on or after January 02, 2020 (MDH 0102XX).			MARKET APPLICABILITY: <input checked="" type="checkbox"/> NA <input type="checkbox"/> CH <input type="checkbox"/> EE <input type="checkbox"/> IAP <input type="checkbox"/> SA <input type="checkbox"/> MEA NOTE: This bulletin applies to the North American market.	
CUSTOMER SYMPTOM:	Customers may comment on the following: <ul style="list-style-type: none"> • Front bumper paint is dull Fig. 1. 				
CAUSE:	Manufacturing defect

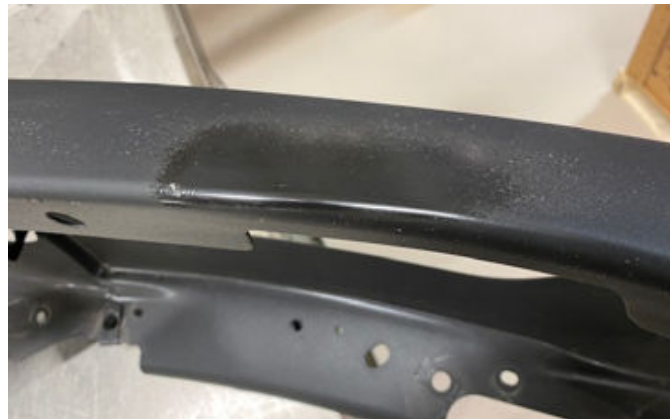
Fig. 1
Dull Bumper Paint Example

This bulletin involves inspecting and possibly replacing the front bumper.

1. Replace the front bumper. Refer to the detailed procedures available in DealerCONNECT > Service Library> under: 13 - Frame and Bumpers / Bumpers / Bumper, Front / Removal /Installation.
