## Technical Journal

| Technical Journal Title<br>Coolant Pump Dry Coolant Mix Residue | | Ref. No.<br>TJ 36923.6.0 | |
| Function Description<br>Coolant pump, complete | | Page<br>Page 1 of 4 | |

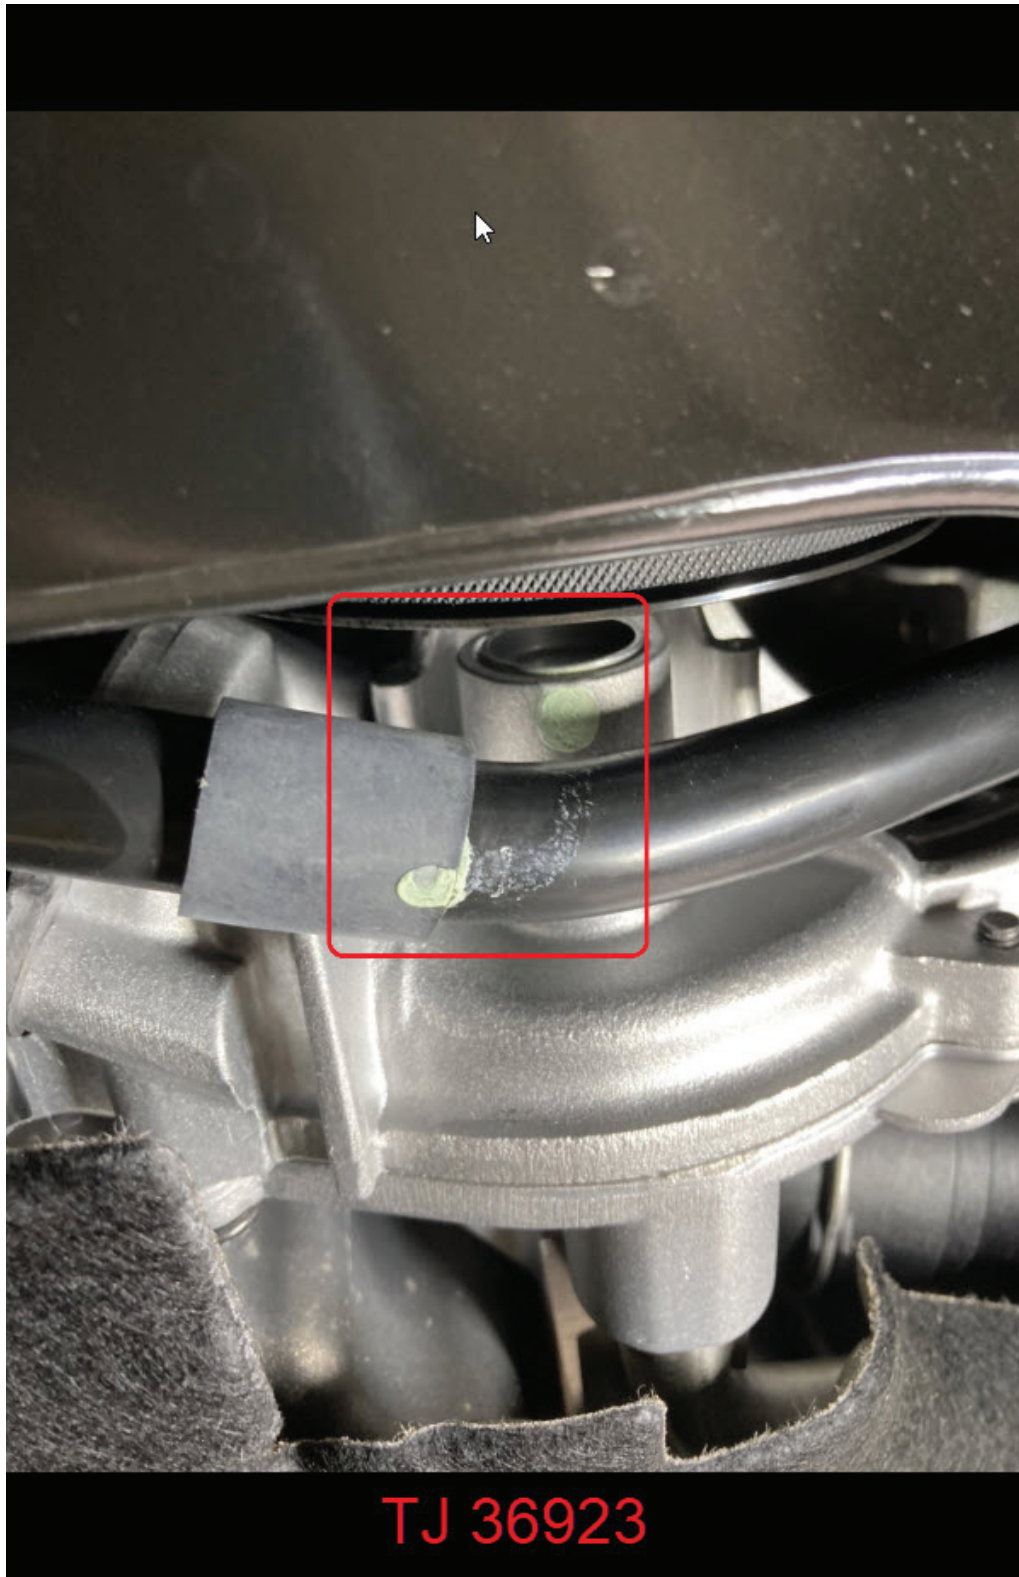
\* Sealing improvements have been made to PN 32382367 and 32382368, but the part numbers are unchanged. To assist with identification of improved parts, a marking has been added to the parts: an "X," as shown in the attached document *TJ\_36923\_1.pdf*.

\* If you receive a replacement pump that does not have the "X" marking, please return it and order a replacement.

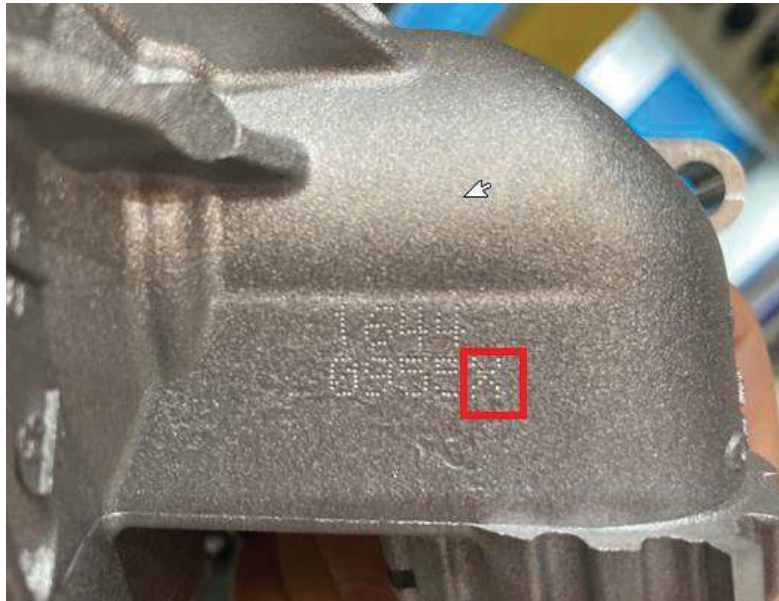
TJ 36923

If the coolant pump has a small sign of dry green/white coolant mix (see example as in attached picture TJ\_36923\_1) without a DTC set, follow advice under "Service".

If the coolant pump has a small sign of dry green/white coolant mix **but no other symptoms** (e.g., warning message(s), visible coolant leakage under the vehicle, etc.), this is considered OK, do not replace any parts.
