Volvo Car USA LLC

Technical Journal

<small>Technical Journal Title</small> Towing Hook Interferes with Bumper		<small>Ref. No.</small> TJ 37350.1.0	
<small>Issuer (Dept.)</small> Technical Service		<small>Issue Date</small> 4/10/25	<small>Status Date</small> 4/17/25
<small>Car Market</small> United States and Canada	<small>Partner</small> 3 US 7510 Volvo Car USA	<small>Function Group</small> 8920	
<small>Function Description</small> Recovery and towing unit		<small>Page</small> Page 1 of 3

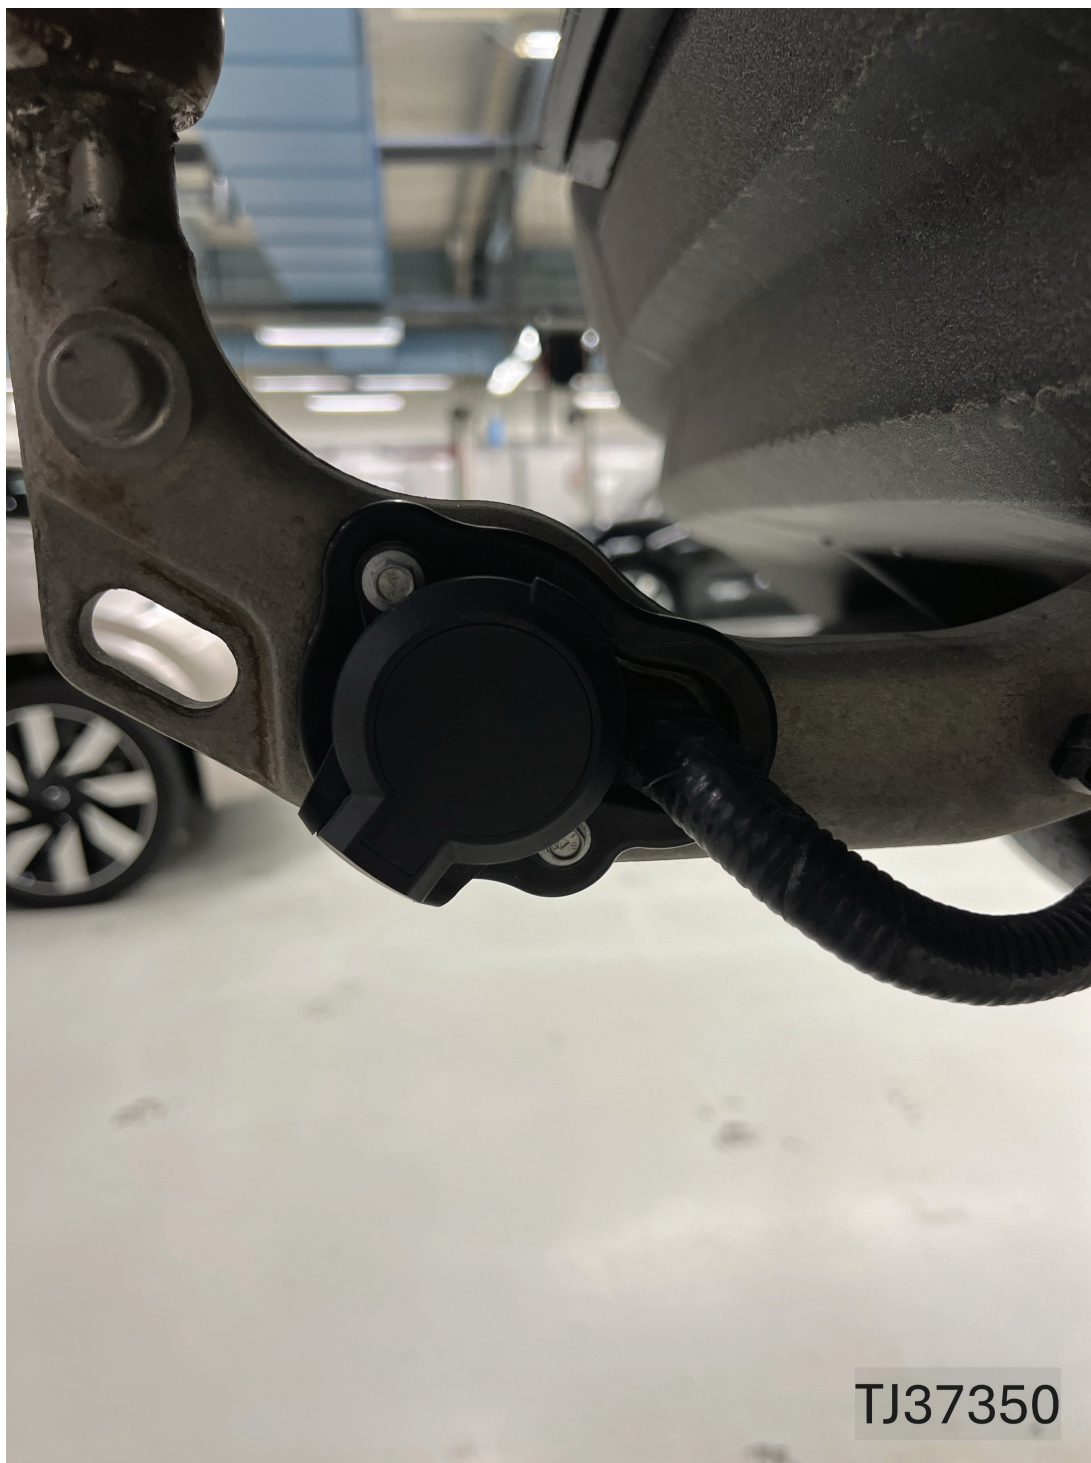
TJ37350

When installing or inspecting the towing hook, check the movement when folding / unfolding.
 If the connector on towing hook is touching the lower part of the bumper, follow the steps below:

1. Loosen the screws to the connector.
2. Assemble the spacer between the towing hook and the connector, tighten the screw to the towing hook with 5Nm. See attachment TJ_37350_1.JPG.
3. Test the movement of the towing hook by folding/unfolding.
4. If the towing hook is still touching the bumper, carefully cut/file the upper area on the bumper until the towing hook can move freely.
