| <b>Document Title:</b> | Repair of the Battery Fuse on ES12RK | | |
| <b>Document Type:</b> | Technical Service Bulletin | Publication Date: | June 23, 2025 |
| <b>Document #:</b> | 25-02 | Make and Model: | Ember E-Series Spark LE, 12RK |

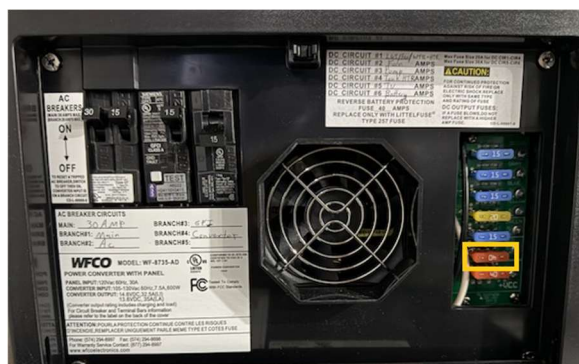
1. Locate and remove the existing 20-amp battery fuse in Circuit #6 of the power center.
2. Install one (1) 40-amp fuse, Ember Item# 35000155, into Circuit #6 of the power center.

3. Apply the provided 'NOTICE' label to the outside of the power center.
