SIB 63 04 18

DAYTIME RUNNING LIGHT IS DIM OR DISCOLORED

This Service Information Bulletin (Revision 8) replaces SI B63 04 18 **dated April 2025**.

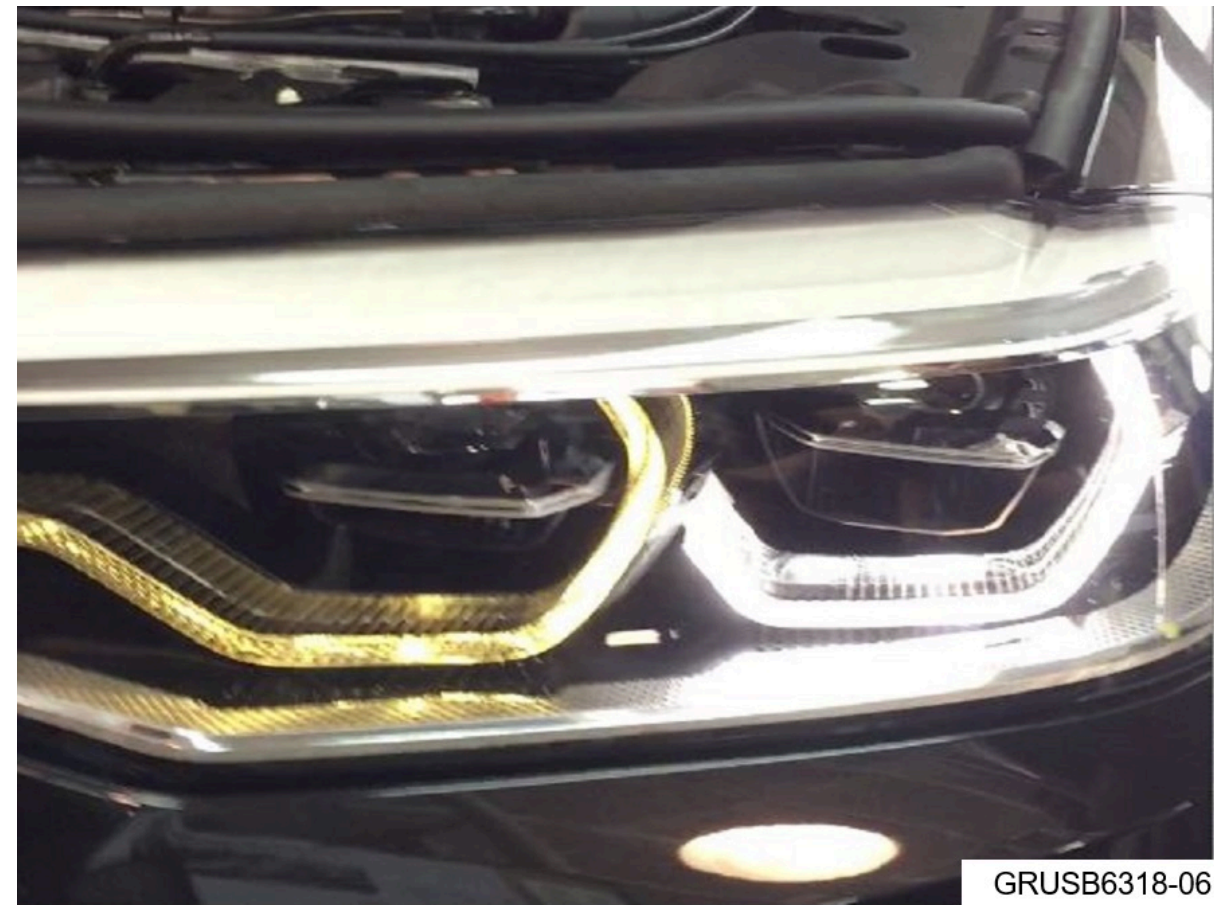
GRUSB6318-06

One or more of the LED daytime running lights are dim or discolored.

The connection between the LED module and light tube inside the headlight is damaged.

Inspect and replace the affected LED module.

Only replace the headlight assembly if internal damage is found to the light tube.
