GROUP	MODEL
ELE	2025MY Soul (SK3)
NUMBER	DATE
395	July 2025

## TECHNICAL SERVICE BULLETIN

### SERVICE ACTION: MDPS CONNECTOR LOCKING INSERT INSPECTION (SA623)

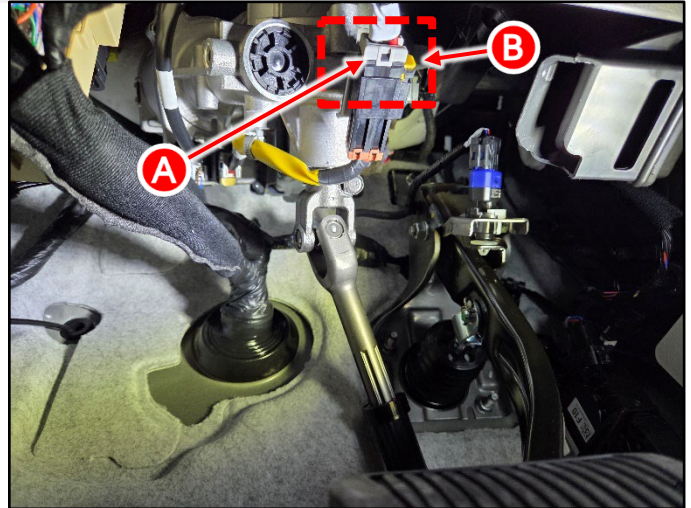
- Inspect the yellow secondary locking insert (B) of the MDPS wiring harness connector (A):

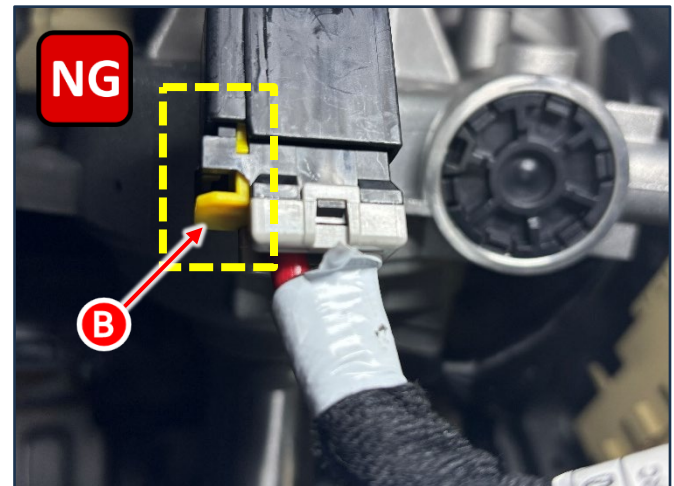
- The yellow secondary locking insert (B) is NOT fully inserted (seated flat) into the MDPS connector (**NG**). If so, simply press the yellow insert inward to complete this service action.

The MDPS wiring connector features a 'double locking' system.

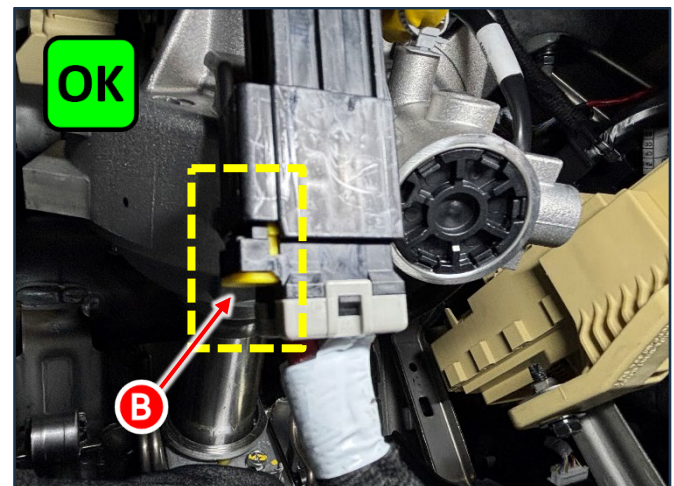
- The yellow secondary locking insert is fully inserted (seated flat) into the MDPS connector (**OK**). If so, no further action is required.

The MDPS wiring connector features a 'double locking' system. When inserting the MDPS wiring connector into the MDPS side, a 'primary' push-button lock/secures the connector in. The yellow secondary insert prevents the primary push-button from being pressed to release the MDPS wiring connector.
