Technical Service Bulletin

Topic	27 48V vehicle electrical system warning, DTC U046900 stored in the ECM
Market area	United States 444 Volkswagen of America, Inc. (6444)
Brand	Audi
Transaction No.	2058831/17
Level	EH
Status	Released for publishing
Release date	Jul 31, 2025

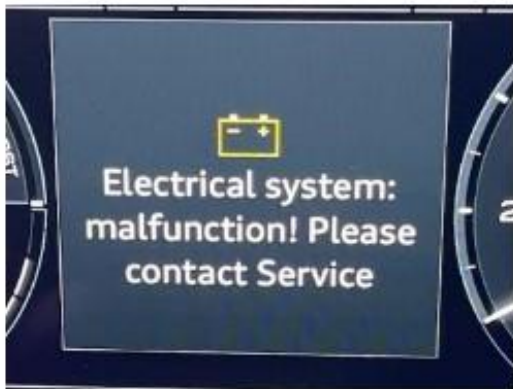
- The message “Electrical system: malfunction! Please contact Service” is displayed on the instrument cluster (Figure 1), in addition the battery symbol lights up in yellow or red.
- Yellow warning lamp related to the electrical system shown in the instrument cluster during driving.

Figure 1. Cluster Warning Message.
