UPDATE PRIOR TO SALE NOTICE

Global Service Action
Number: D020 UPS2625-2

Subject: Rear Right Lamp Assembly - Cosmetic Defect	Publication No.: D020 UPS2625-2
	Model: Range Rover (LK)
	Model Year: 2025
	Date of Issue: 03 June 2025
	Expiry Date: 29 May 2027

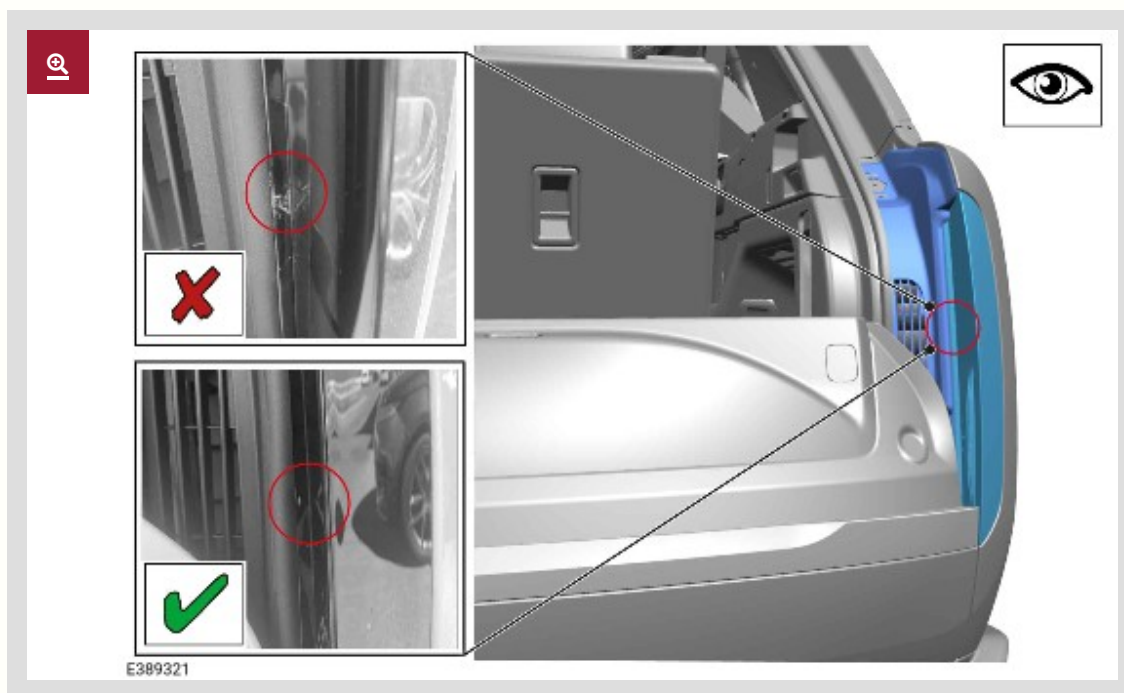
2. Inspect the rear right lamp assembly in the area shown in the illustration.

- If the rear right lamp assembly shows signs of cosmetic defects as shown in the illustration with the **RED X**, the inspection is a **FAIL**. Continue to the Service Instruction.
- If the rear right lamp assembly does not show any signs of cosmetic defects as shown in the illustration with the **GREEN**, the inspection is a **PASS**. Close the upper tailgate and release the vehicle.

1. Renew the rear right lamp assembly (see TOPIx Workshop Manual section 417-01: Exterior Lighting - Removal and Installation - Rear Lamp Assembly).
