## RADIATOR UPPER COOLANT HOSE- ADRIFT – P6

### Range Rover

- 22-25MY Range Rover
- 23-25MY RR Sport

SSM 76338

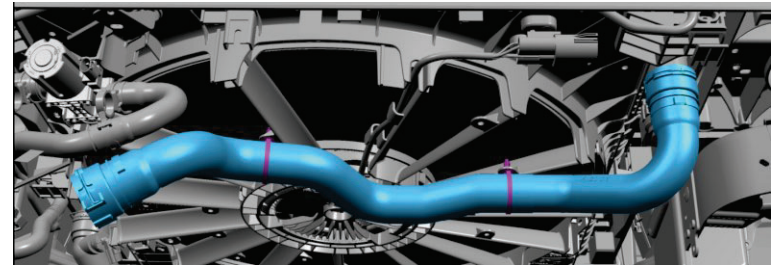
- During inspection of the radiator upper coolant hose, damage is evident as a result of contact with the electric cooling fan with either 1 or both of the cable tie clips incorrectly installed, broken or missing.

- Before removing the radiator upper coolant hose, take clear photographs showing the installed position of the hose, the location of the 2 cable tie clips (a photograph must still be taken even if 1 or both of the clips are missing), the part number of the hose and the damage caused by the contact with the electric cooling fan.
- Before installing a new radiator upper coolant hose, make sure the new hose is equipped with 2 clips.
- Only install a new radiator upper coolant hose after the photographs have been taken.
- NOTE: Ingenium I6 3.0L Petrol radiator upper coolant hose part number - LR151598
- Please raise an Electronic Product Quality Report (EPQR) which should include the information below:
  - Reference to PTS\_500
  - Reference to this SSM (SSM76338)
  - The requested photographs
