REFERENCE:	TSB: 23-029-25 GROUP: 23 - Body	Date:	August 6, 2025	REVISION:	—
VEHICLES AFFECTED:	2024 - 2026 (B1) Jeep Renegade (Brazil) This bulletin applies to vehicles built on or after June 28, 2024 (MDH 0628XX) and on or before May 23, 2025 (MDH 0523XX).			MARKET APPLICABILITY: <input checked="" type="checkbox"/> NA <input type="checkbox"/> MEA <input checked="" type="checkbox"/> SA <input type="checkbox"/> IAP <input type="checkbox"/> EE <input type="checkbox"/> CH NOTE: This bulletin applies to the North and South America markets.	
CUSTOMER SYMPTOM:	Customers may experience the following: <ul style="list-style-type: none"> • Water infiltration in the CHMSL. 				
CAUSE:	Manufacturing issue

This bulletin involves inspecting and possibly replacing the CHMSL.

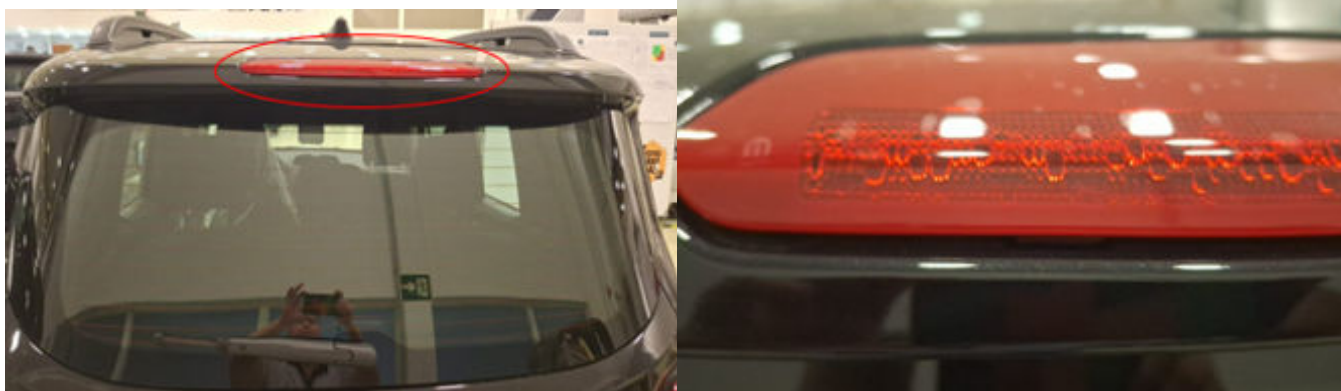
Fig. 1
CHMSL

1. Check if there is water in the CHMSL [Fig. 1](#).

2. Is there water in the CHMSL?
 - YES>>> Proceed to [Step 3](#).
 - NO>>> This bulletin has been completed. Use Inspect LOP (08-50-88-97) to close the active RSU.
3. Replace the CHMSL. Refer to the detailed procedures available in DealerCONNECT> Service Library> under: 5550D16 - Terceira Luz De Freio (Brake-Light) - Remoção/Recolocação.
