August 13, 2025

Rear Camera Displays Black and White Image

Year	Model	Trim Level	VIN Range
2023–25	Accord	LX, EX, and SE	ALL

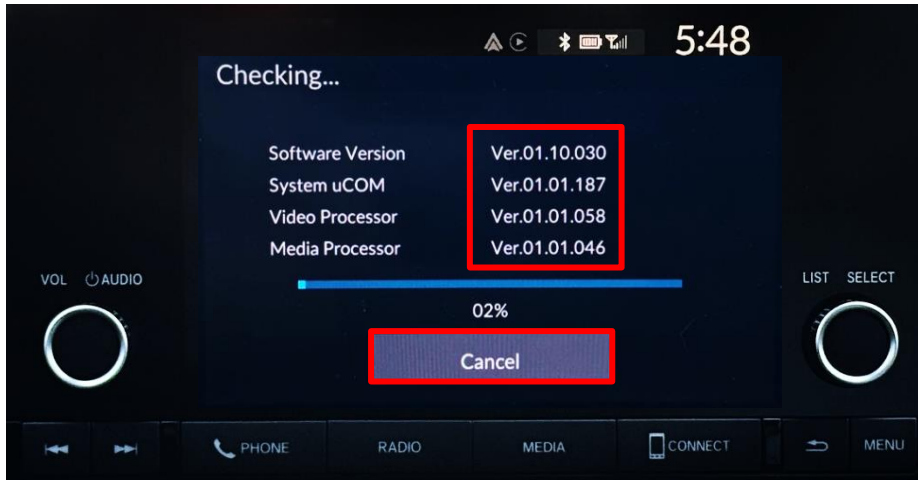
EXAMPLE: Incorrect Software

1. During the software "Checking" stage, it is important to confirm the software information on the screen matches the software table.

If the information does not match the table below, immediately press **CANCEL**. The update file on the USB flash drive **does not** apply to this vehicle. Confirm that you have downloaded the correct file for the vehicle model/trim you are working on.

Updating with the incorrect software will damage the audio unit and will require unit replacement.
