August 13, 2025

Rear Camera Displays Black and White Image

Year	Model	Trim Level	VIN Range
2022–25	Civic 4 Door	LX, EX, Sport	ALL
	Civic 5 Door

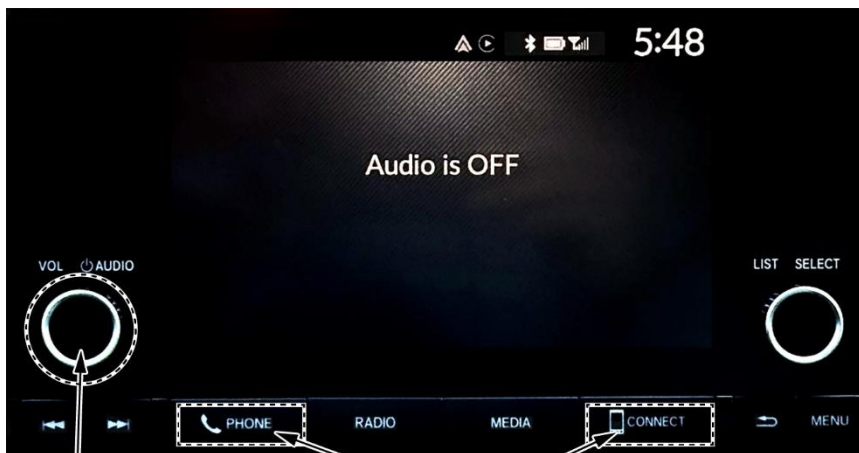
5. With the audio unit turned **OFF**, press the **PHONE** and **CONNECT** buttons at the same time, continue to hold the buttons, then press the **VOL/ AUDIO** knob **5 times** to enter the diagnostic menu.

VOL/AUDIO KNOB
Press 5 times.

PHONE and CONNECT BUTTONS
Press and hold simultaneously.

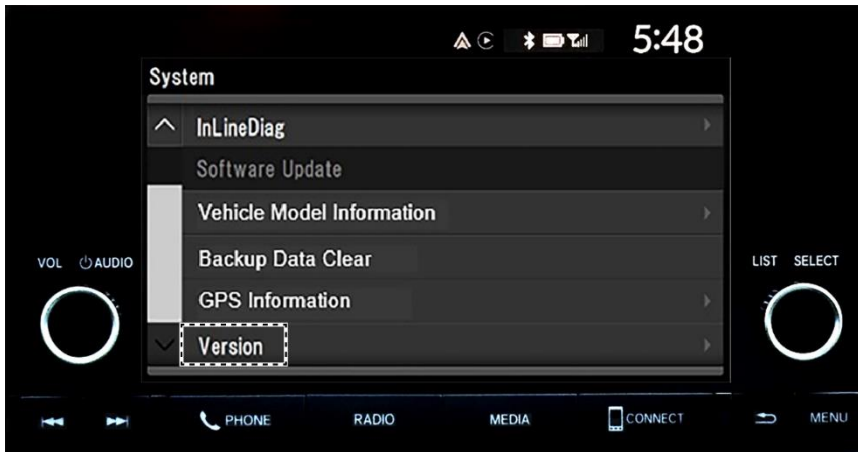
6. Select **System**, then scroll down and select **Version**.

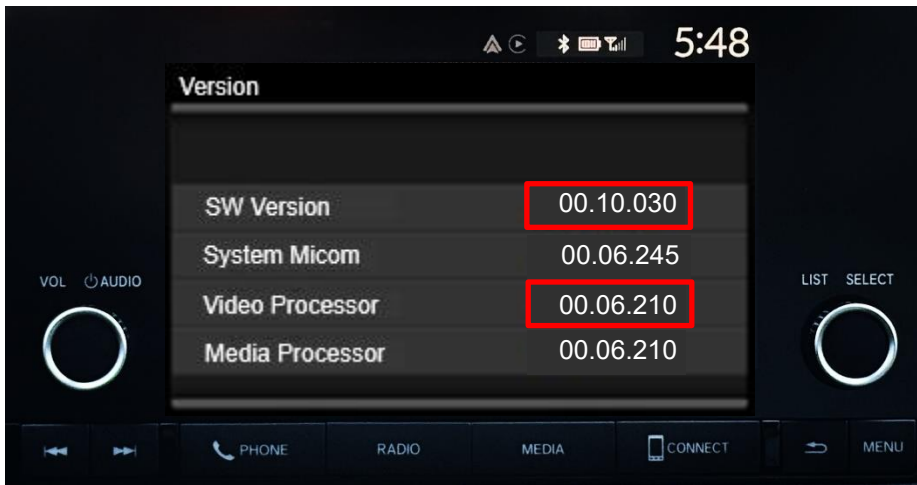
7. Check the audio unit **SW Version** and the **Video Processor** version.

Is the **SW Version** and the **Video Processor** equal to or greater than 00.10.030 and 00.06.210?

- **Yes** - The update has been applied; continue normal troubleshooting.
- **No** - Update the SW Version and Video Processor to the following:
 - SW Version 00.10.030
 - Video Processor 00.06.210

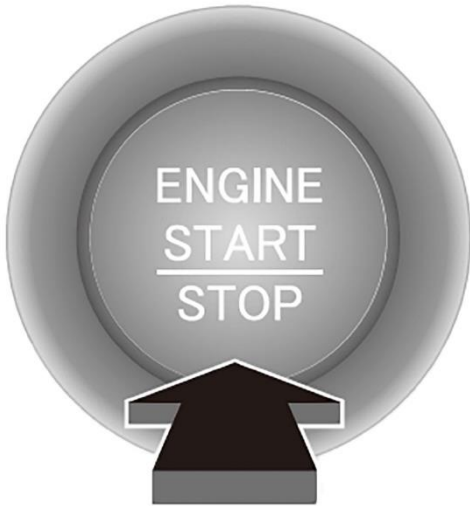
8. Push the **ENGINE START/STOP** button to **OFF**.

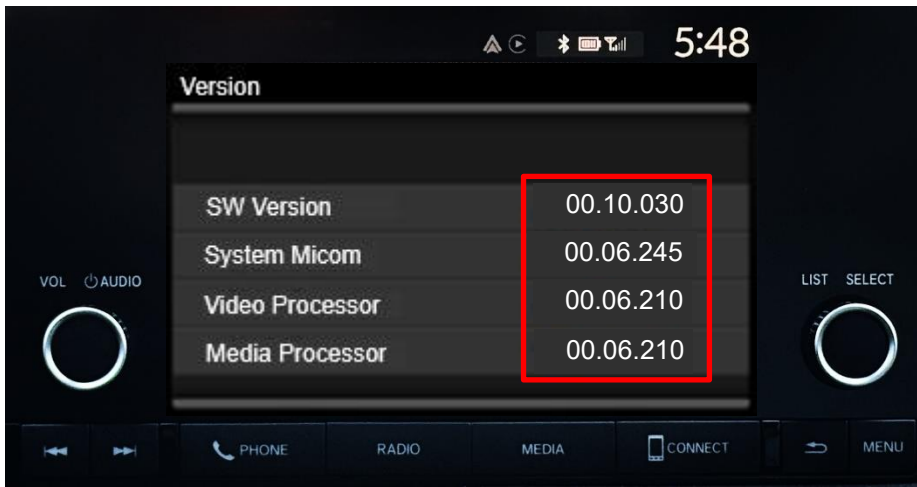
3. Confirm the software versions match the table below.

Software Version	00.10.030
System uCOM	00.06.245
Video Processor	00.06.210
Media Processor	00.06.210
