SIB 64 05 25

HVAC FLAP LINKAGE NOT FULLY CONNECTED

This Service Information Bulletin (Revision 4) replaces SI B64 05 25 **dated May 2025**.

# G45 HVAC: Air Vent Flaps/Kinematic & Stepper Motor Master Info.

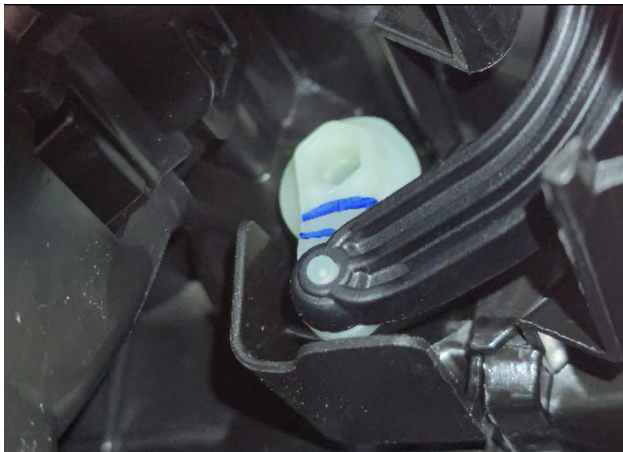
Check that the linkage has not come loose from the HVAC flap for the zone that is malfunctioning.

There is a white plastic mechanism that connects the black linkage arm and the HVAC flap assembly.
