UPDATE PRIOR TO SALE NOTICE

Global Service Action
Number: N949 UPS5324-3

Subject: SV Paint Bloom	Publication No.: N949 UPS5324-3
	Model: Range Rover Sport (L1)
	Model Year: 2025
	Date of Issue: 11 August 2025
	Expiry Date: 30 November 2026

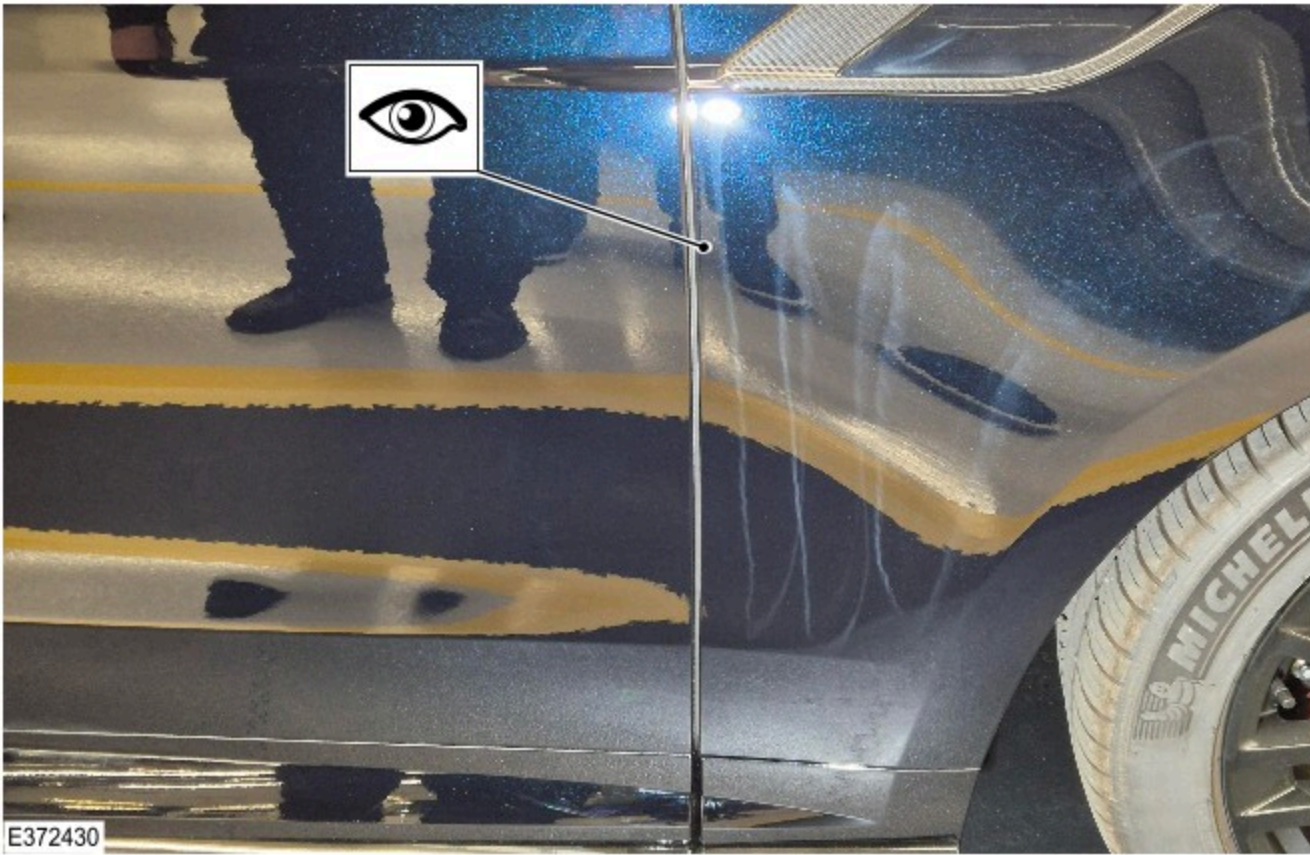
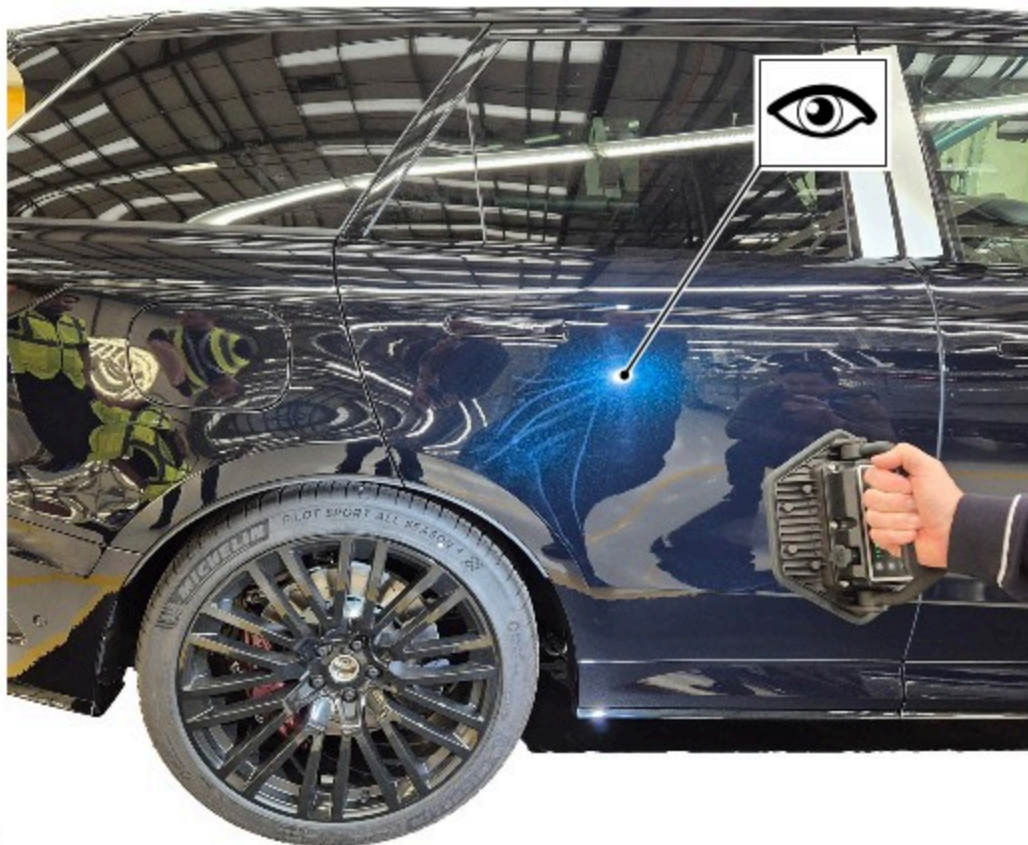
E372431

- All vehicles affected by this campaign will display varying levels of paint bloom.
- The paint bloom defect becomes more visible when viewed with a suitable light source and in some cases is not visible in natural day light.

The illustrations show examples of paint bloom visible on the vehicle.

Using a JLR approved bodyshop or equivalent vehicle detailing specialist, all body panels affected by paint bloom must be suitably polished to remove the defect.
