A6 e-tron, and Q6 Variants

Transaction No.: **2078072/2**

91 PSS Audi connect - Short lived remaining charging duration displayed in myAudi app

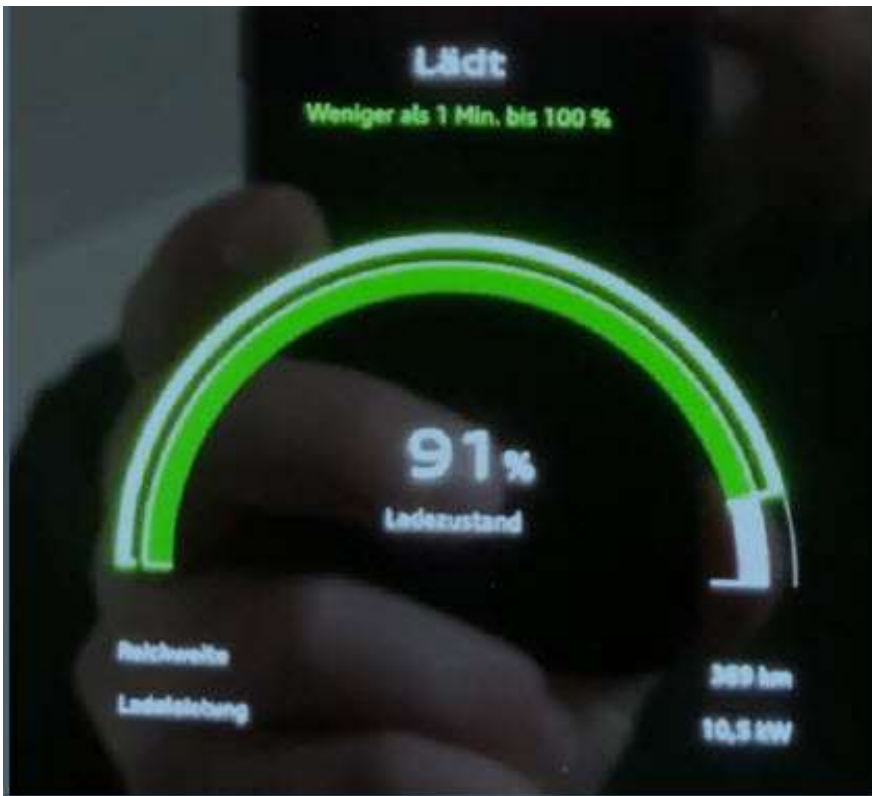
Figure 1. Remaining charging time message.

When the vehicle is connected for charging and the vehicle is ready for charging (LED switched from white to green in charging flap), the remaining charging time is displayed as being "Less than 1 min. to 100%" in the myAudi app for a short time (Figure 1) (while the charging time is being calculated).

The complaint can be reproduced.

Software issue.

1. Explain to the customer that a solution is expected to be available by the end of the 4th quarter of 2025 (subject to change) and that no repairs are necessary at this point.
2. Do not replace any components for this condition since this will not resolve the customer's concern.
3. Create a PSS record in the PSS application through the Pending Service Solutions (PSS) link in Access Audi (under *Related Links* >> *Service*).
