## Technical Service Bulletin

<b>Topic</b>	55 Rear lid does not close and opens again
<b>Market area</b>	United States 444 Volkswagen of America, Inc. (6444)
<b>Brand</b>	Audi
<b>Transaction No.</b>	2077738/3
<b>Level</b>	EH
<b>Status</b>	Released for publishing
<b>Release date</b>	Aug 29, 2025

### Audi Q6 Etron

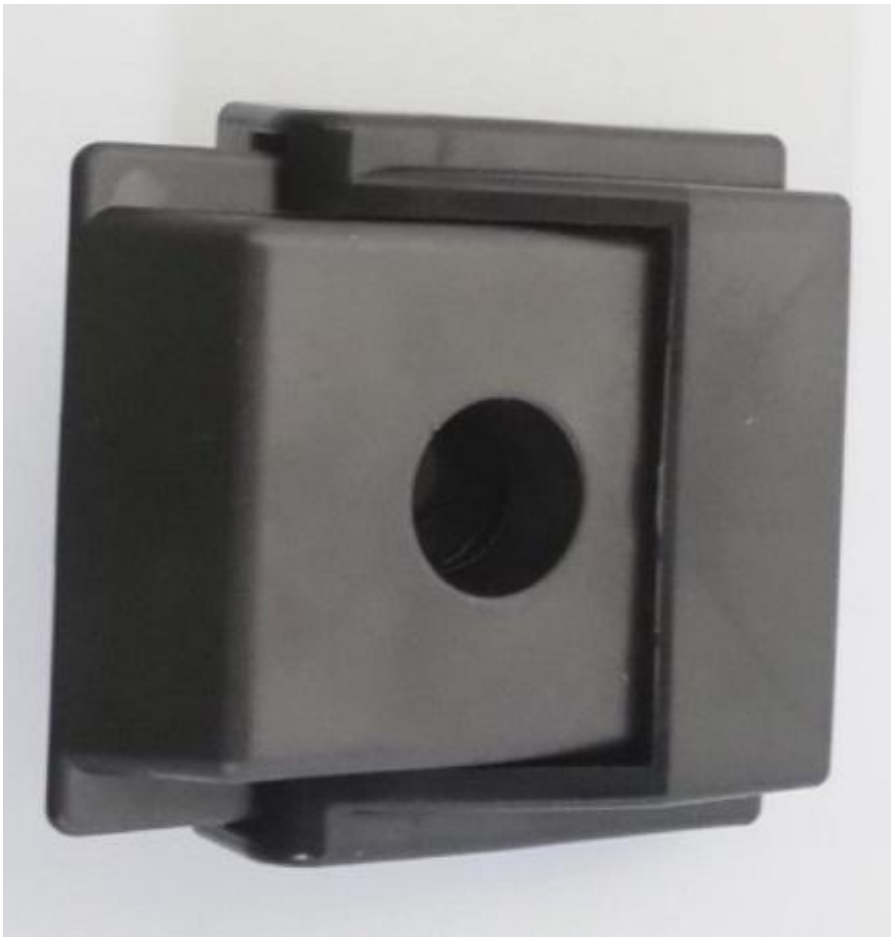
**Figure 1.** Pre-tensioned bump stop.

1. Remove the side bump stops (pre-tensioned spring buffers (Figure 1)). Using the Workshop Manual, spring force gauge VAS 895 035 and measurement film VAS 895 037, adjust the rear lid buffer force to between 40 N and 60 N and then fit the pre-tensioned spring buffers again. Alternatively, you can leave the side bump stop installed and set the buffer forces to the lower limit of 40 N. Please also observe the Special Technical Service Training video on the spring force gauge VAS 895 035 in the Audi Knowledge Tank (AKT). **NOTE:** If your vehicle is not equipped with side bump stops (Figure 1), please start from the point: "**Adjusting buffer forces using spring force gauge VAS 895 035**".
2. Then reset initialization of the rear lid and then adapt the flap opening angle again. Proceed as follows:

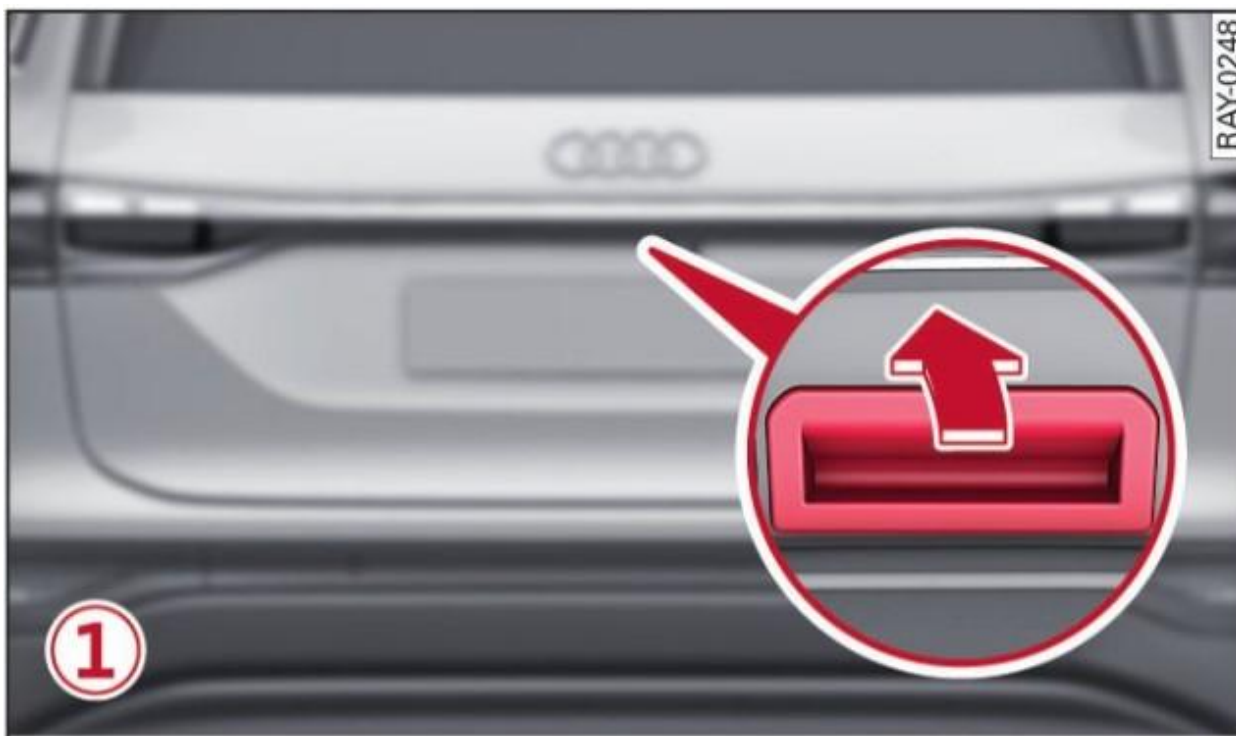
**Figure 2.** Electric rear lid lock actuation button.

Press and hold the electric rear lid lock actuation button on the outside (Figure 2) and the electric rear lid lock actuation button on the inside (Figure 3, item 3) simultaneously for at least 5 seconds. An audible signal will be given.
