GROUP	MODEL
	SST	All Applicable Models
	NUMBER	DATE
	082 (Rev 1, 09/04/2025)	April 2025

# TECHNICAL SERVICE BULLETIN

## SUBJECT: PISTON NOISE SENSING SYSTEM (PNSS) INSPECTION

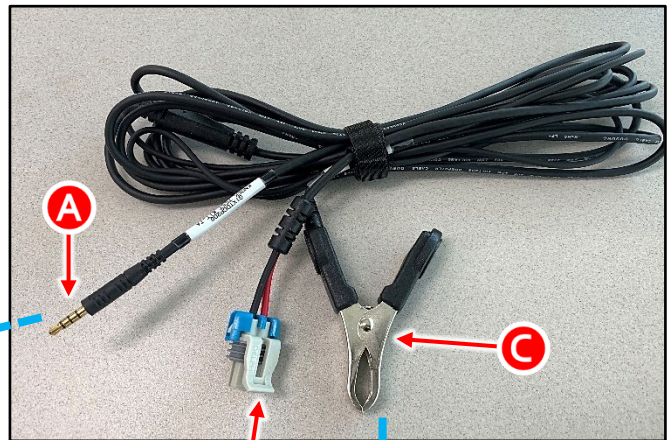
2. Connect the engine vibration inspection harness audio jack port\* (A) to KDS tablet.

Samsung USB Type C – 3.5mm adapter may be required.  
Model: EE-UC10JUWEGUS

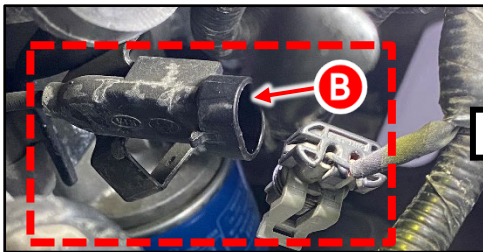
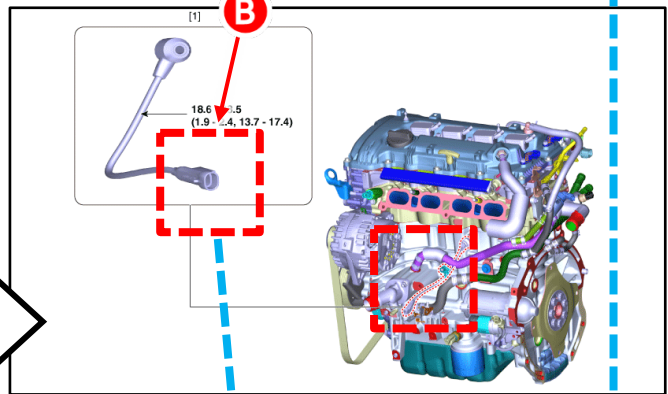
3. Disconnect the knock sensor connector and connect the knocking sensing connector of the engine vibration inspection harness to the engine knock sensor (B).

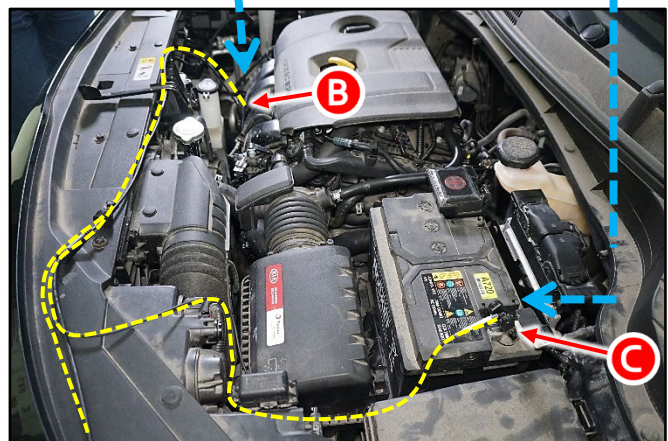
4. Connect the ground clamp (C) from the harness to the battery (-) terminal.

If the vibration inspection harness is placed over the engine components, external vibration may negatively affect to the inspection result. Route the wiring around the engine (yellow outline) shown in the photo.

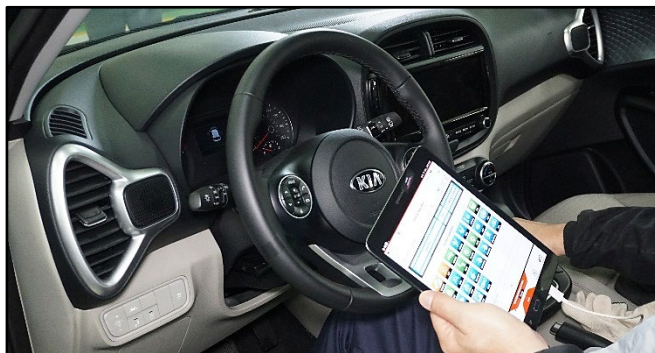
5. Connect the VCI-II to the vehicle's OBD2 port and confirm the Bluetooth pairing condition between KDS and VCI-II.

Open the 'KTUS' App and select 'KDS'.

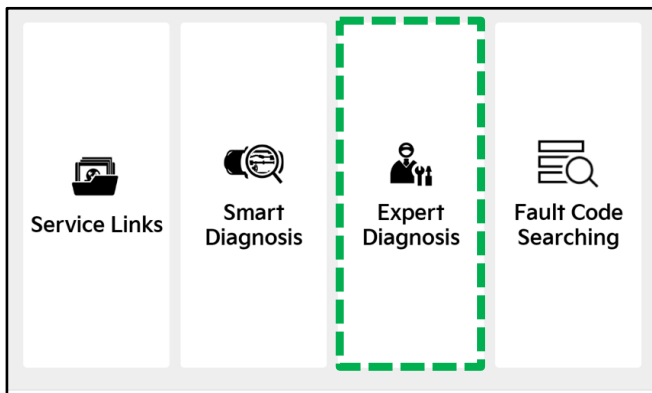
6. Select 'Expert Diagnosis'.

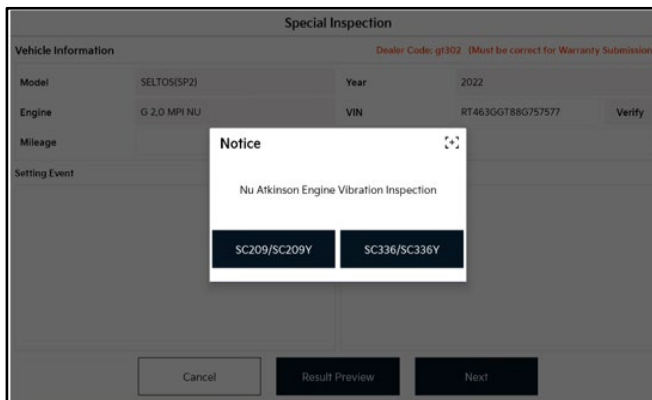
8. Select the applicable campaign for the vehicle in service.

1. SC209/SC209Y or
2. SC336/SC336Y

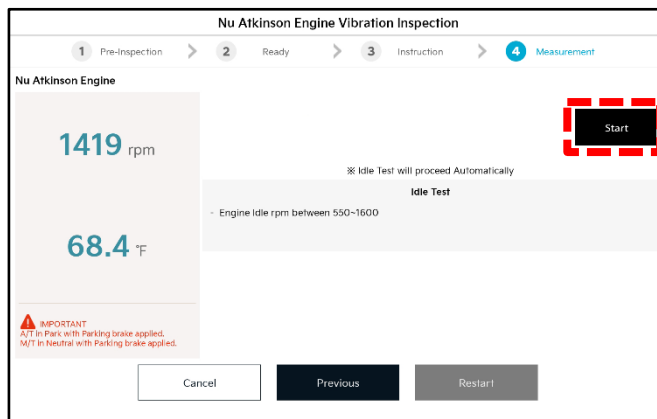
15. Select the engine 'Start' or turn the ignition 'ON' (engine running).
16. Select 'Start' on the KDS screen.

**NOTE:** If the measured vibration test is too low or abnormally higher than the set value, a pop-up message will display to check the audio jack input (microphone) or knock sensor connector.

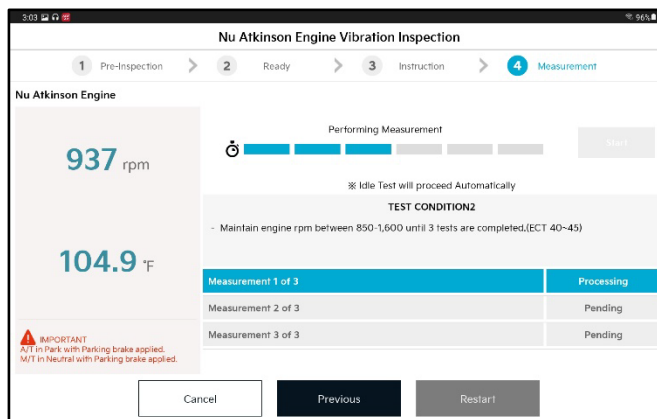
17. Follow the KDS screen instructions closely and ensure you follow the correct RPM and temperature values on the vehicle.

If the RPM or Temperature values are not within the required range, the color of the values will display in red.

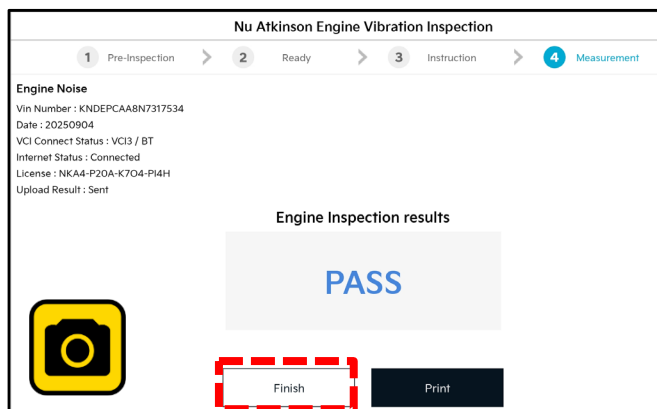
- 18a. **PASS:** If the measured engine vibration test has a normal condition, capture the screen image/screenshot for record keeping.

Select 'Finish'.

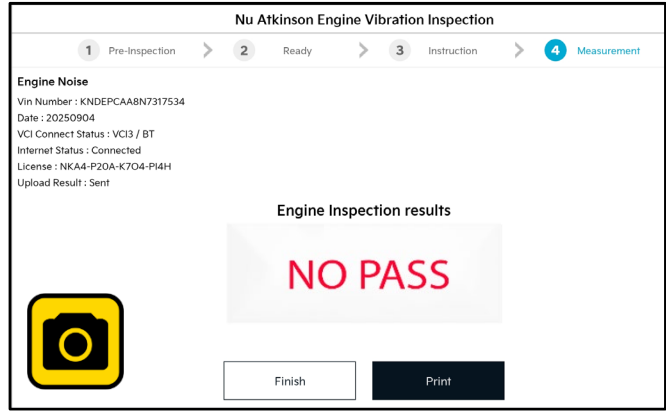
- 18b. **NO PASS:** If the measured engine vibration test is abnormal condition, **capture the screen image/screenshot for record keeping.**

Select 'Finish'.

Refer to TSB [ENG190](#) for information regarding engine replacement practices.
