**Washer Fluid Leaking at Front Left Cover Hinge/Hose for Front Windshield Washer System Leaking: Observe the Specified Procedure (58/25)**

Model Line: **718 (982)**

Model Year: **As of 2017**

Concerns: **Windshield washer system hose**

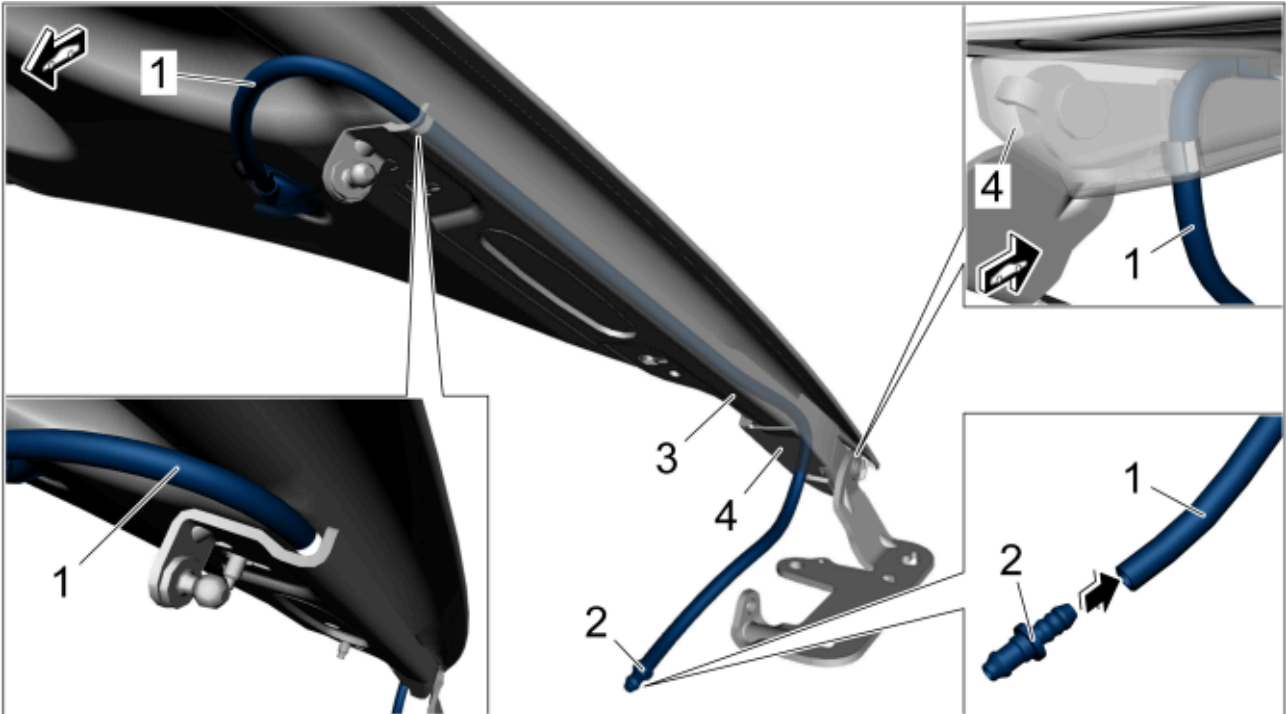
Cause: **The customer complains about water leaking at the front left cover hinge, as well as no or insufficient function of the front windshield washer system.**  
 The leak can be narrowed down to a damaged hose for the front windshield washer system in the area of the cover hinge.

- 1 – Front windshield washer system hose
- 2 – Connection piece
- 3 – Front left cover hinge
- 4 – Hose holder

- 3 Replace the previous hose for the front windshield washer system with a **new** hose for the front windshield washer system ⇒ *Front windshield washer system hose -1-*.  
Connect an **additional** new connection piece ⇒ *Front windshield washer system hose -2-* to the new hose on the front windshield washer system ⇒ *Front windshield washer system hose -1-*.

Make sure that the hose is laid in the same way as the original hose installation. ⇒ *Front windshield washer system hose*
