Complaint - Oil leaks on double clutch transmission (Porsche Doppelkupplung (PDK)): Observe specified procedure (163/20)

Model Line: **Panamera (971)**

Model Year: **As of 2017**

Concerns: **Double clutch transmission (PDK)**

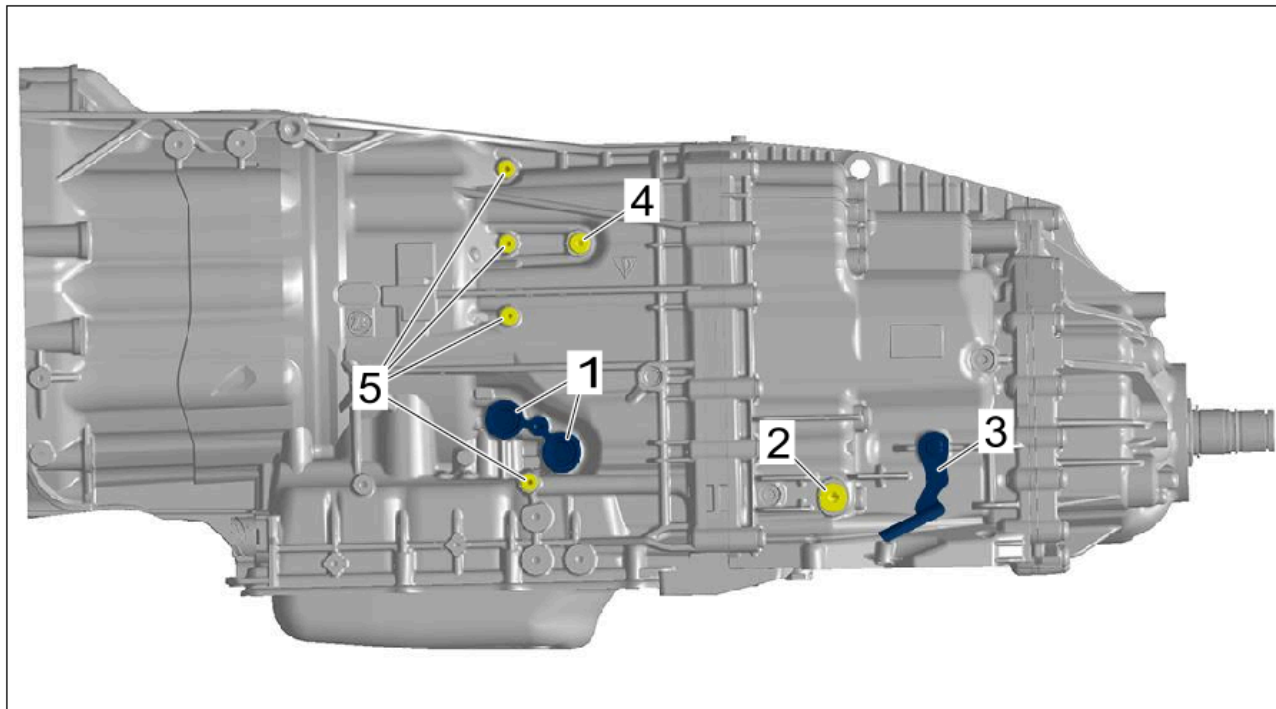
Position	Leak area	Possible cause(s)	Repair measure
<p>⇒ Left side of transmission -1-</p>	<p>ATF cooler connections</p>	<p>Sealing ring damaged:</p>

⇒ Left side of transmission -5-	Screw plug	Screw loose	Check that it is installed securely. Replace screw plug if necessary, see ⇒ <i>Technical Information 'Replacing screw plug'</i> .
		Sealing ring damaged

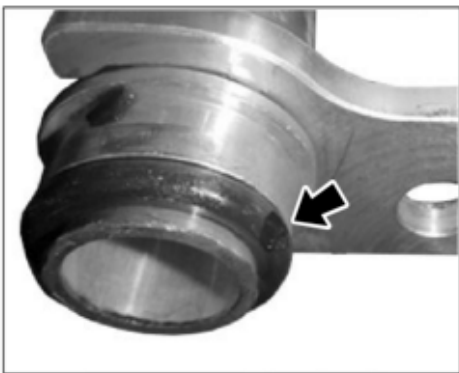
<p>ATF cooler sealing ring</p>	<p>Replace sealing ring on ATF cooling line, see ⇒ Technical Information 'Replacing sealing ring on ATF cooling line'.</p>

Replacing sealing ring on ATF cooling line

- Work Procedure: 1 Replace sealing ring on ATF cooling line, see
 ⇒ *Workshop Manual '386219 Removing and installing ATF cooling line (rear section)'* or
 ⇒ *Workshop Manual '386219 Removing and installing line for ATF cooling (hybrid)'*.
- 2 Check and top up ATF; see ⇒ *Workshop Manual '370235 Checking and topping up ATF'*.

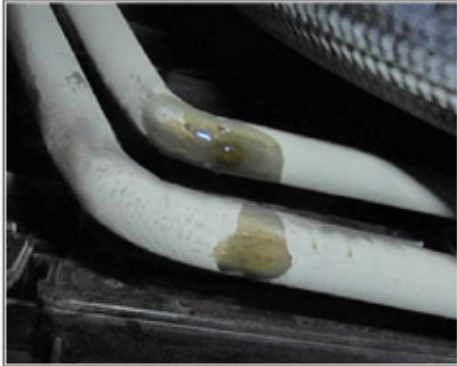
<p>Line corroded or crimping damaged:</p>

<p>ATF cooling line - corroded</p>

<p>ATF cooling line - crimping damaged</p>	<p>Replace ATF cooling line, see ⇒ <i>Technical Information 'Replacing ATF cooling line'</i>.</p>
⇒ Left side of transmission -2-	Screw plug	Screw loose	Check that it is installed securely.
		Sealing ring damaged	Replace double clutch transmission, see ⇒ <i>Technical Information 'Replacing double clutch transmission'</i> .
⇒ Left side of transmission -3-	Parking lock	Sealing ring damaged	Replace sealing ring for parking lock, see ⇒ <i>Technical Information 'Replacing sealing ring for parking lock'</i> .
⇒ Left side of transmission -4-	Screw plug	Screw loose	Check that it is installed securely.
		Sealing ring damaged	Replace double clutch transmission, see ⇒ <i>Technical Information 'Replacing double clutch transmission'</i> .

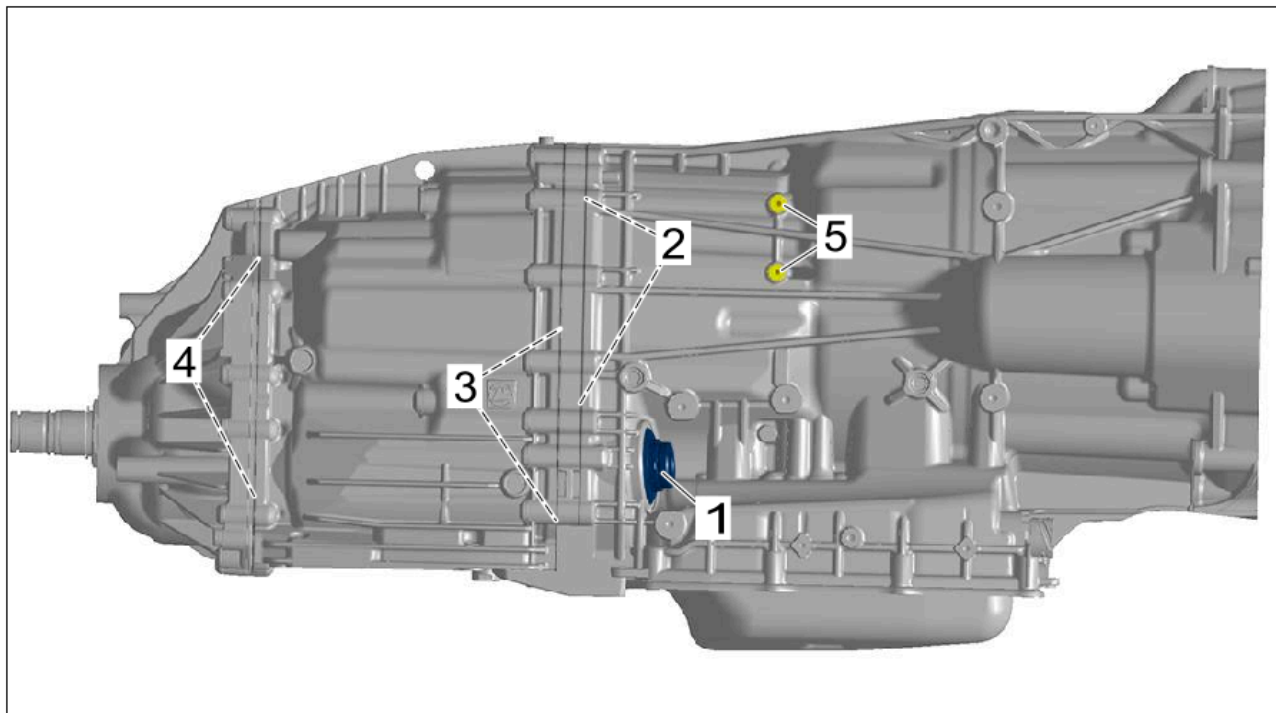
Position	Oil leakage	Possible cause(s)	Repair measure
⇒ Right side of transmission -1-	Front output shaft	Sealing ring damaged:

⇒ Right side of transmission -3-	Transmission housing	Screw loose	Check that it is installed securely.
		Seal damaged	Replace double clutch transmission, see ⇒ <i>Technical Information 'Replacing double clutch transmission'</i> .
⇒ Right side of transmission -4-	Transmission housing	Screw loose	Check that it is installed securely.
		Seal damaged	Replace double clutch transmission, see ⇒ <i>Technical Information 'Replacing double clutch transmission'</i> .
⇒ Right side of transmission -5-	Screw plug	Screw loose	Check that it is installed securely. Replace screw plug if necessary, see ⇒ <i>Technical Information 'Replacing screw plug'</i> .
		Sealing ring damaged

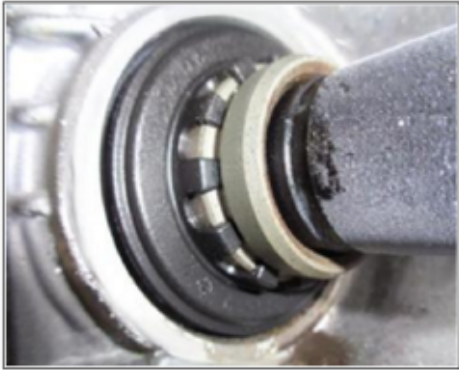
Output shaft sealing ring	Replace sealing ring for front output shaft, see ⇒ <i>Technical</i>
		O-rings damaged:

Replacing sealing ring for front output shaft

- Work Procedure: 1 Replace sealing ring for front output shaft, see ⇒ *Workshop Manual '387055 Replacing sealing ring for front output shaft'*.
- 2 Check and top up ATF; see ⇒ *Workshop Manual '370235 Checking and topping up ATF'*.

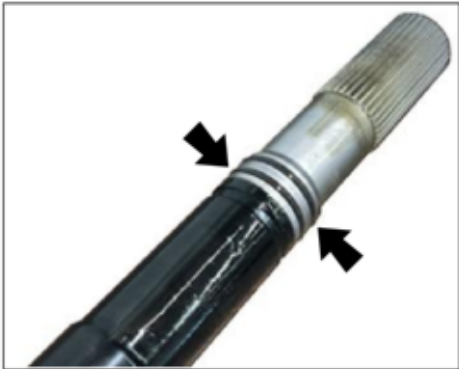
Output shaft O-rings	Information 'Replacing sealing ring for front output shaft'.
		Connecting shaft damaged	Check connecting shaft and replace it if necessary, see ⇒ <i>Technical Information</i> 'Replacing connecting shaft'.
		Cap damaged (2WD)	Replace cap at transmission output, see ⇒ <i>Technical Information</i> 'Replacing cap at transmission output'.
⇒ Right side of transmission -2-	Transmission housing	Screw loose	Check that it is installed securely.
		Seal damaged	Replace double clutch transmission, see ⇒ <i>Technical Information</i> 'Replacing double clutch transmission'.

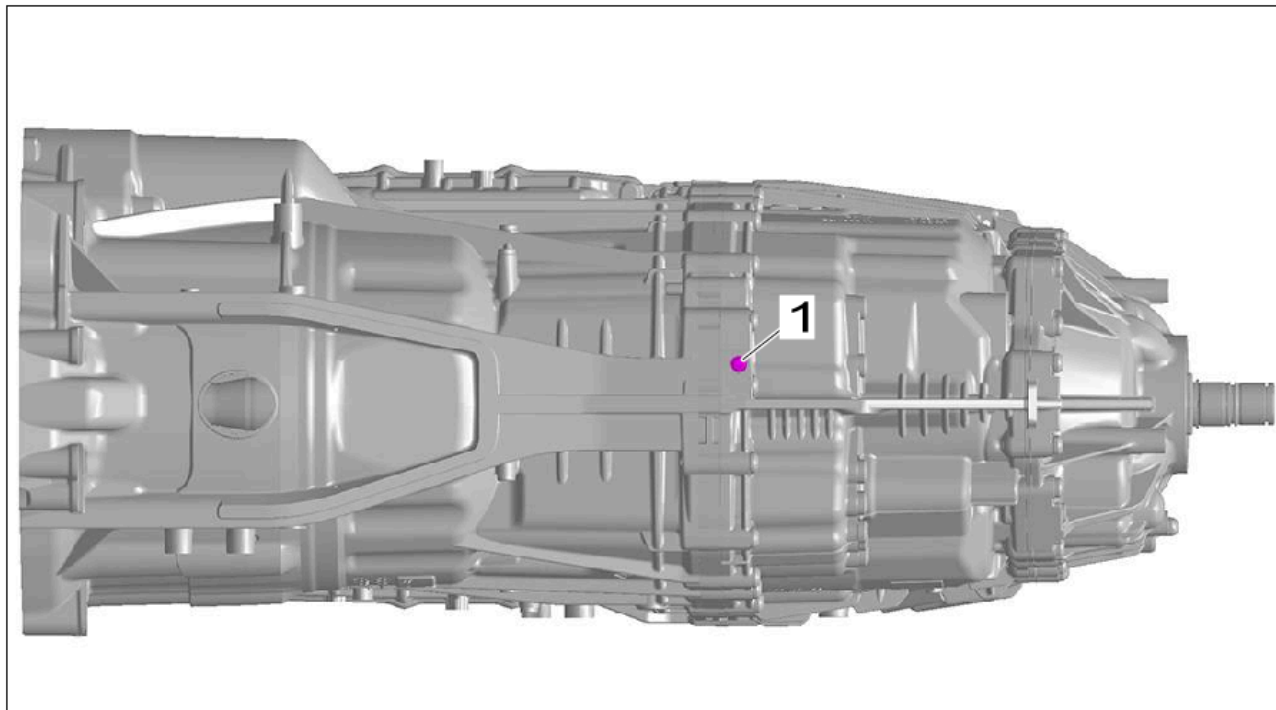
Position	Oil leakage	Cause	Repair measure
⇒ Upper side of transmission -1-	Hydraulic space bleeder	Oil over-filled	Check and top up ATF; see ⇒ <i>Technical Information 'Checking and topping up ATF'</i> .
		Insufficient defoamer	Change ATF, see ⇒ <i>Technical Information 'Replacing oil drain plug'</i> .
		Breather defective	Replace hydraulic chamber breather, see ⇒ <i>Technical Information 'Replacing breather'</i> .

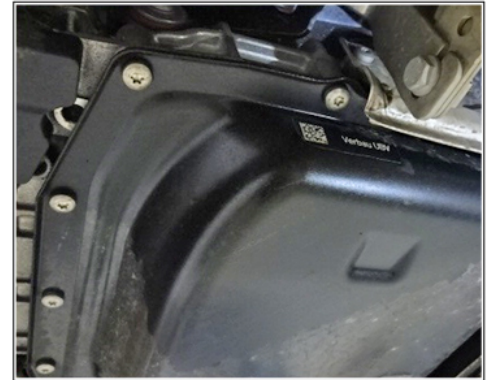
ATF oil pan

If the oil leak has spread so that the oil pan is also oily, as shown, proceed as follows in the event of a complaint:

- Ensure that the accessible oil pan screws are tighten to the specified torque.
- Before carrying out any further work, the entire transmission must be thoroughly cleaned in the areas of oil leaks/ oil contamination and sprayed with a suitable leak tracer/ spray (commercially available).
- Clean the transmission oil pan area extremely thoroughly. An oil pan seal leak can lead to incorrect interpretations. Then perform a test drive.
- **After the test drive, check the transmission for oil leaks below.**

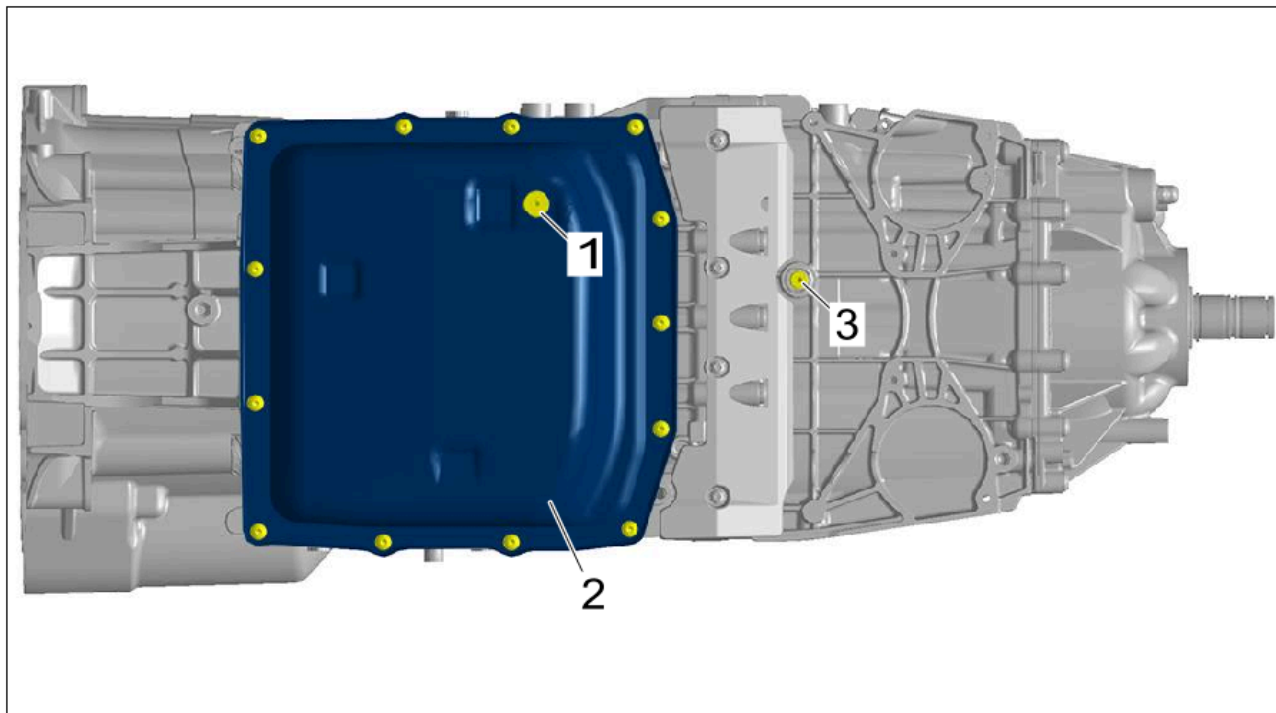
Position	Oil leakage	Cause	Repair measure
⇒ Lower side of transmission -1-	Oil drain plug	Screw loose	Check that it is installed securely. Replace oil drain plug if necessary, see ⇒ Technical Information 'Replacing oil drain plug'.
		Sealing ring damaged

⇒ Lower side of transmission -2-	ATF pan	Screws loose	Check that it is installed securely. Replace screws on the ATF pan if necessary.
		Seal damaged	Replace ATF pan, see ⇒ <i>Technical Information 'Replacing ATF pan'</i> .
⇒ Lower side of transmission -3-	Oil inspection plug	Screw loose	Check that it is installed securely. Replace lifting tube and oil inspection plug if necessary, see ⇒ <i>Technical Information 'Replacing oil inspection plug and oil pipe'</i> .
		Lifting tube loose

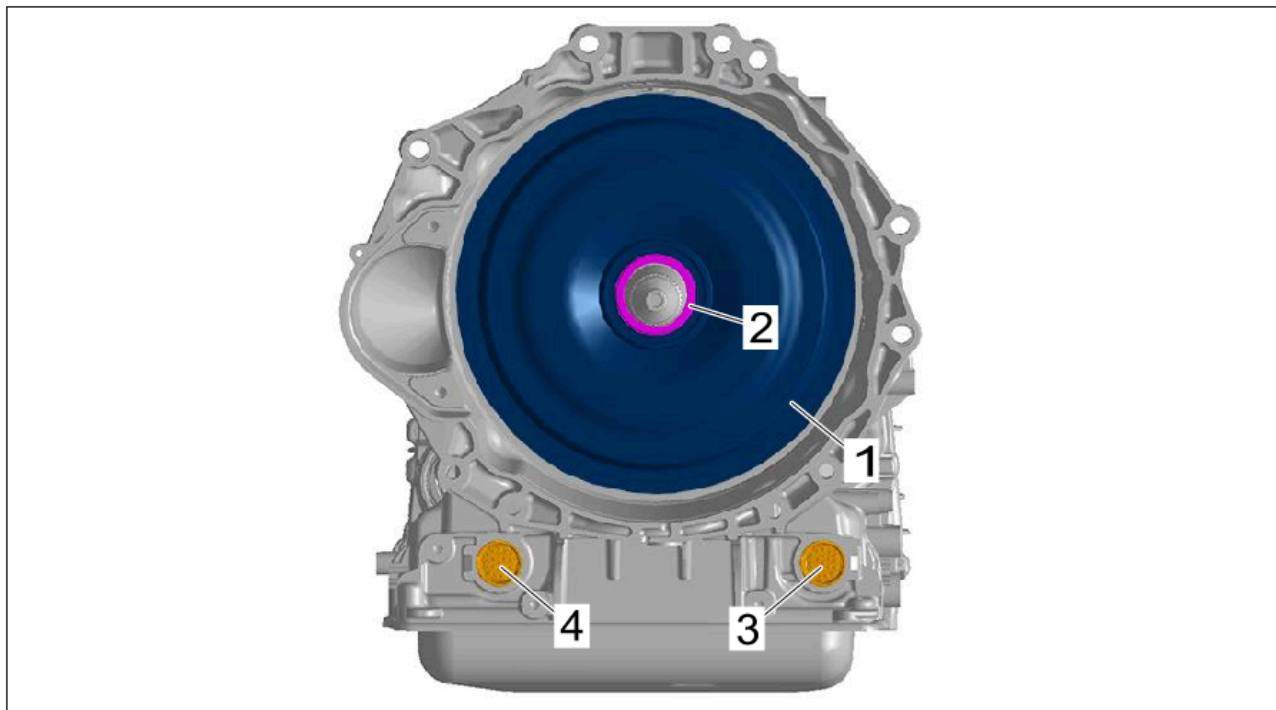
Position	Oil leak	Cause	Repair measure
⇒ Front side of transmission -1-	Clutch bell-housing and clutch cover	Apparent assembly grease leak	No action required.
		Grease leak on dual-mass flywheel	Check dual-mass flywheel, see ⇒ <i>Technical Information 'Checking dual-mass flywheel (DMF) on vehicles with PDK (11/14)'</i> .
		Engine leaking	Find oil leaks and fix them.

Radial shaft seal on clutch cover damaged	Replace radial shaft seal, see ⇒ <i>Technical Information 'Replacing radial shaft seal'</i> .
		Clutch cover O-ring damaged	Replace double clutch, see ⇒ <i>Technical Information 'Replacing double clutch'</i> .
⇒ Front side of transmission -2-	Clutch cover	Radial shaft seal on clutch cover damaged	Replace radial shaft seal, see ⇒ <i>Technical Information 'Replacing radial shaft seal'</i> .
⇒ Front side of transmission -3-	Central connector on the left	Connector leaking	Replace wire harness in transmission, see ⇒ <i>Technical Information 'Wire harness displaced'</i> .
⇒ Front side of transmission -4-	Central connector on the right	Connector leaking	Replace double clutch transmission, see ⇒ <i>Technical Information 'Replacing double clutch transmission'</i> .

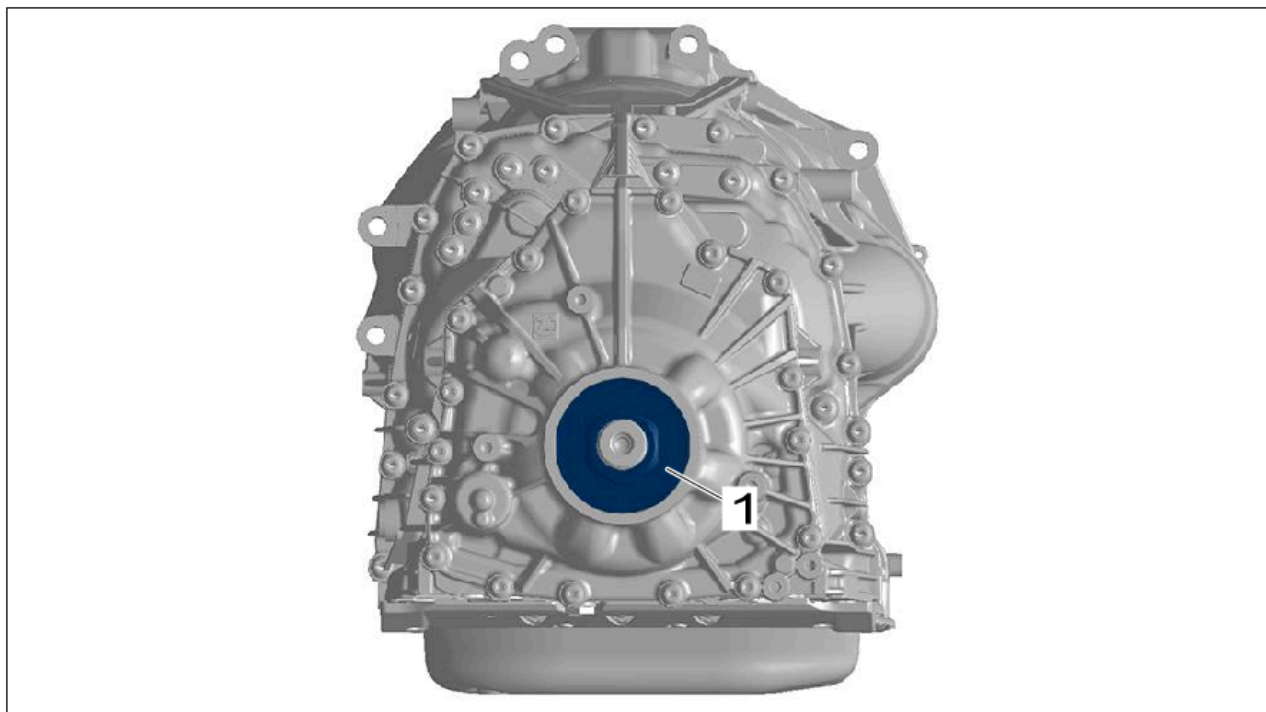
Position	Oil leak	Cause	Repair measure
⇒ Rear side of transmission -1-	Rear-axle shaft	Shaft sealing ring damaged	Replace sealing ring on cardan flange, see ⇒ <i>Technical Information 'Replacing cardan flange sealing ring'</i> .

Replace cardan flange sealing ring

Work Procedure: 1 Replace sealing ring on cardan flange, see ⇒ Workshop Manual '398255 Replacing cardan flange sealing ring'.
