Service Bulletin

Bulletin No.: PIT5479H

Subject: Diagnostic Tip - Perceived Brake Fluid Leak at Caliper Piston Boot

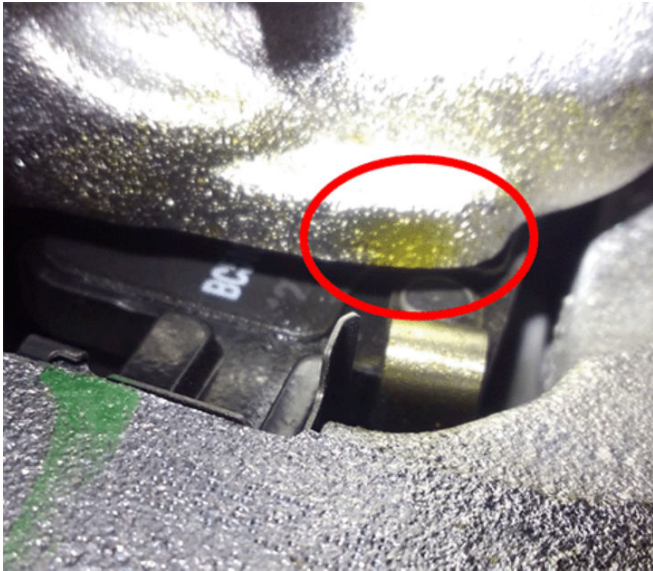
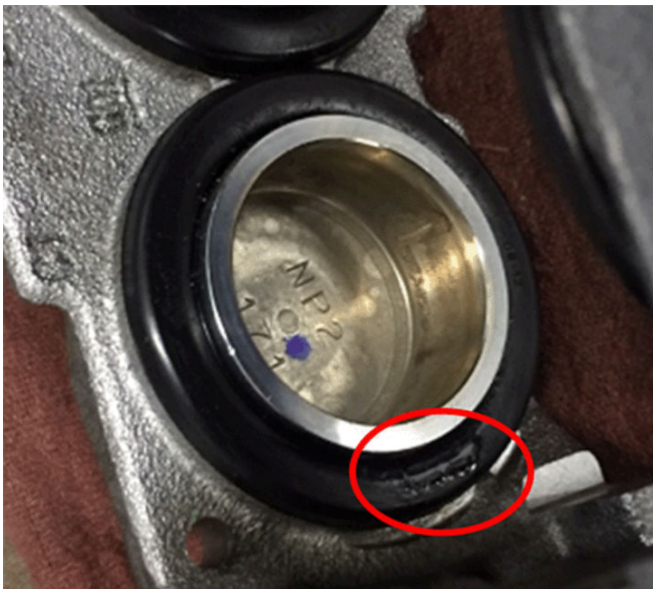
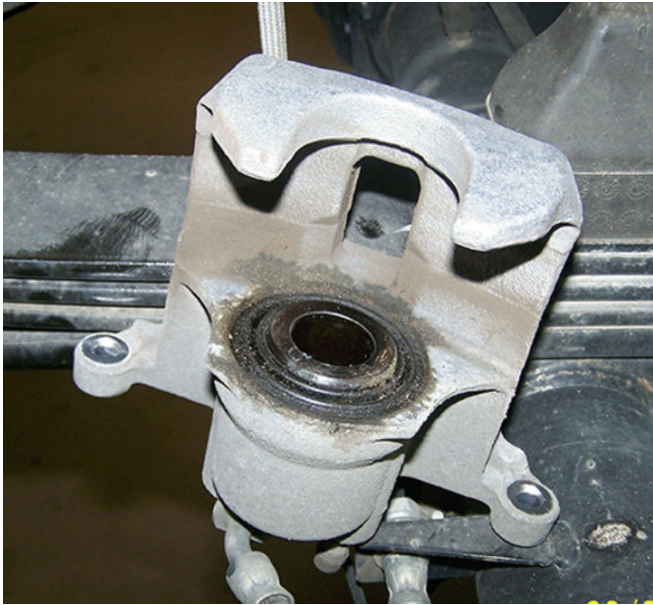
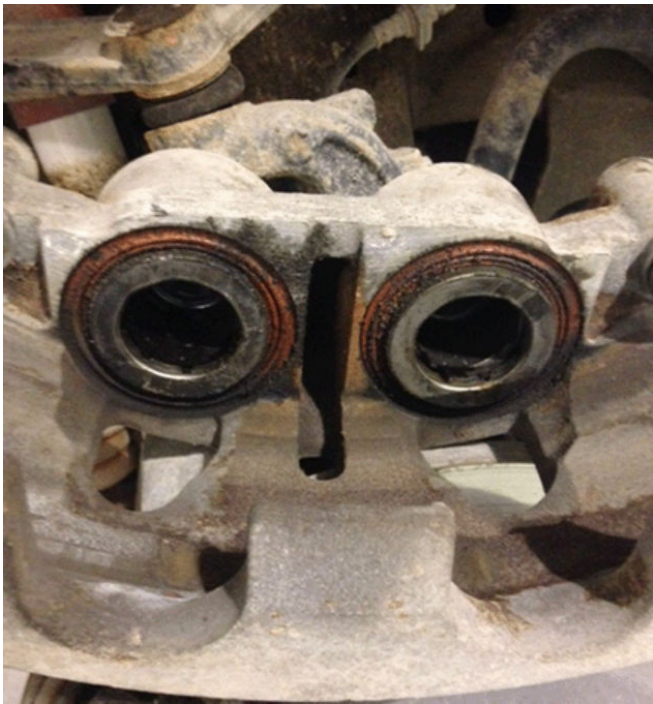
A technician may comment that, during service, it appears there is fluid leaking from the brake caliper piston area. Shown below are examples of newer low mileage vehicles and older higher mileage vehicles.

The substance shown is actually excess assembly grease from the caliper boot and piston installation. This grease can be cleaned off and the rest of the service completed.

Note: When diagnosing a brake fluid leak or certain DTC's for hydraulic brake circuit leaks, such as C05B0, do not confuse excessive assembly grease as a brake fluid leak. If it is uncertain what is seen is assembly grease, then clean off the excessive grease and apply the brake pedal 20 times and re-inspect for a leak.
